Texas A&M University
Graduate Engineering Class Presentation

AXIAL VIBRATION FOR A SYNCHRONOUS MOTOR, GEARBOX, COMPRESSOR TRAIN

TWO POLE MOTOR VIBRATION DIAGNOSTICS, ANALYSIS AND SOLUTION

Vertical Turbine Pump Reliability Improvement

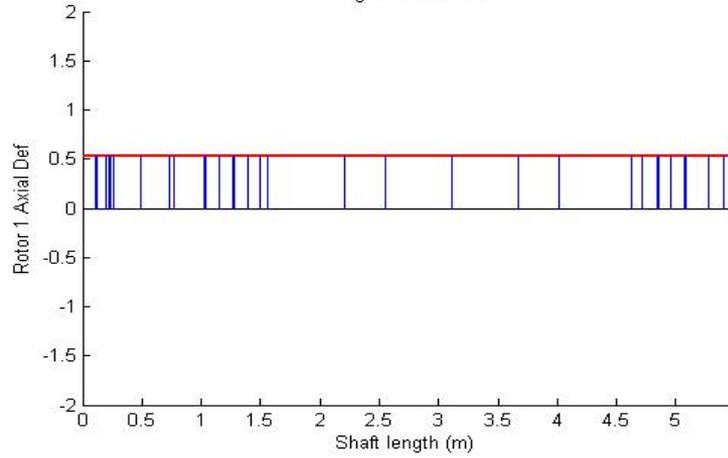
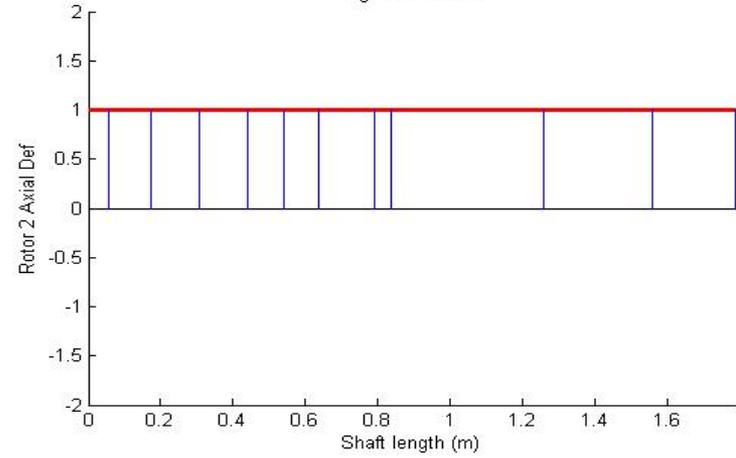
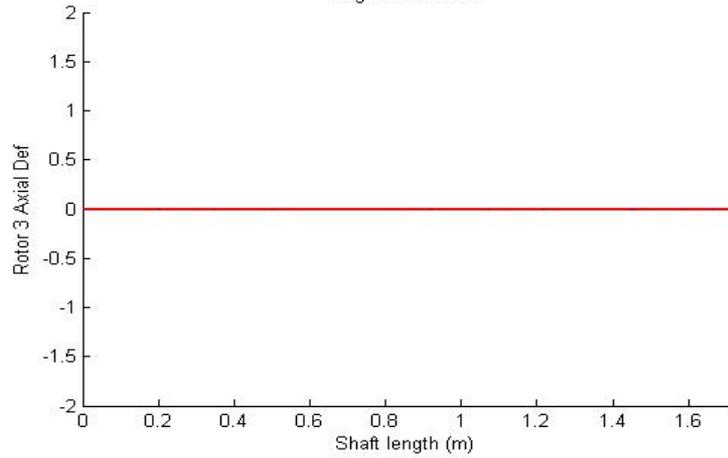
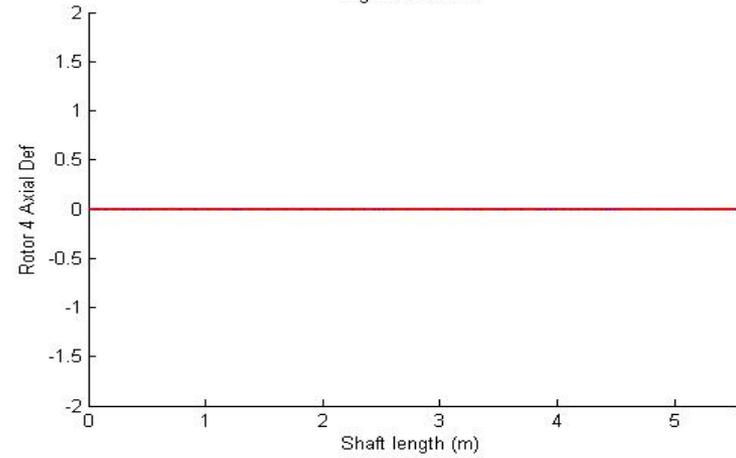
Rotor 1
Damped Freq=74.8049 RPM
Log Dec=4.4464

- Ncrit1-axial = 1.4 Hz (85 CPM)

- The axial oscillation frequency is 2.8 Hz.
- The rotor oscillates at 2X Ncrit1-axial and is visible to the observer.

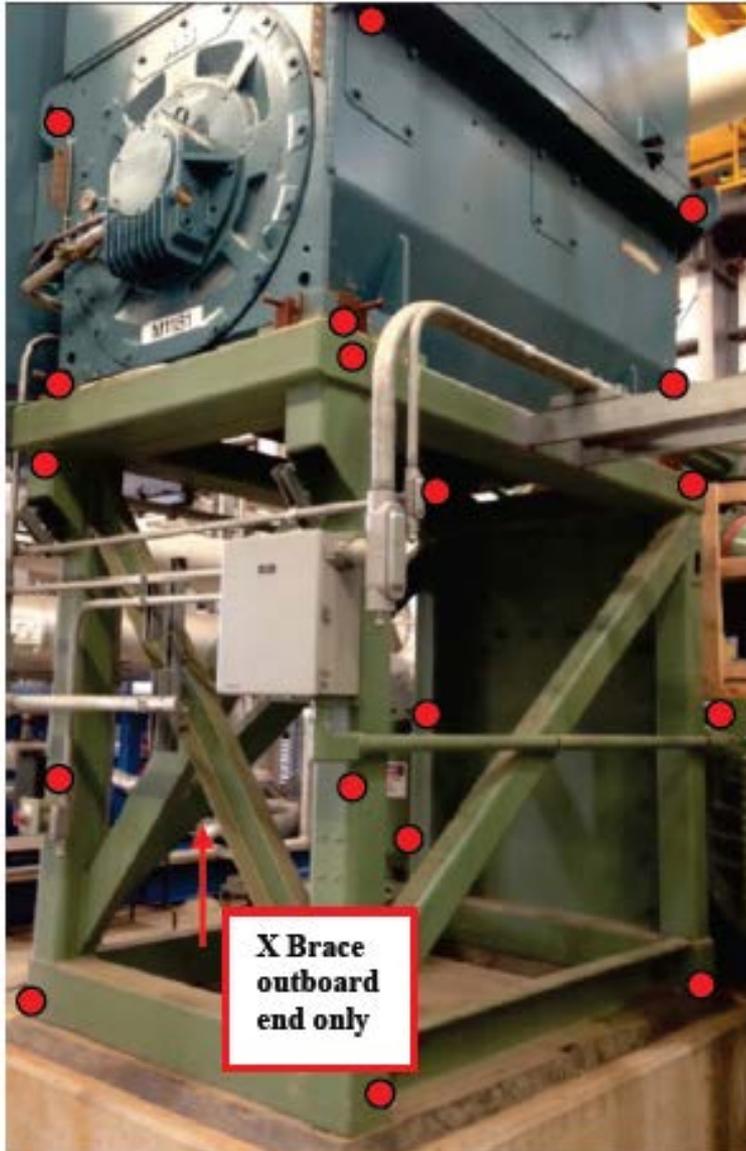
Field Measurement

- 1X dominant
- Found structural mode at 3000 rpm with cracked foundation
- Mode shape is mainly lateral vibration on the drive end, where the crack foundation is – at the anchor bolt location.
- Lose foot was foundation a year before and corrected, alignment done as well. Vibration amplitude unchanged.

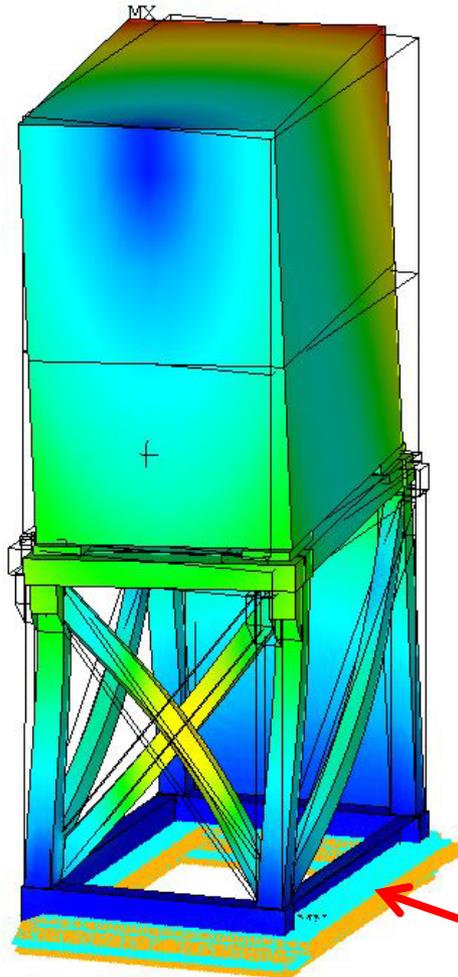
As-Design Condition

- The support has a natural frequency at 57.9 Hz, which is very close to the motor's running speed of 60 Hz
 - This resonance was likely the original cause of the foundation crack
 - Simply fixing the loose foot due to the damaged foundation did not and will not solve the resonance problem
 - This mode must be pushed away from the motor's synchronous excitation

All DOFs fixed on the bottom, no loose foot due to damaged foundation

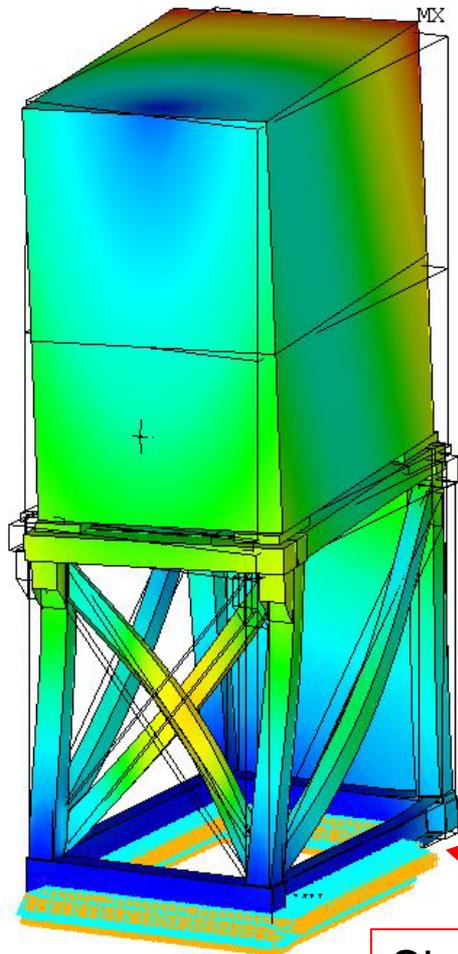
As-Found Condition

- The frequency of the problematic mode is reduce to 52.8 Hz
 - Both the frequency and the mode shape match the field measurements
 - This good correlation validates the FE model
 - Provides a good baseline to investigate solutions
 - The objective is to achieve 20% separation margin

Simulate the loose foot due to the damaged foundation by removing the constraints near the foot

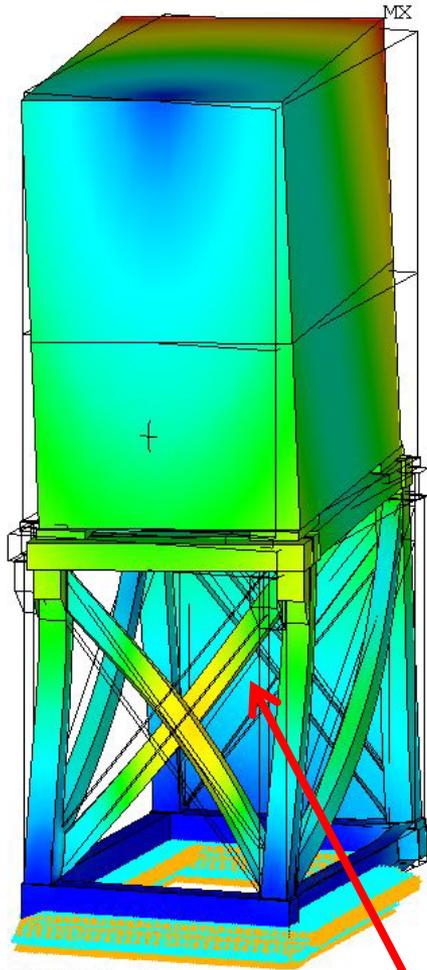
Initial Modification

- The frequency of the mode is increased to 53 Hz
 - Not a solution
 - Since the inboard end shows large displacement, it was intuitive to strengthen this end
 - However, this end is already very stiff due to the plate
 - Further stiffening is not effective
 - Strengthening device should be applied to the area showing the most twist, rather than the area showing the most displacement

X-brace added on the inboard end, loose foot

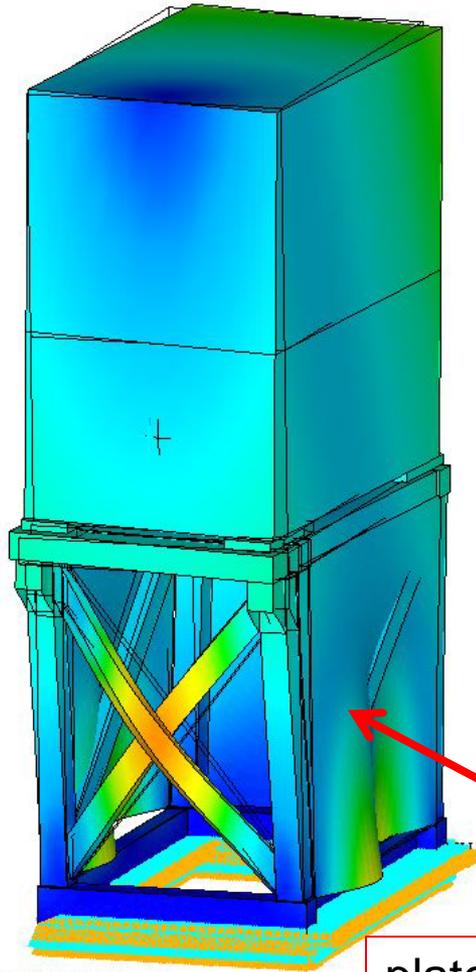
A Viable Modification

plate added to both sides

- Plates are added to the side surfaces
- The frequency of the problematic mode is increased to 72.8 Hz
 - 20% SM is achieved
- As a solution
 - Bottom of these plates should be welded as well
 - The plate should also be welded to the X-brace to reduce noise

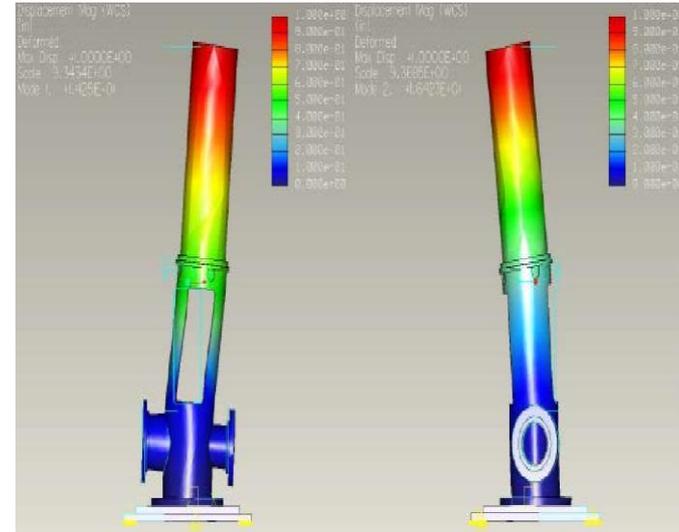
Operating Deflected Shapes at Resonance Speed

- Narrow operating speed range (885 – 985 RPM)
- Pump critical speed is highly reliant upon bushing clearances.
- Large clearance bushings were originally installed
 - Typical bushing clearance (per OEM):
6 - 13 mils diametral (1.7" journal, $Cd/D= 3.5\sim7.6$)
 - Actual bushing clearance:
11 - 21 mils diametral (1.7" journal, $Cd/D= 6.5\sim12.4$)

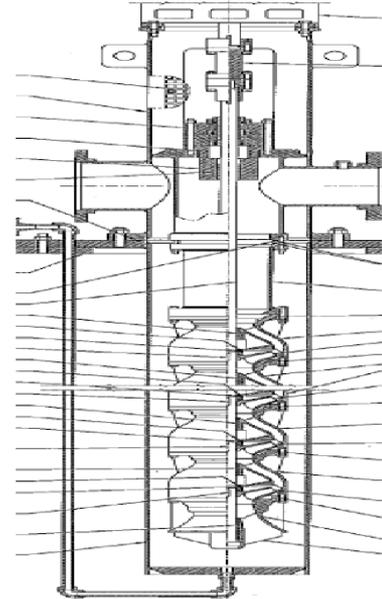
Wear Pattern – Shaft and Bushings

Flow recirculation on the top stage caused more damage to the top two bushings. Bottom 1st stage bushing was edge loaded.

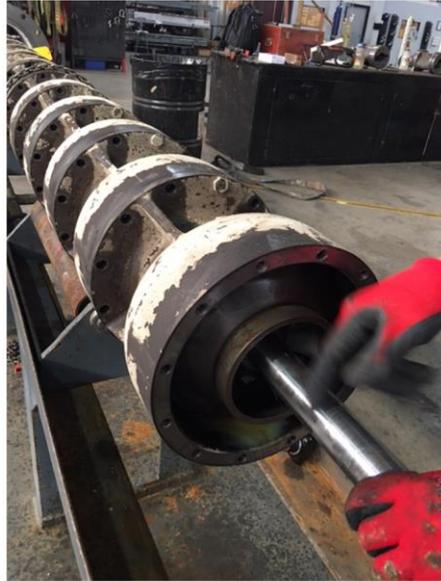
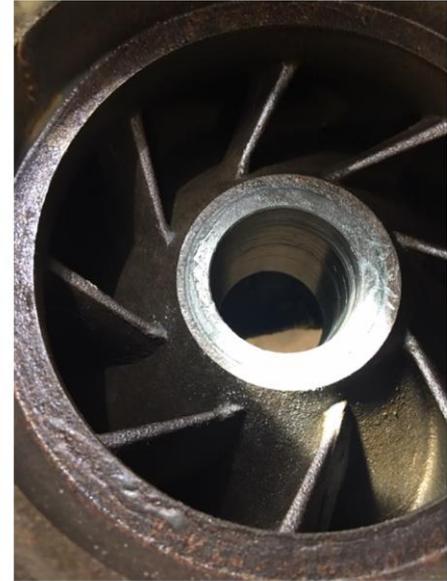
Turbine/Pump Impellers – No Balance Orifice

- Variable Speed Drive.
- Unbalanced impeller Thrust.
- Rigid Drive Shaft
- **Motor Bearing takes Thrust Load!!!**
