Forty-Eight Case Histories of Intriguing Machinery Problems

Nelson Baxter, ABM Technical Services, Mooresville, Indiana

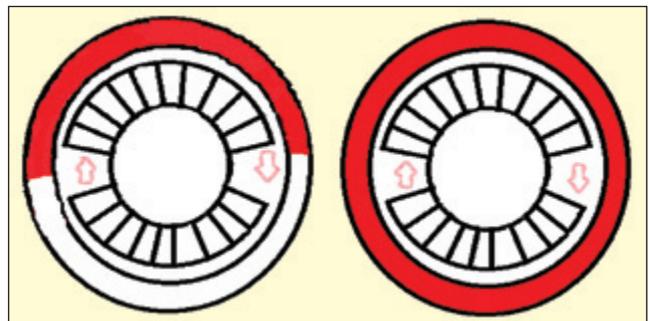
Figure 1. Steam admission to wheel; partial arc (left), gaps go in and out; full arc right, gaps are always in steam path.

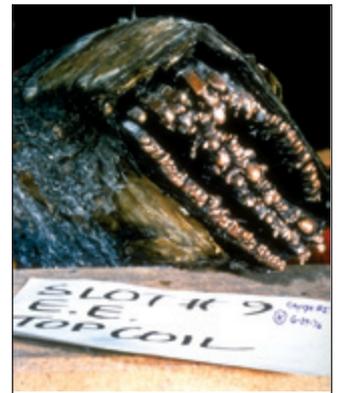
Figure 2. Melted 500 megawatt generator phase lead.

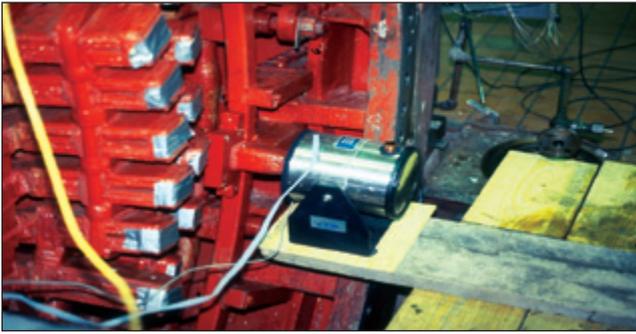
Figure 3. Electro-magnetic shaker testing phase leads.

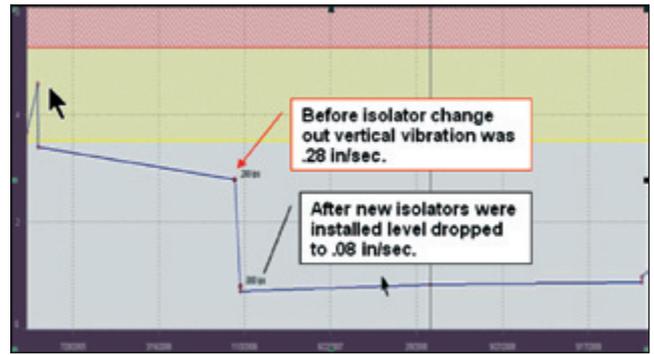
Figure 4 Vertical fan vibration levels before and after installing new isolators.

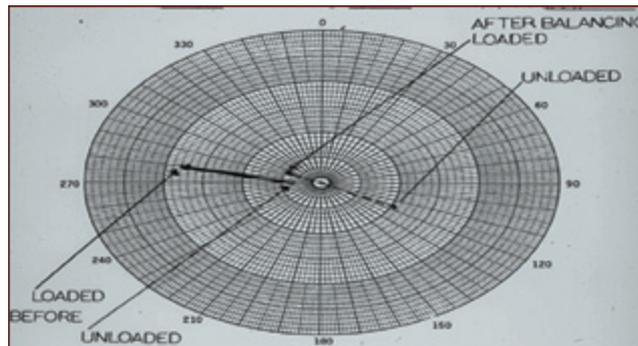
Figure 10. Balance shot.

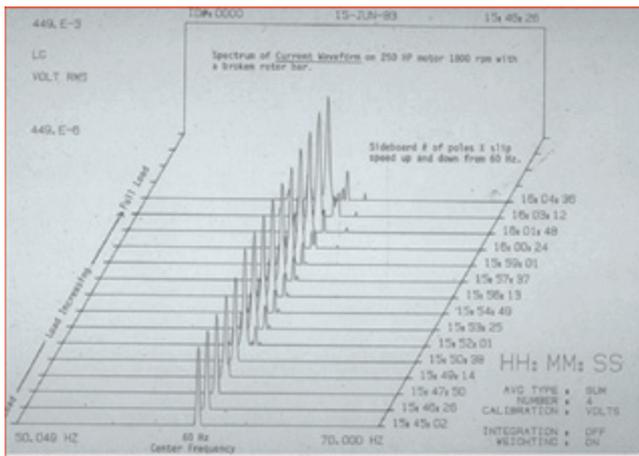
Figure 11. Cracked rotor bar analysis.

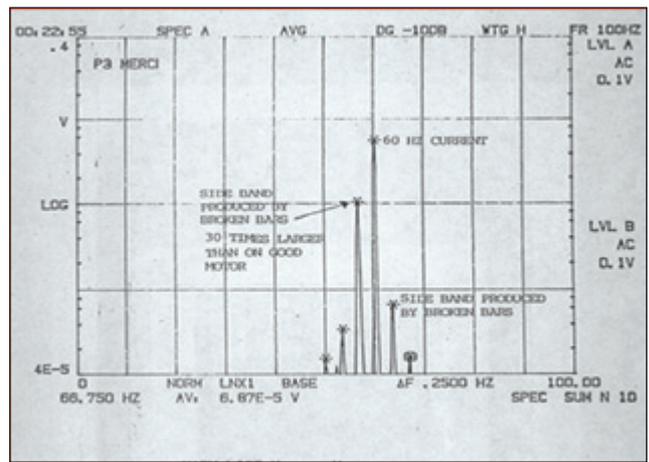
Figure 12. Cracked end ring analysis.

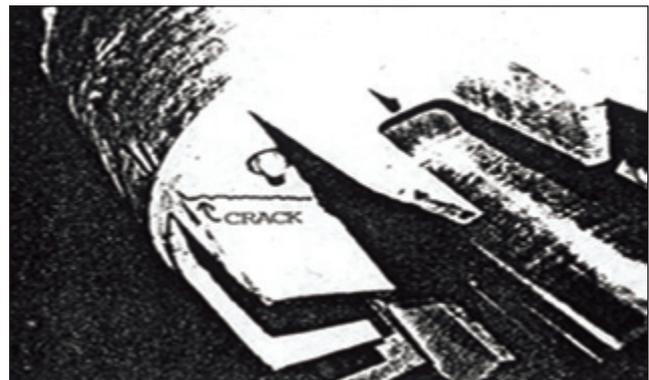
Figure 13. Cracked rotor bar.

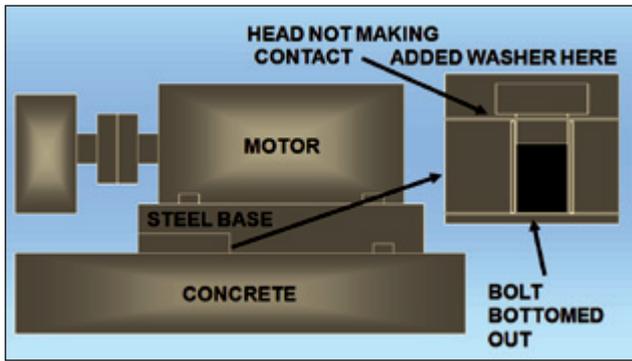
Figure 14. Motor vibration 8 mils; bolt tightened but not making contact; when washer added, vibration fell to below 1 mil.

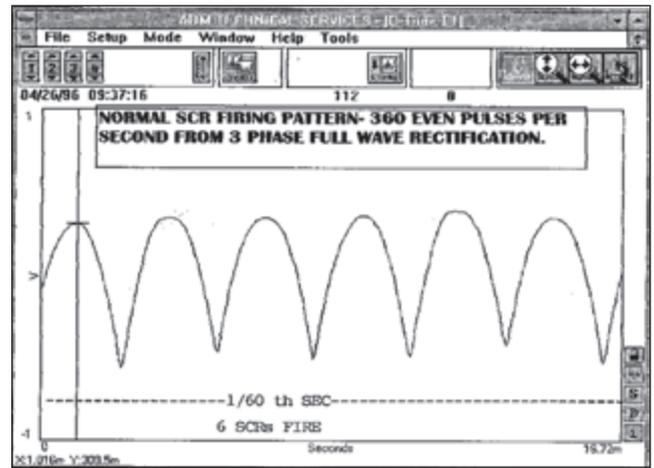
Figure 15. Waveform from pump drive following replacement of bad SCR.

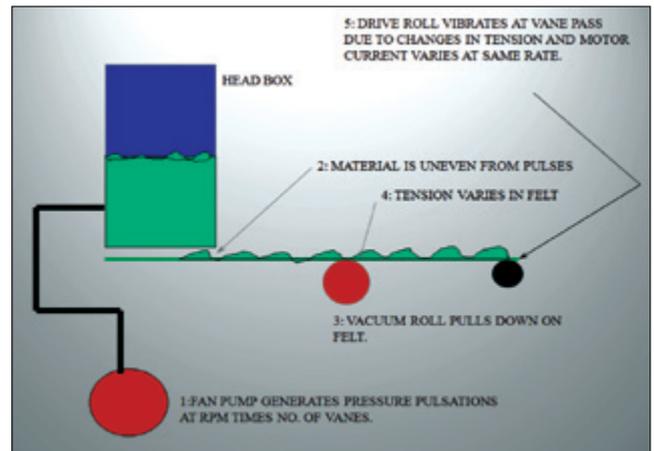
Figure 16. Paper machine problem.

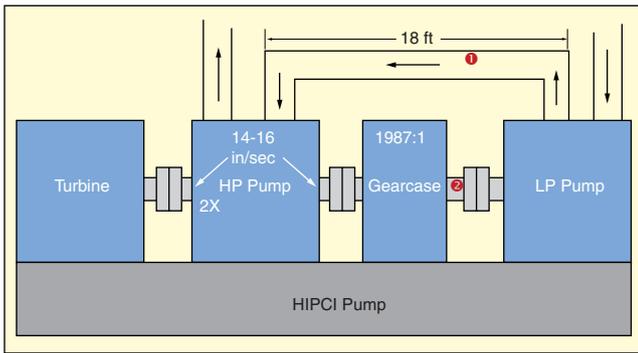
Figure 17. Pump layout.

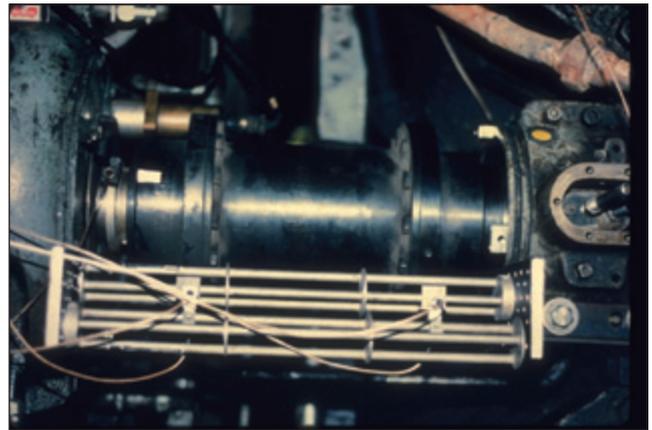
Figure 18. Dynalign bar setup.

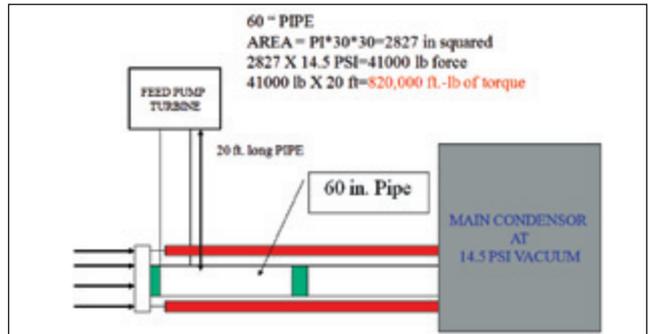
Figure 19. Force calculations.

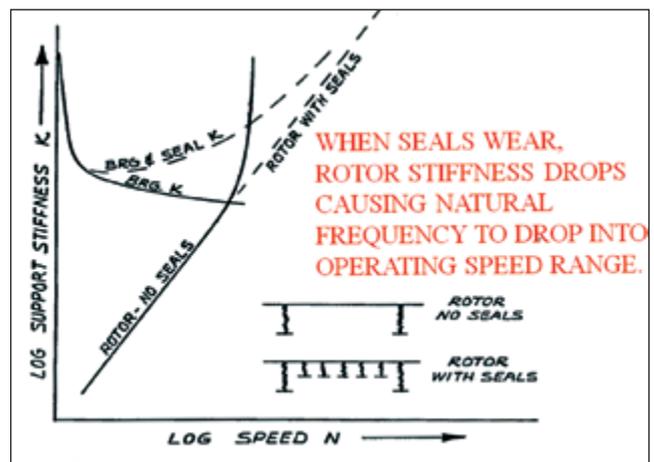
Figure 20. Lomakin effect.

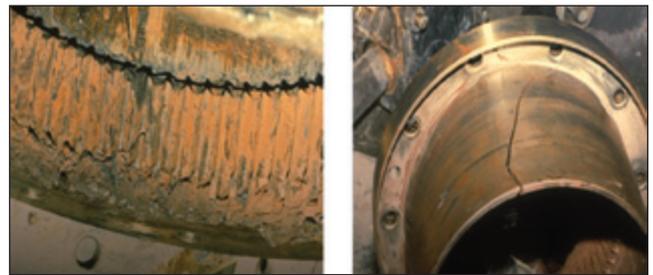
Figure 22. Couplings destroyed on steam generator feed pump at nuclear station.

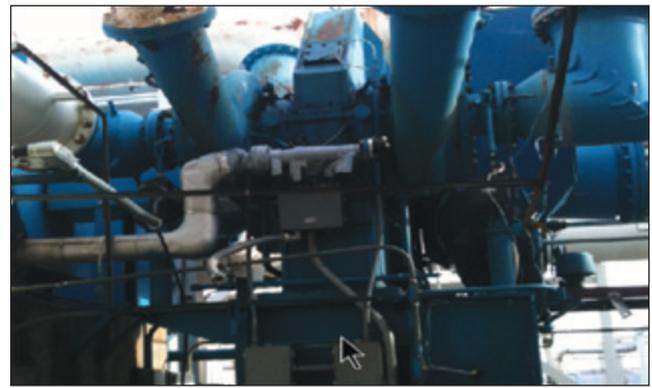
Figure 26. Morton effect caused shutdown of 23,000-HP compressor.

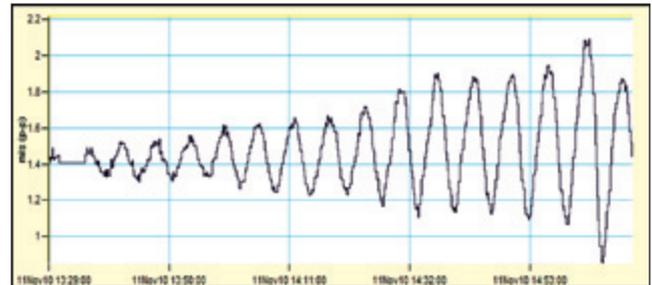
Figure 27. Overall amplitude showing Morton effect induced cycles that last 6-7 minutes.

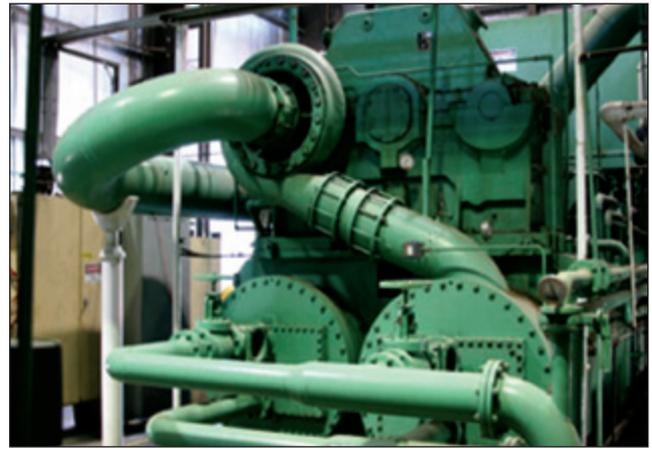
Figure 29. 5000-HP centrifugal compressor.

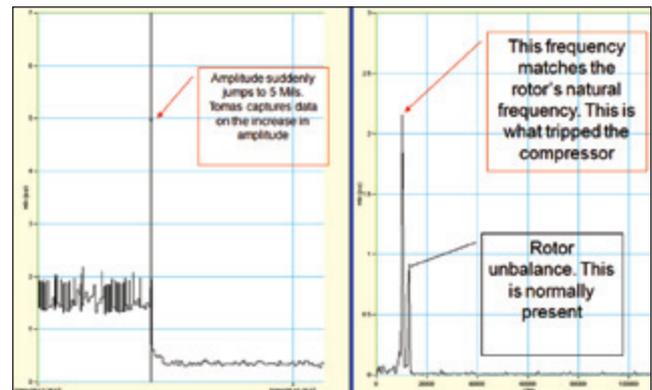
Figure 30. Trend showing sudden increase when compressor surged.

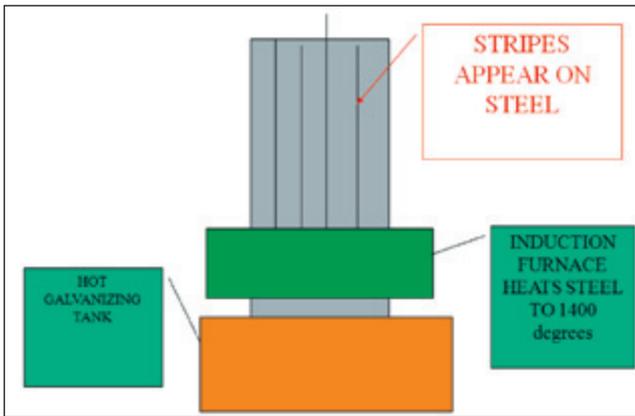
Figure 31. Trouble in steel mill.

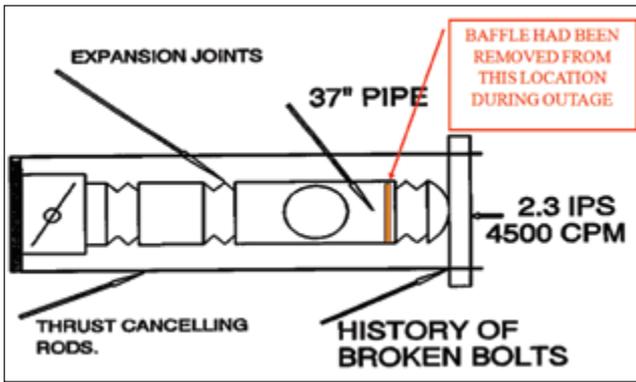
Figure 34. Missing component.

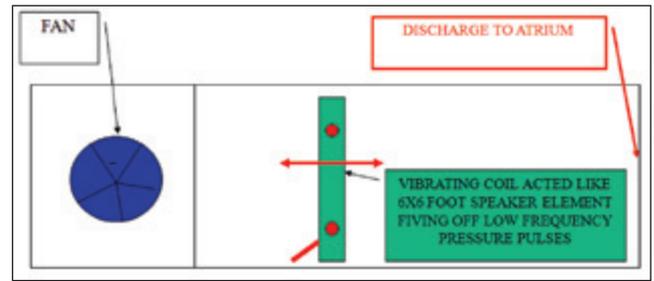
Figure 35. Loose coil.
