Bently Nevada Rub, Morton Effect, Parametric Excitation, and Shaft Crack in Rotating Machinery - Real Cases

John J. Yu, PhD **Senior Technical Manager** Machinery Diagnostic Services

April 2, 2019

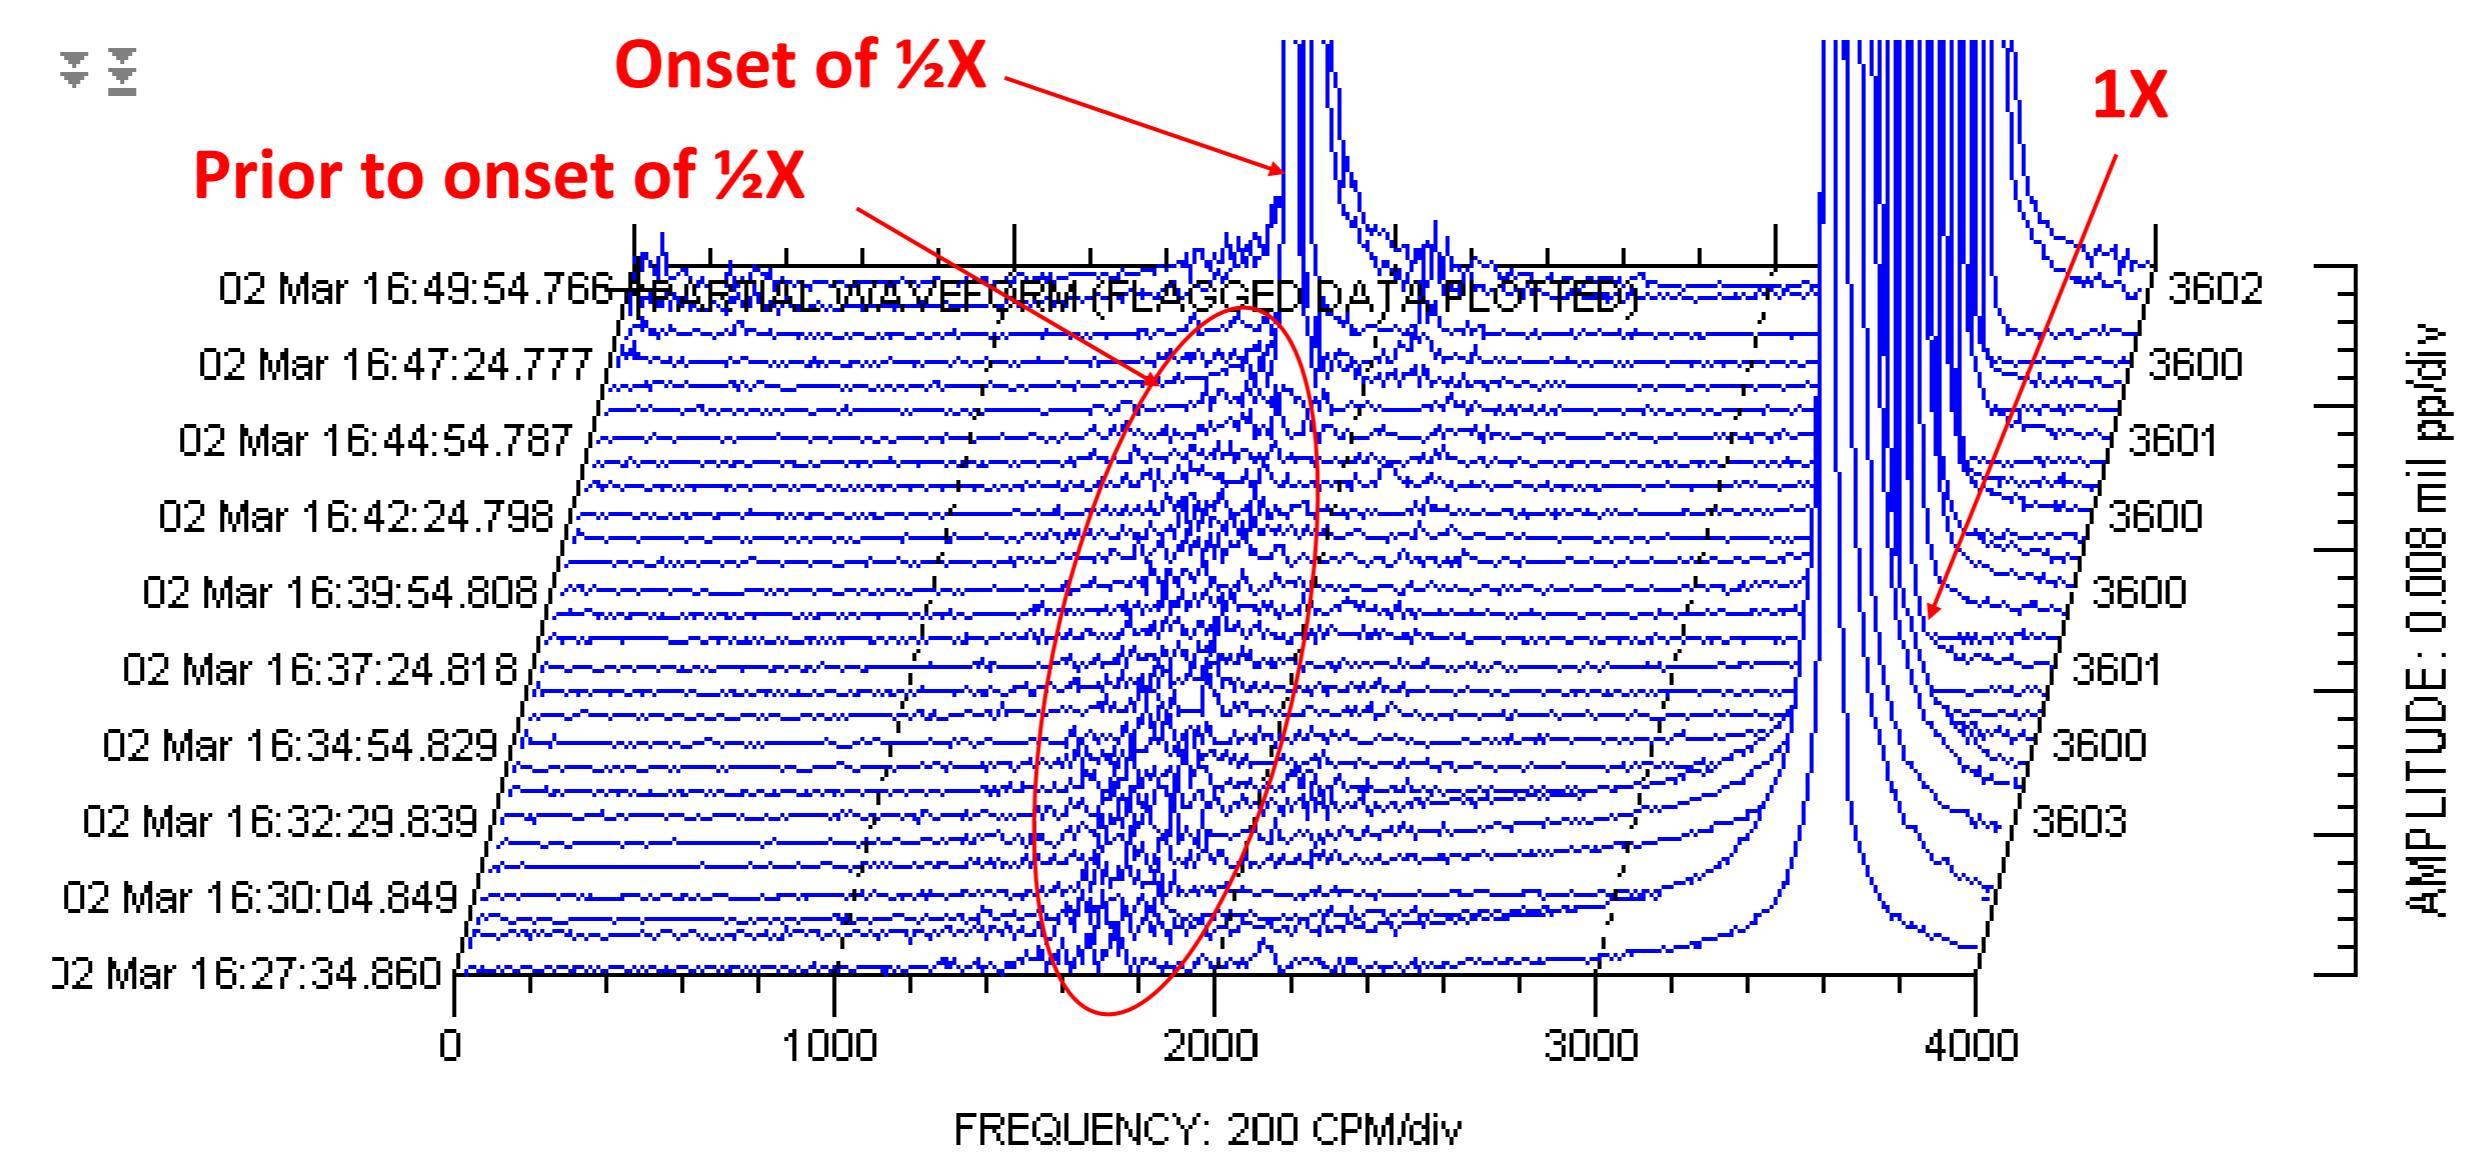
Waterfall plot from Bearing #3 Y-Probe

Indicative of natural frequency at near 1800 cpm or half of the running speed (most likely due to suppressed oil whip), prior to onset of $\frac{1}{2}X$.

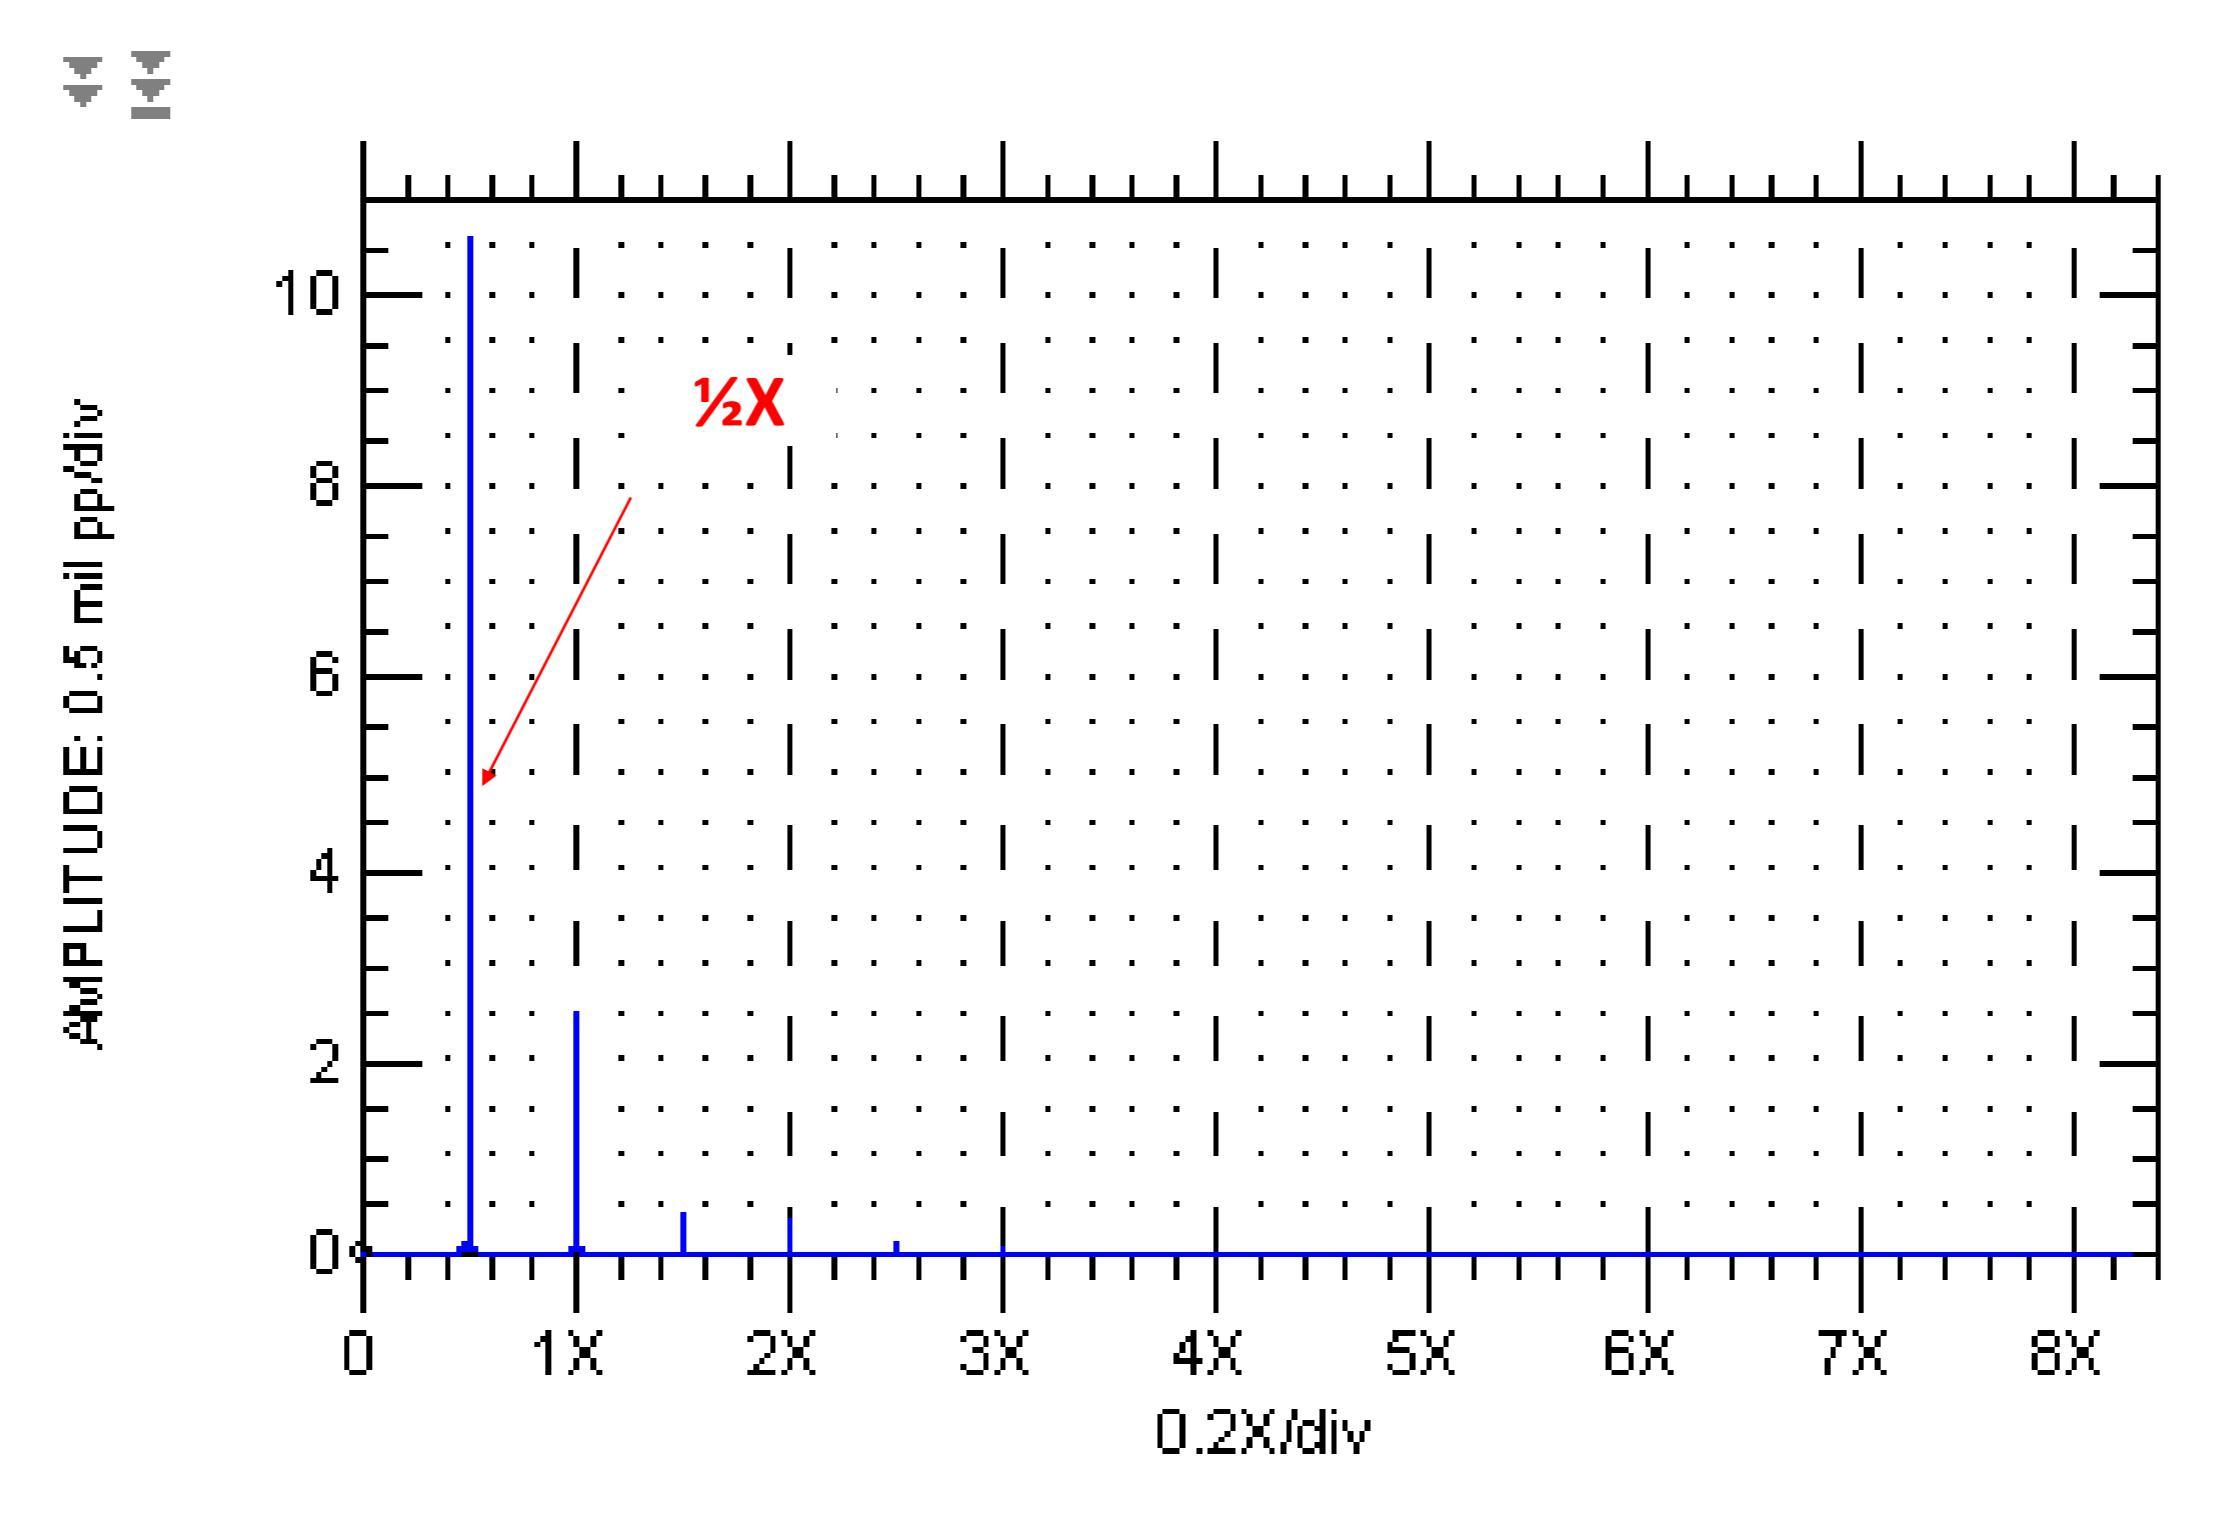
Spectrum plot from Bearing #3 Y-Probe

Primarily ¹/₂X component without significant harmonics

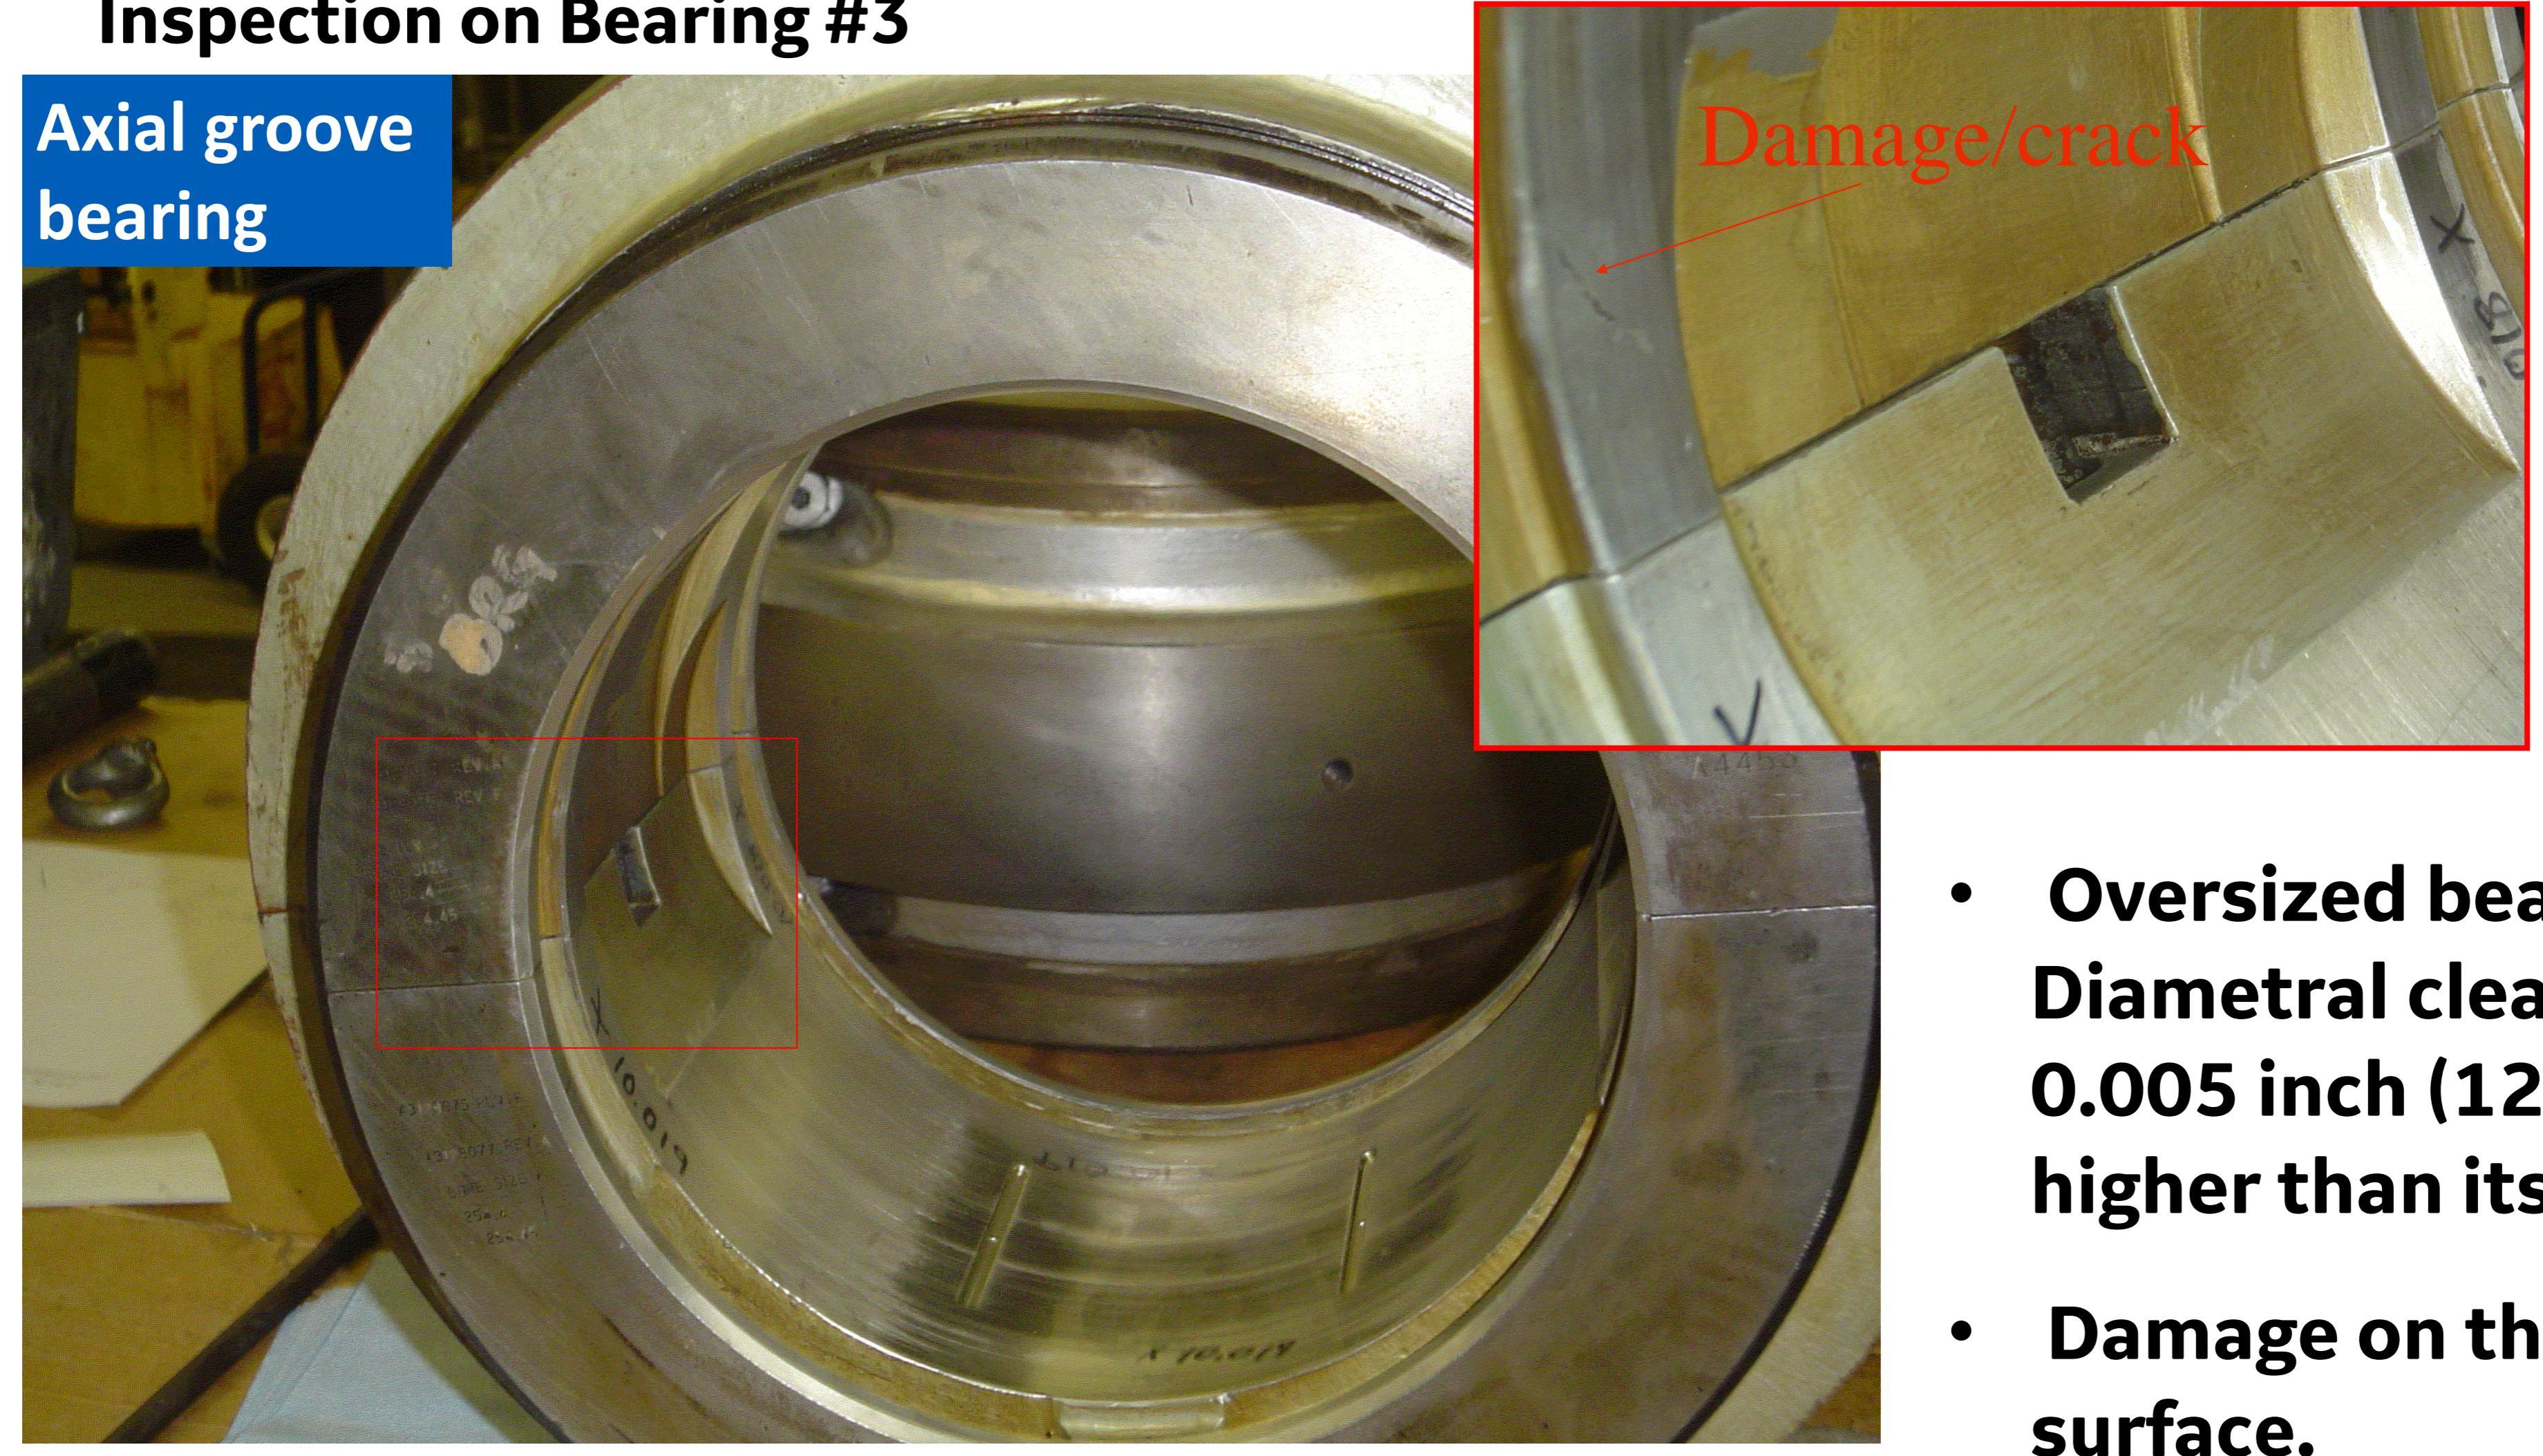
Inspection on Bearing #3

- **Oversized bearing. Diametral clearance** 0.005 inch (127 µm) higher than its spec
- Damage on the bearing surface.

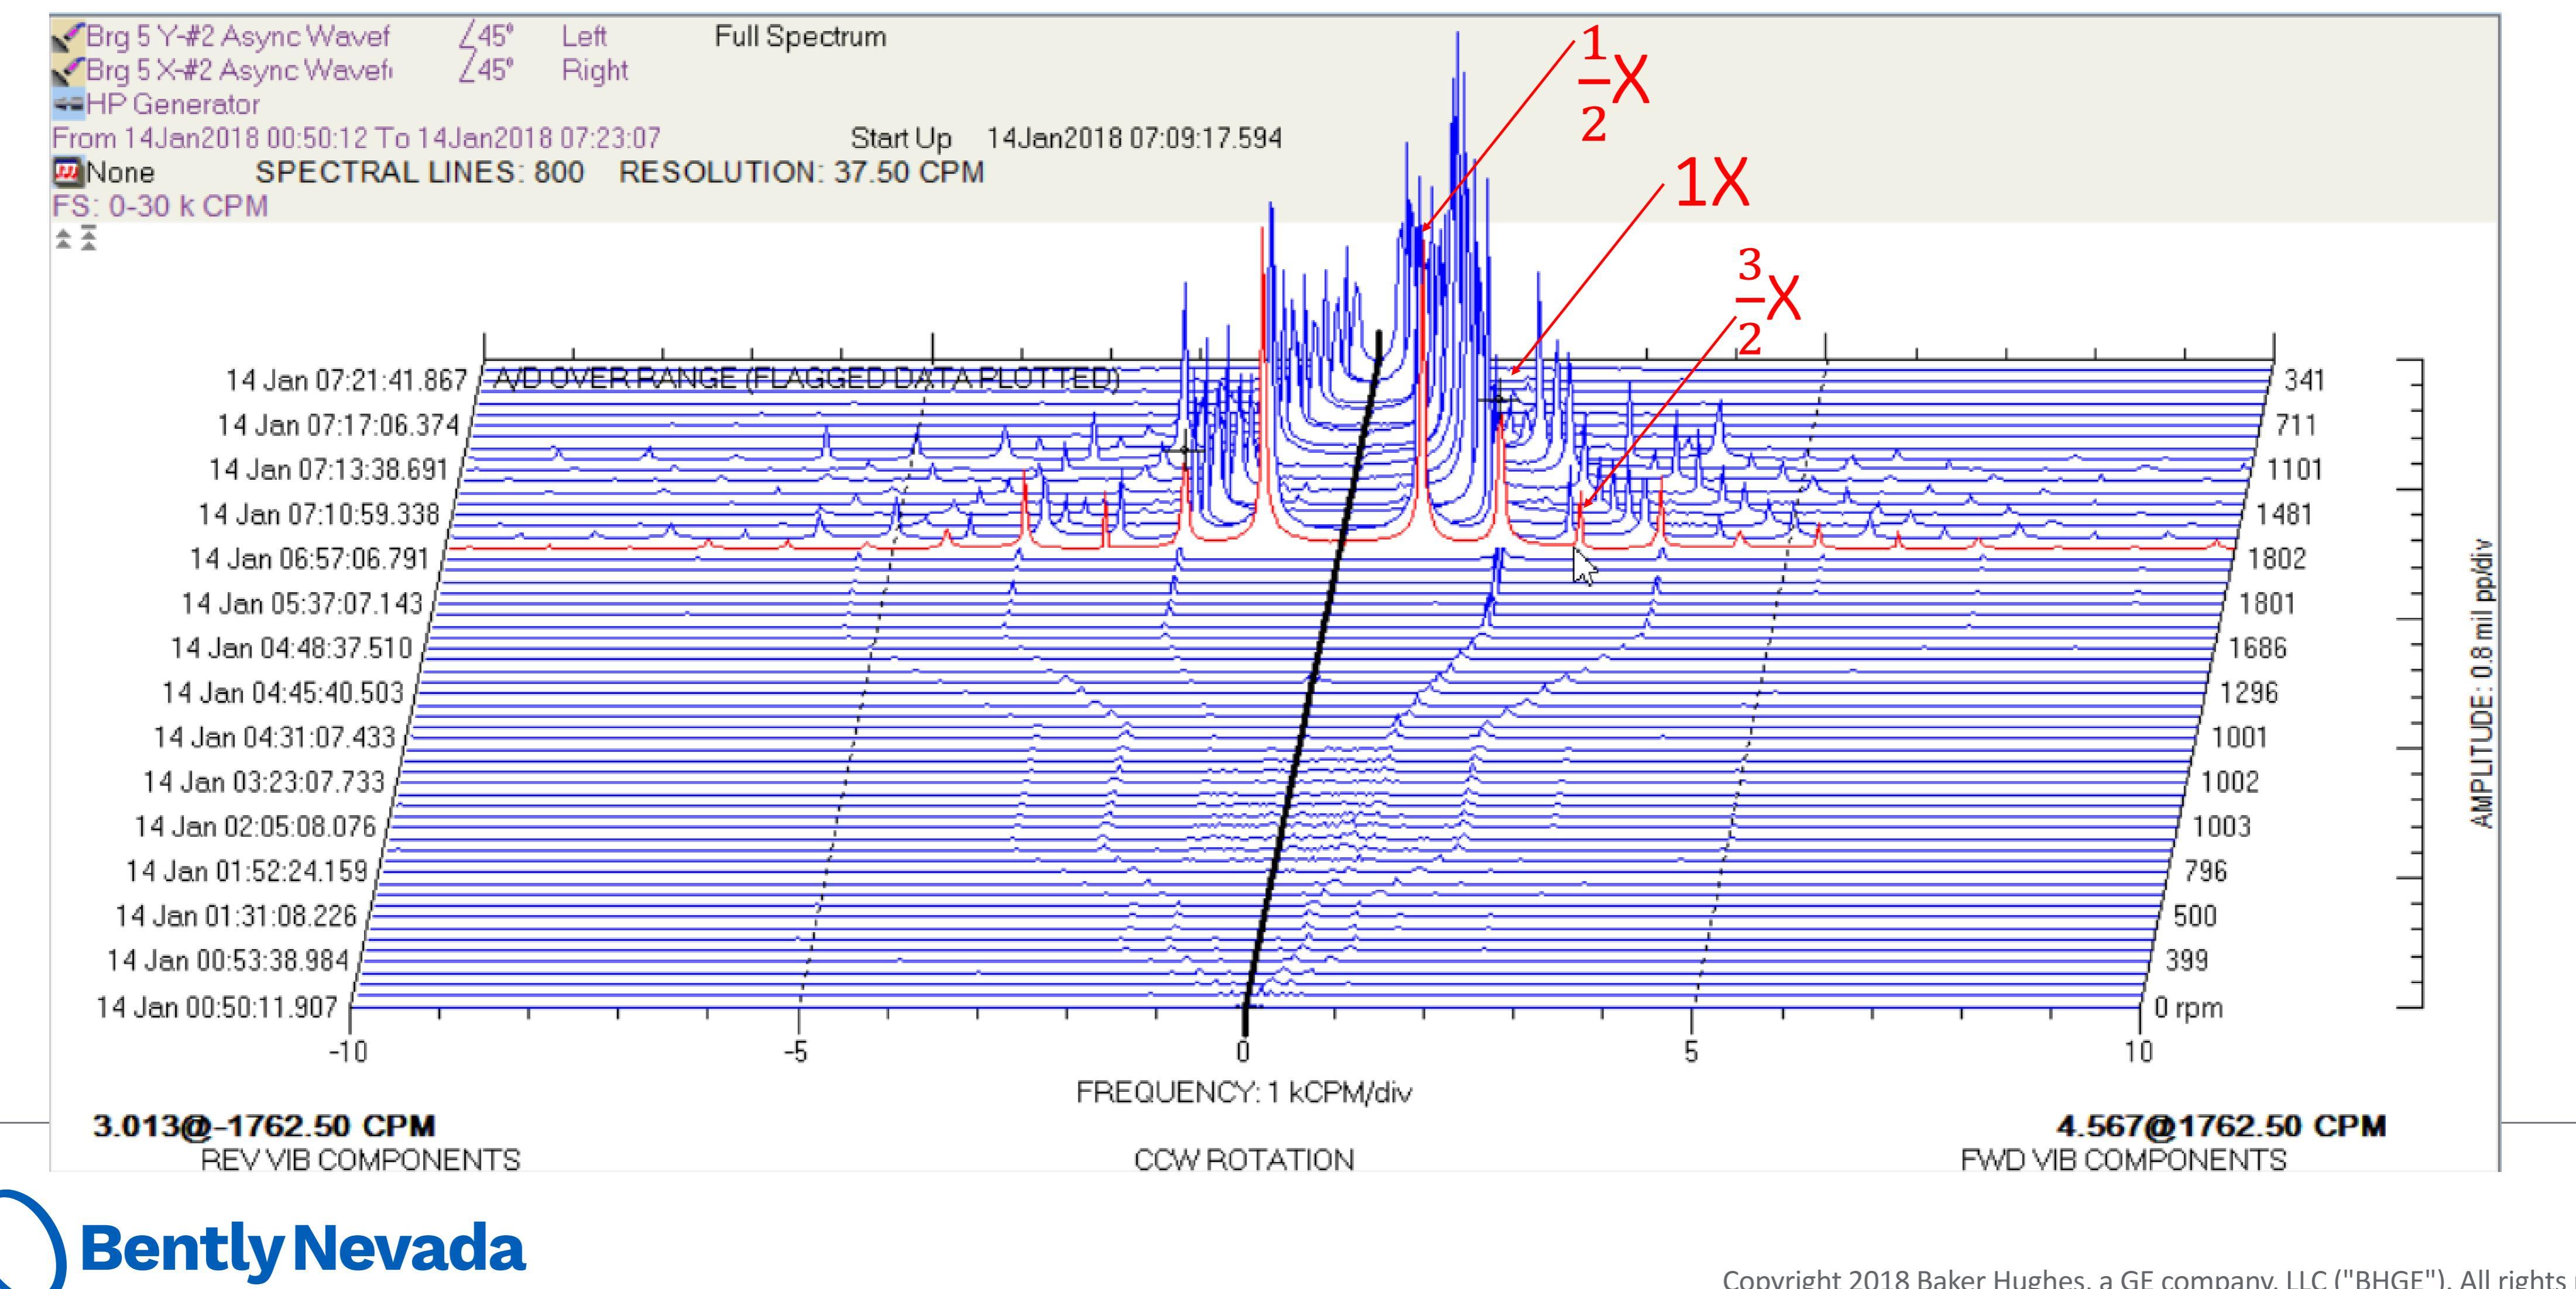
Waterfall plot

Abnormal ¹/₂ X and its multiples during shutdown

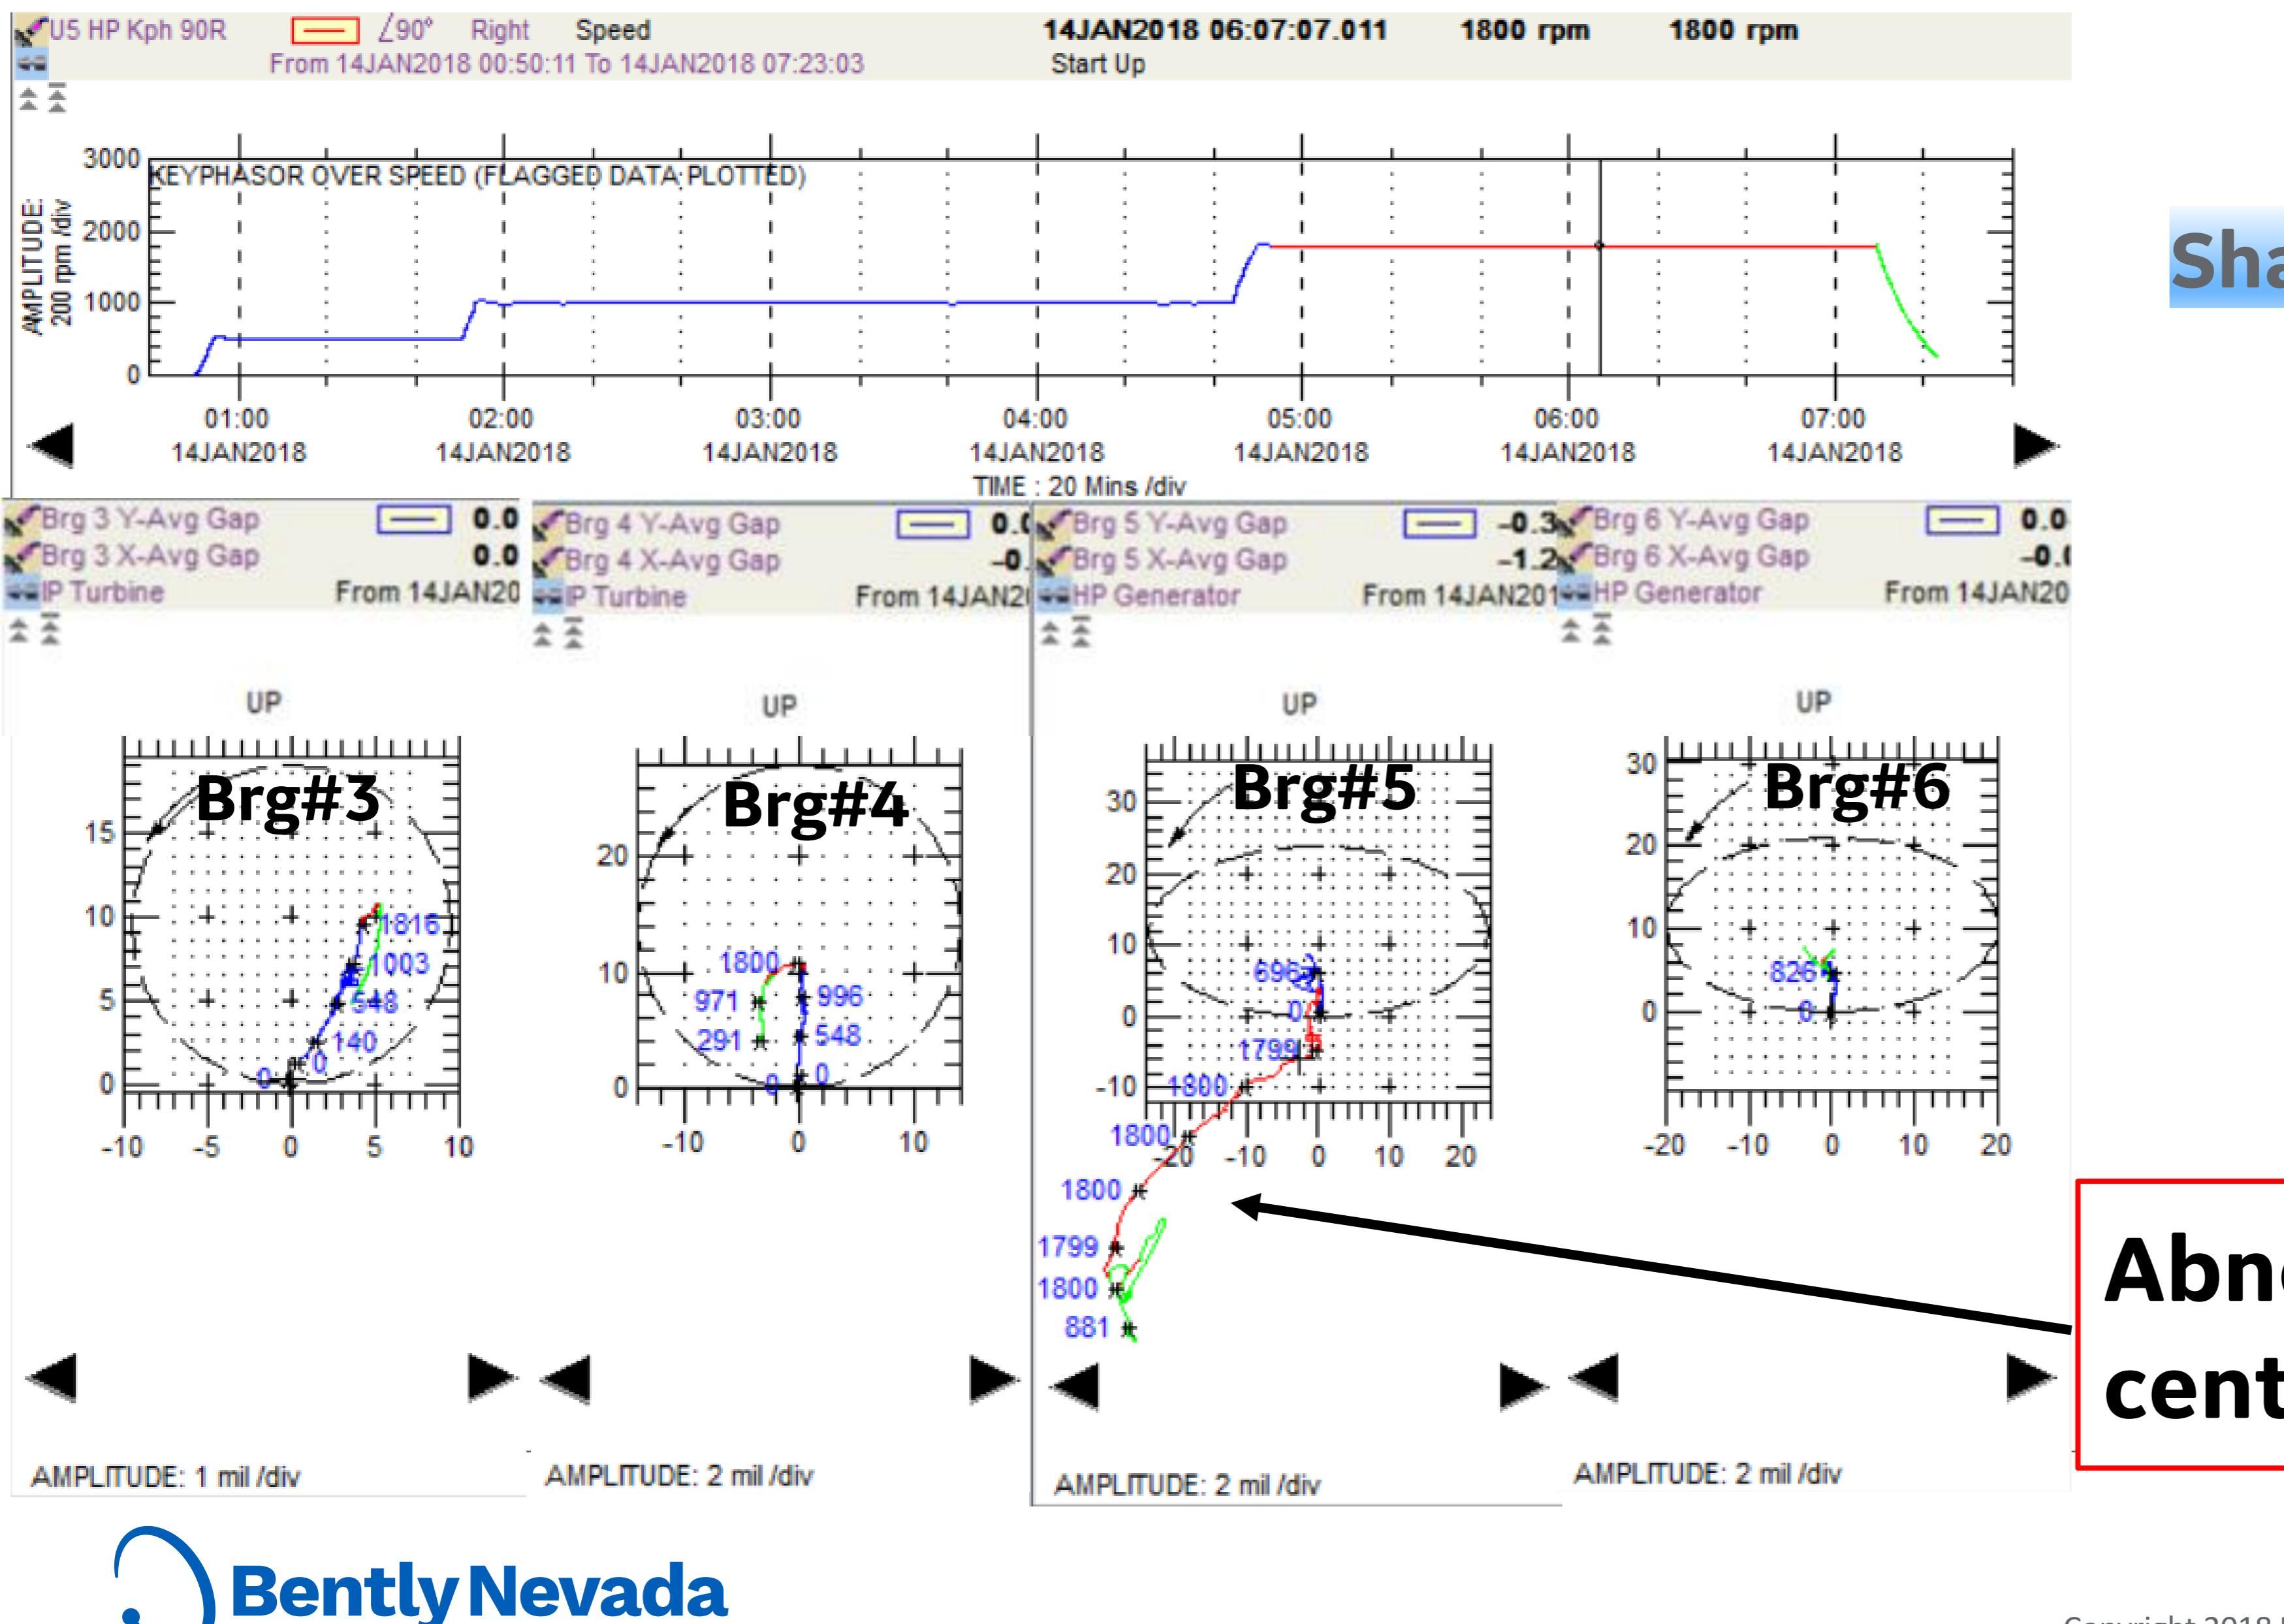
Shaft centerline plots

Abnormal shaft centerline plot at Brg#5

• Bearing damage? – Most likely > At constant speed of 1800 rpm and during coast-down, shaft centerline position was far beyond the bearing clearance boundary at the bottom at Brg#5. > Unfortunately, bearing metal temperature reading was invalid due to the sensor issue.

- Open Brg#5 for inspection
- Check rub locations

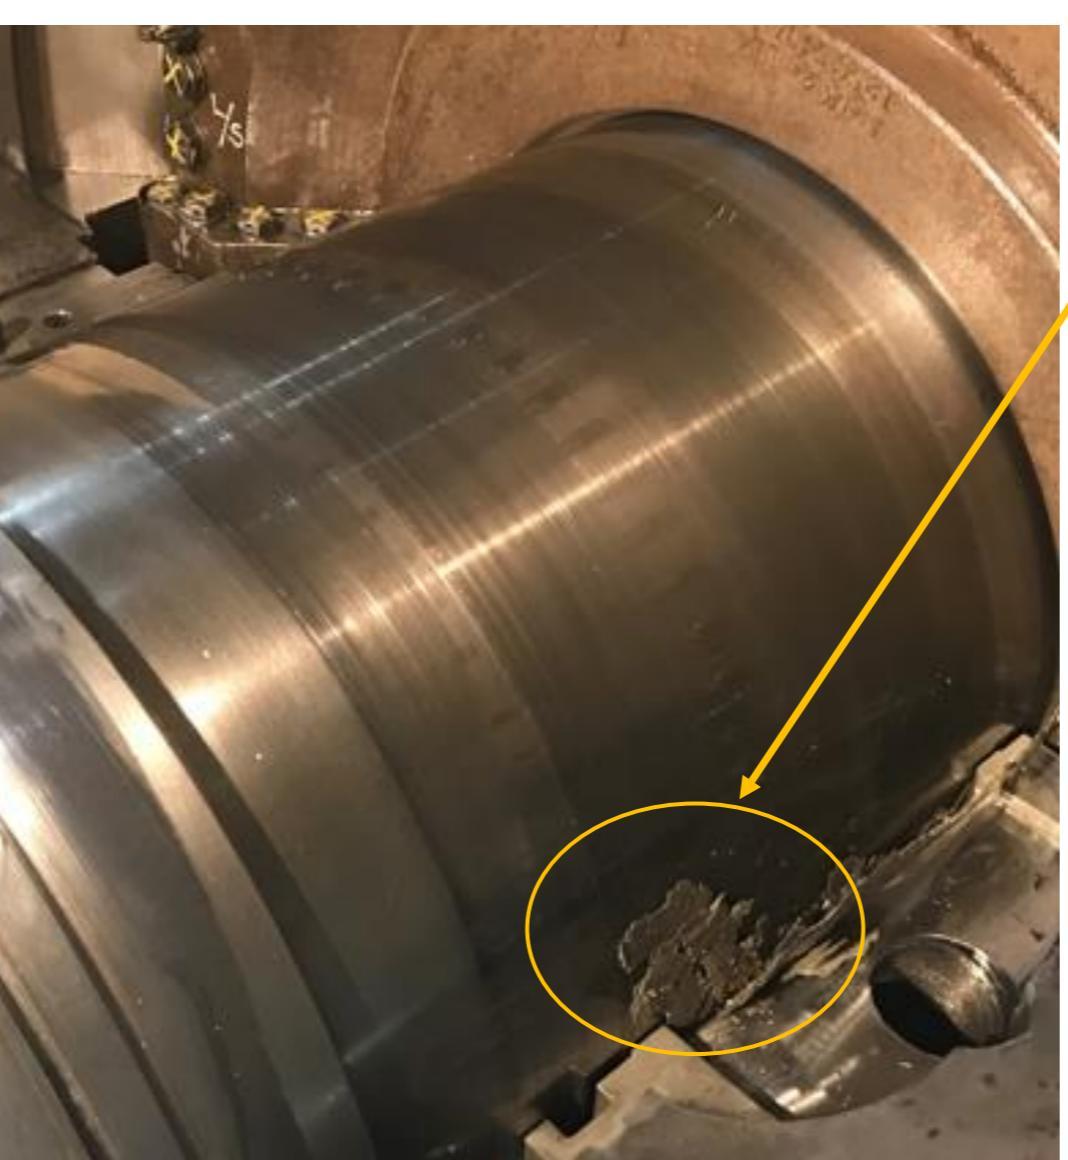
The findings indeed indicated Brg #5 bearing wiped, mostly at the left bottom with additional 42 mils clearance due to wear beyond as-left clearance of 24 mils in vertical direction, matching the diagnosis. Obviously the wear was due to journal rubbing against the babbitt surface.

Babbitt wear at the left bottom

The bearing was repaired and re-installed correctly.

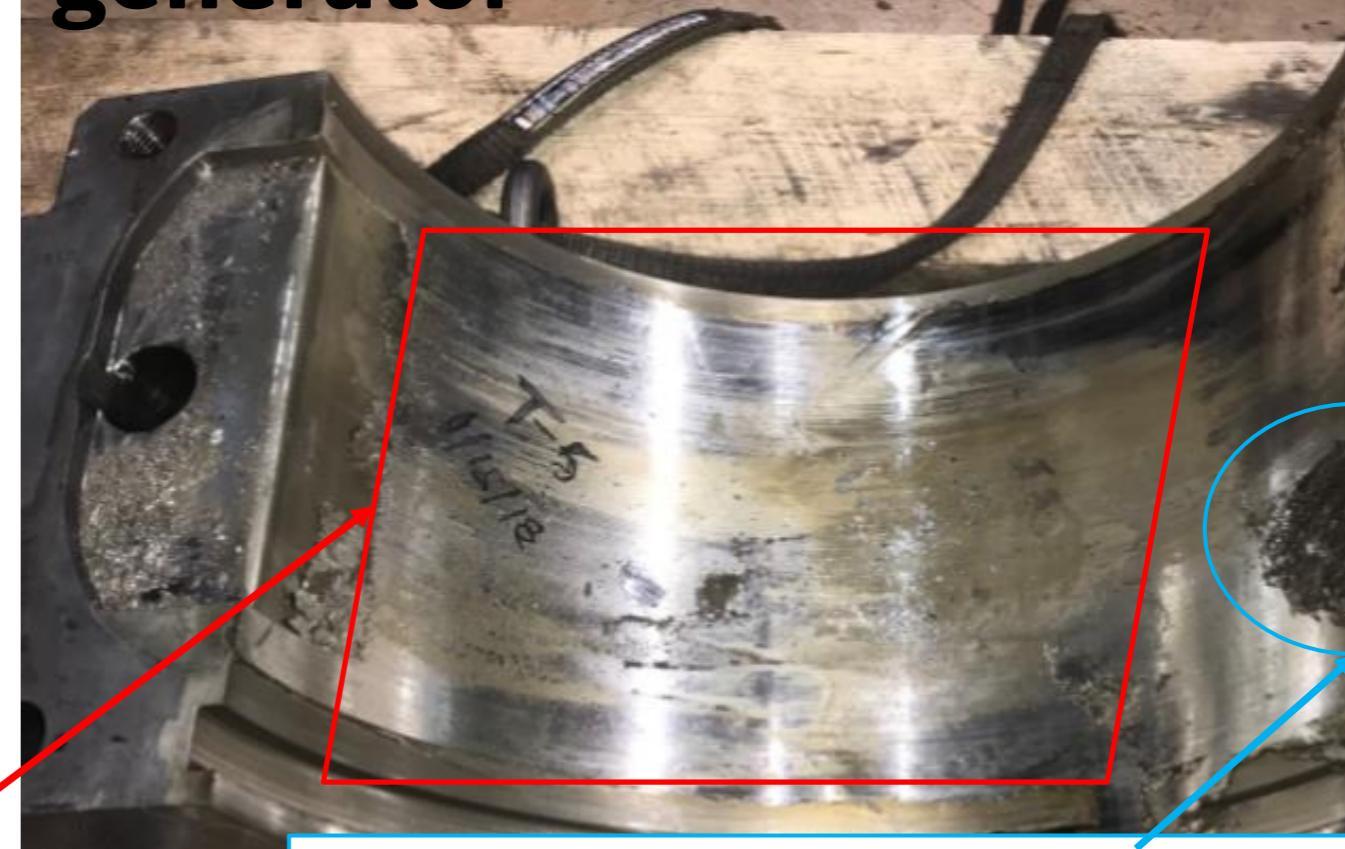
Babbitt material transferred to e to

generator

- It was found that a fine strainer was mistakenly left, causing oil reduction and starvation, and finally wiping the bearing.
 Bearing was shipped offsite to be re-spun.
- Rubs occurred on inner and outer oil deflectors at Brg #5 as well as that at adjacent Brg #4 generator side. All three were shipped offsite for teeth replacement.
- Brg#5 H_2 seal casing oil deflector rubbed and replaced with new one.
- Adjacent Brg #4 turbine side oil deflector clearance and alignment acceptable.

Damaged oil deflectors were replaced with new ones.
