Bently Nevada Rub, Morton Effect, Parametric Excitation, and Shaft Crack in Rotating Machinery - Real Cases

John J. Yu, PhD **Senior Technical Manager** Machinery Diagnostic Services

April 2, 2019

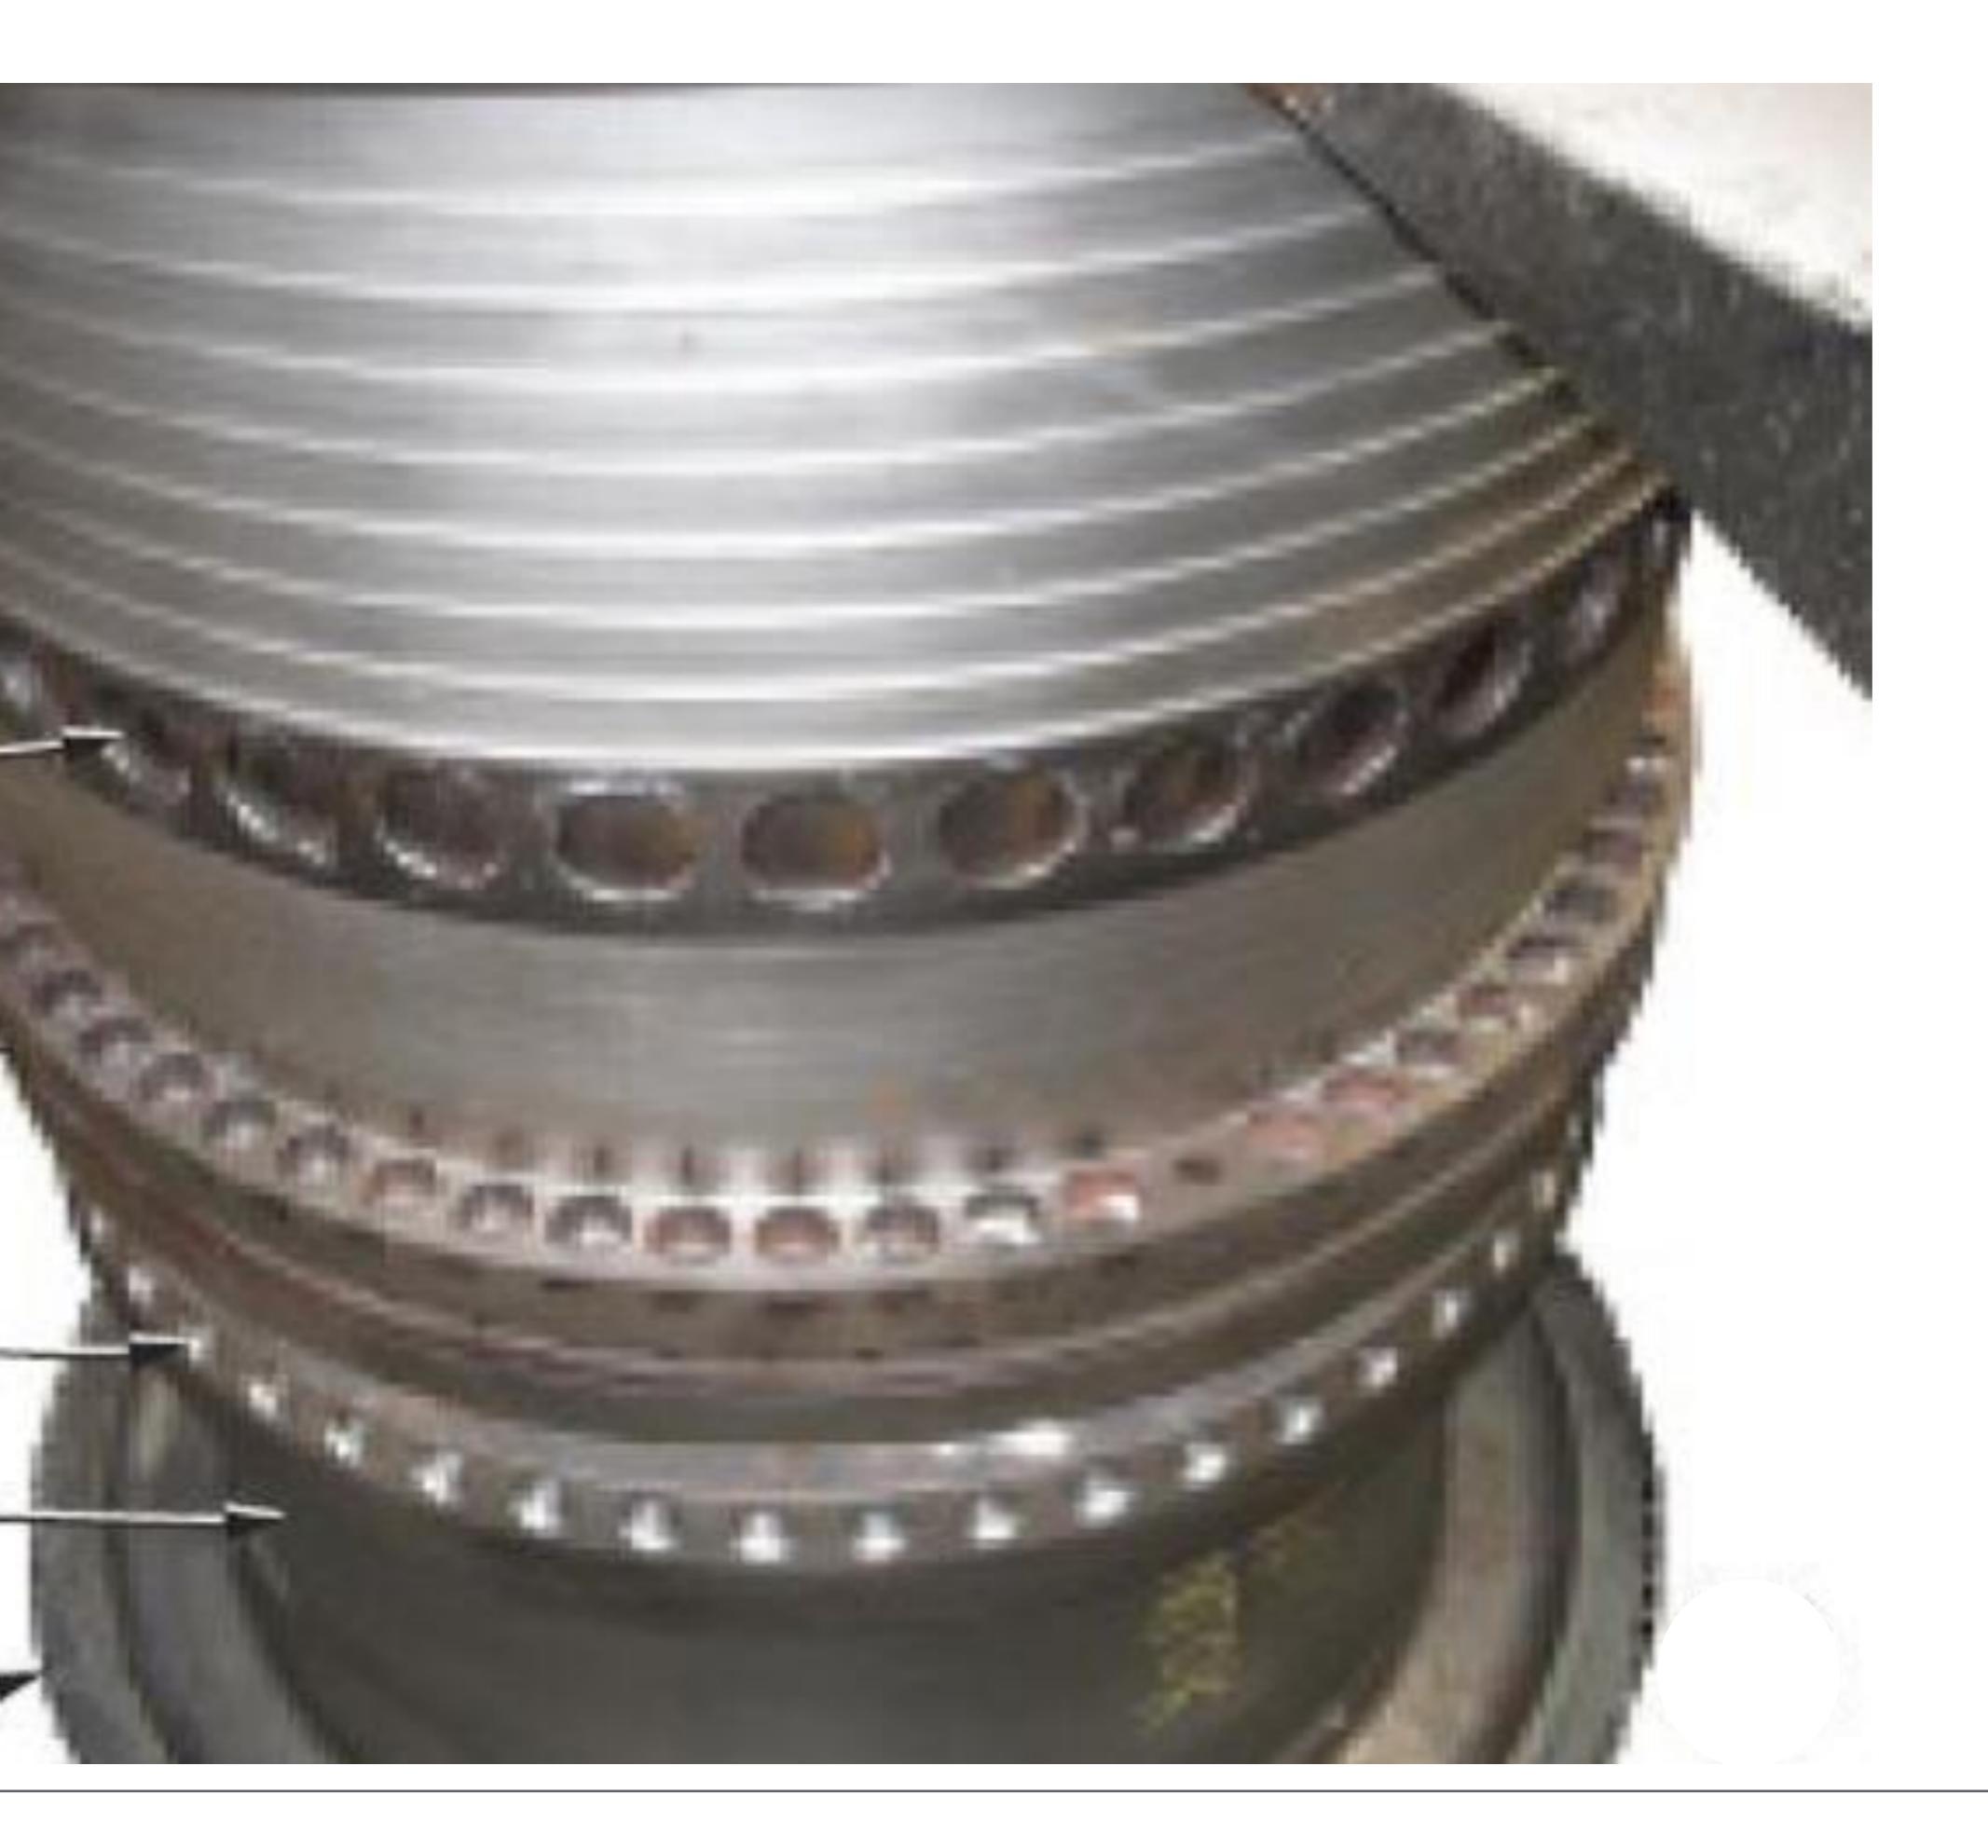
Cracks on torque tube that joins the compressor and turbine sections of the rotor
