A Destructive Failure Incident and Revamping of Thrust Bearing Test Rig

TRC-B&C-03-2014

Research Progress Report to TAMU Turbomachinery Research Consortium

A Test Rig for Evaluation of Thrust Bearings and Face Seals

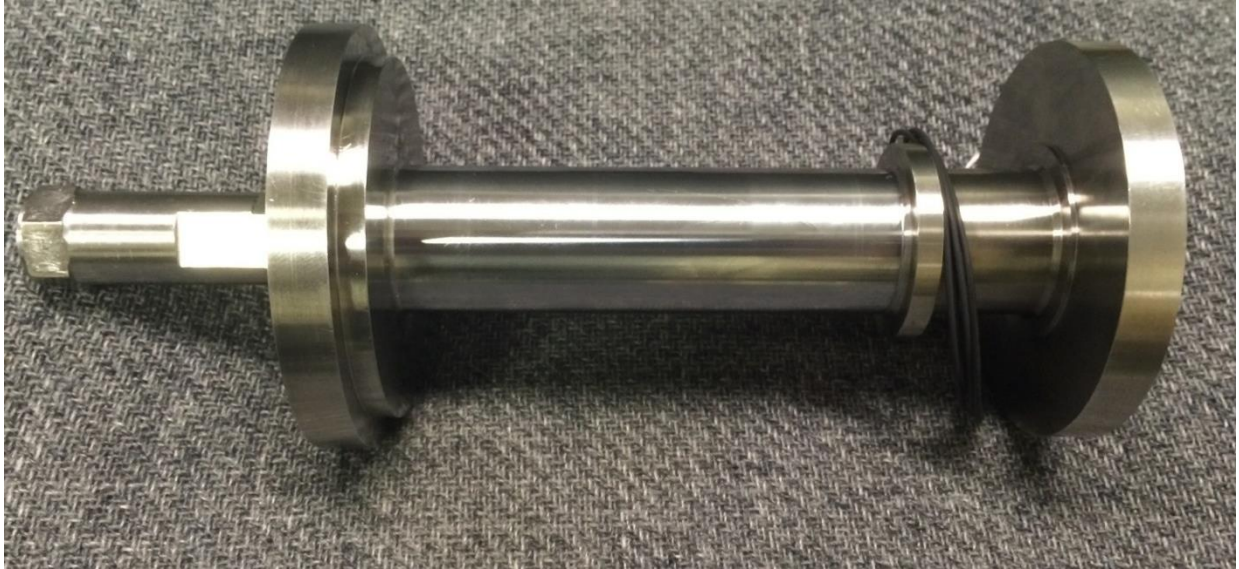
Figure 23 shows the rotor after being repaired and balanced. In the locations where the air buffer seals and the eddy current sensors deposited foreign material, WD-40 and 600-grit sandpaper polished off the foreign material. In the locations of the journal bearings, Multichrome/Microplate Company grinded off the affected material, chrome-plated the rotor with 76.2 micron of thin-dense chrome, and grinded the rotor until the rotor diameter was its original size for a cost of \$958. This process replaced the affected material with thin-dense chrome. Moscow Mills balanced the new rotor by grinding off significantly more material than the original rotor had ground off at a cost of \$787.

Figure 23. Photograph of rotor after being polished, pre-grinded, chrome-plated, post-grinded, and balanced (March 2014).

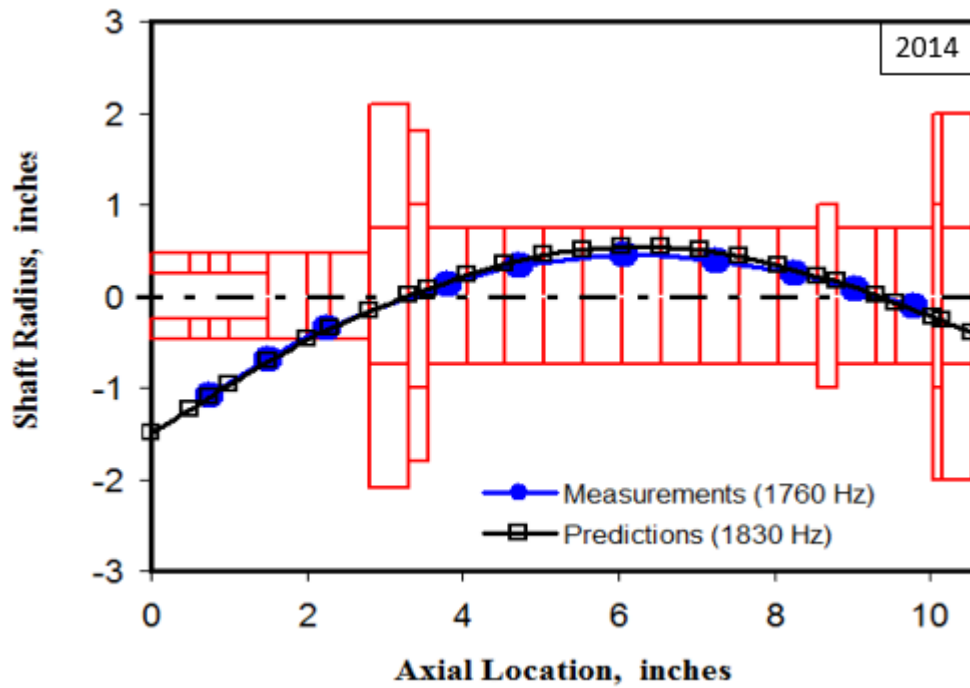
Table 6 and Figure 24 show the rotor free-free mode natural frequency, measured and predicted, and the corresponding mode shapes. XLTRC² predicts the rotor free-free natural frequency and mode shape. Appendix D describes the apparatus and procedure for measuring the free-free natural frequencies and mode shapes. The measured first free-free natural frequency is 1760 Hz. The rotor end facing the coupling experiences the highest amplitude displacements. The predicted natural frequency is 1830 Hz, 4% higher than the measured natural frequency. The measured and predicted mode shapes of the rotor first mode compare well to each other.

Figure 24. Measured and predicted first free-free mode shape of rotor.

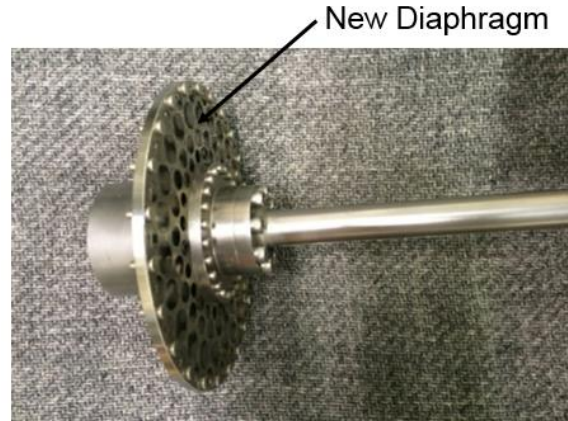
Figure 26 shows the repaired coupling, early 2014. At a cost of \$6,780, the original manufacturer replaced the diaphragm and the outer hub ring and reused other original parts, and then balanced the new assembly.

Figure 26. Photograph of flexible coupling after repair by Coupling Corporation of America.

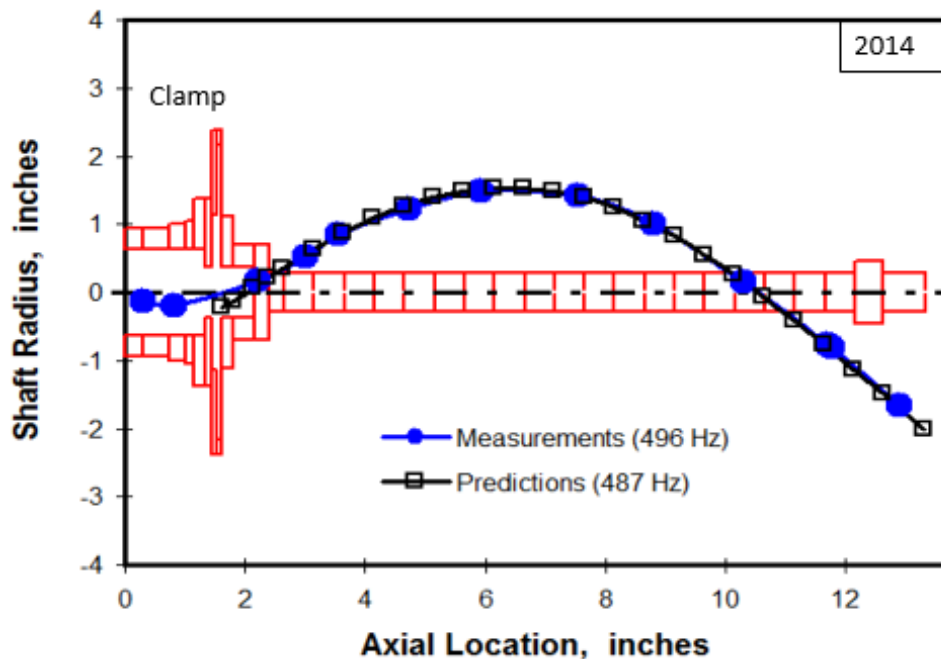
Table 8 and Figure 27 and 28 show the measured and predicted first and second natural frequencies of the flexible coupling and corresponding free-free mode shapes. XLTRC² predicts the free-free natural frequencies and mode shapes. The first and second free-free natural frequencies of the coupling are 496 Hz and 1504 Hz, respectively. The first natural frequency is particularly important because the maximum operating speed of the motor is 500 Hz and it is close to the rotor speed when the failure occurred. The coupling vibrates with the highest amplitude at the end that attaches to the rotor. The predictions for the free-free natural frequencies and mode shapes compare well to the measurements.

Figure 27. Measured and predicted first free-free mode shape of coupling.

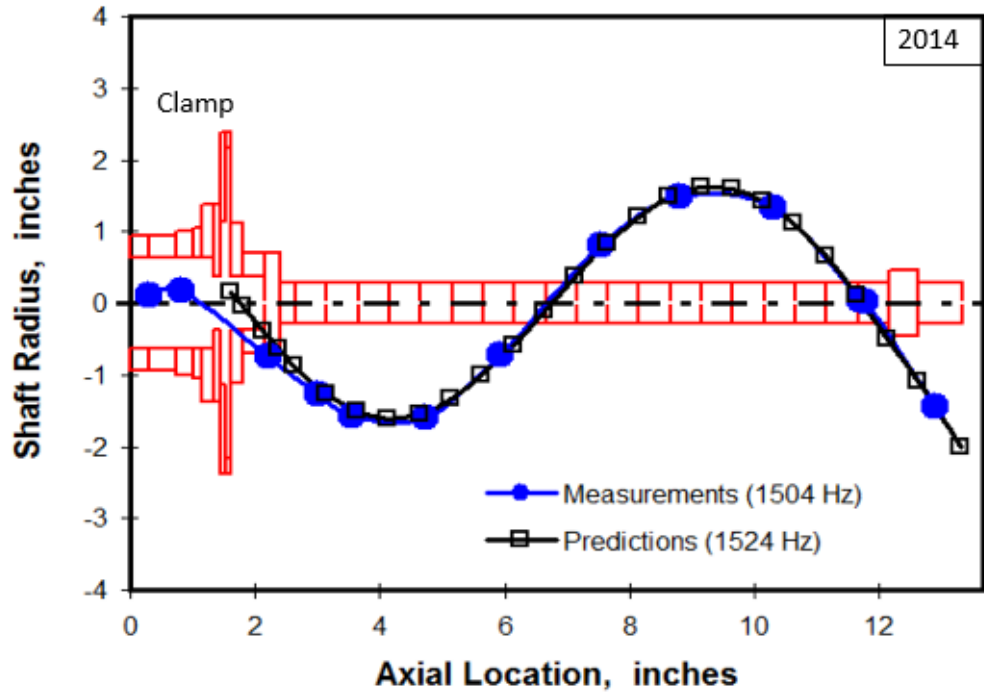
Figure 28. Measured and predicted second free-free mode shape of coupling.

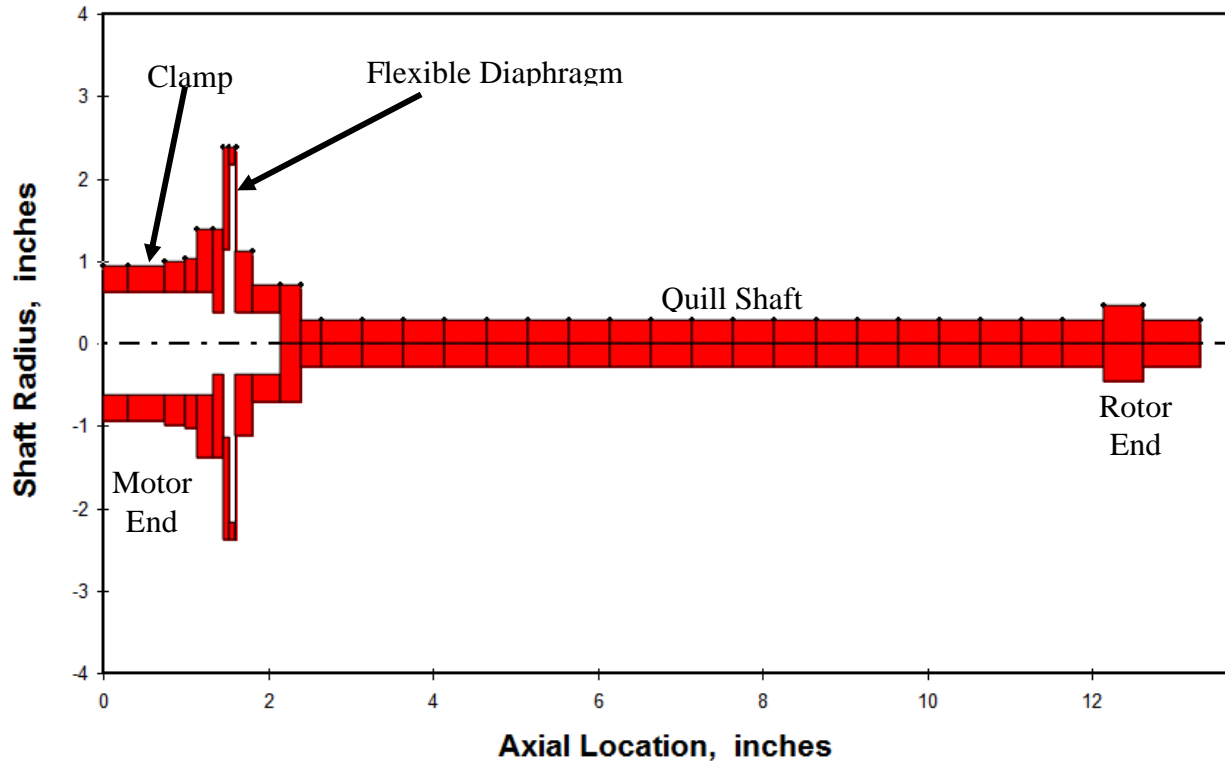
Figure 40 shows the coupling modeled in XLTRC² as a rigid shaft. This model does not consider the flexibility introduced by the diaphragm. This model predicts mass properties only. The model divides the coupling into 34 stations of alloy steel 4140.

Figure 40. Model of entire coupling as a rigid shaft in XLTRC².

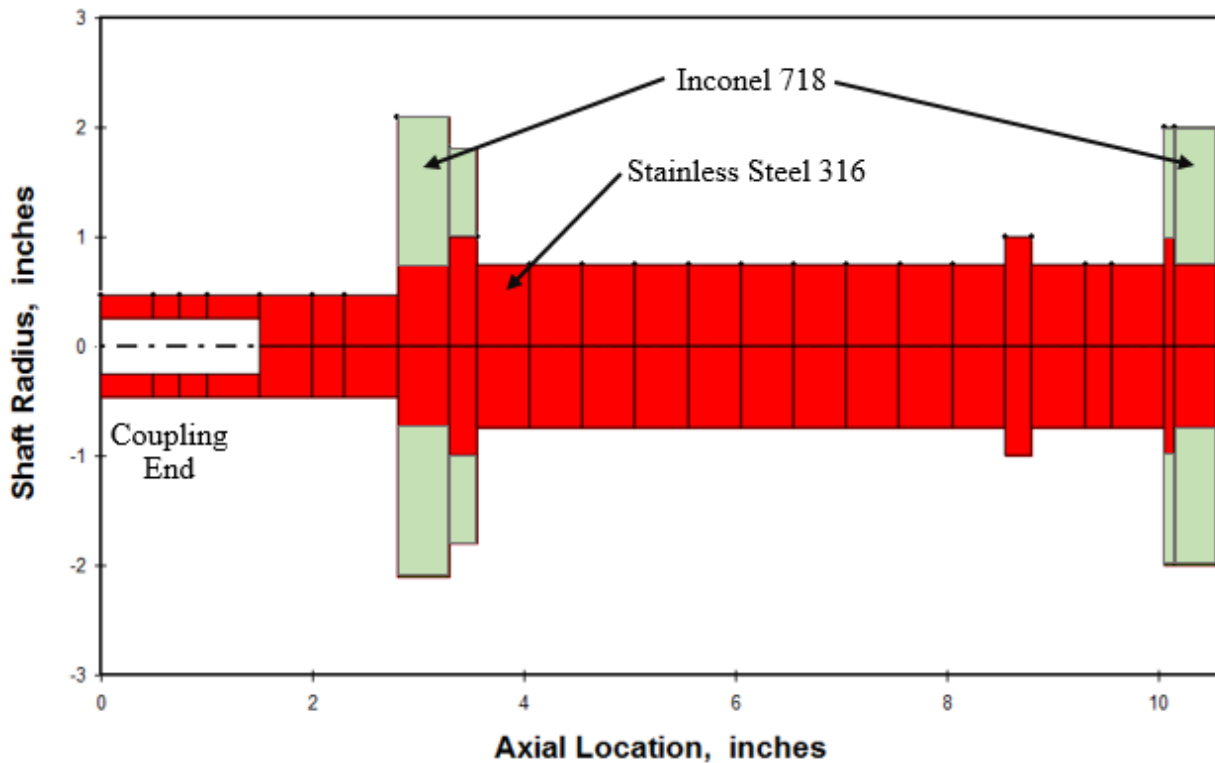
Figure 43 shows the model of the rotor in XLTRC². The model divides the rotor into 25 stations of stainless steel 316 or Inconel 718.

Figure 43. Model of rotor in XLTRC².

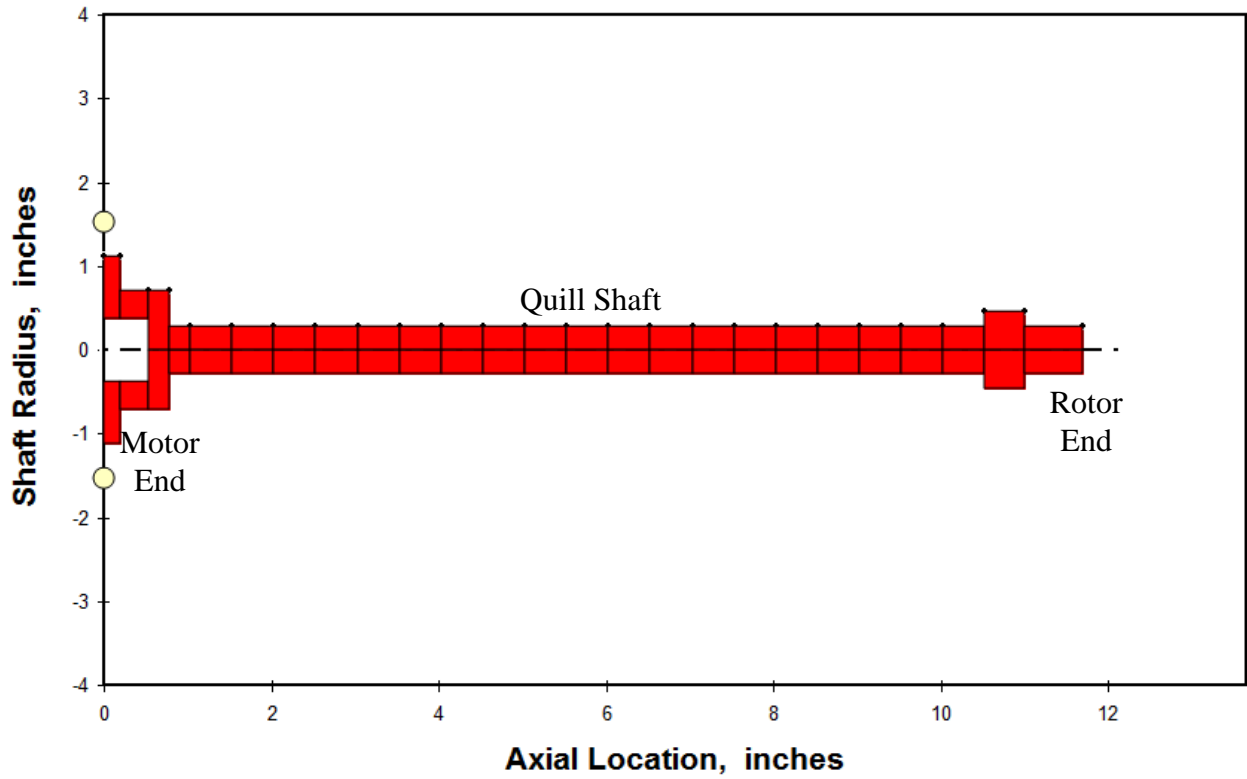
coupling. This model assumes that the flexible diaphragm isolates the quill shaft from the inertia of the other side of the diaphragm but not the mass.

Figure 44. XLTRC² model of quill shaft of coupling with clamp as a point mass.
