MEEN 459/659 – Spring 2019

Adventures in Field Vibration Testing

Dustin Pavelek, P.E.
Sr. Consultant
Kelm Engineering, LLC

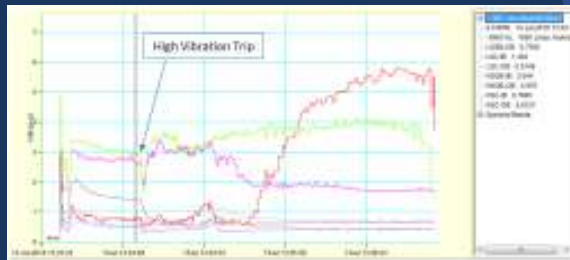
- Vibration trends from prox probes show high speed gearbox vibration was excessive

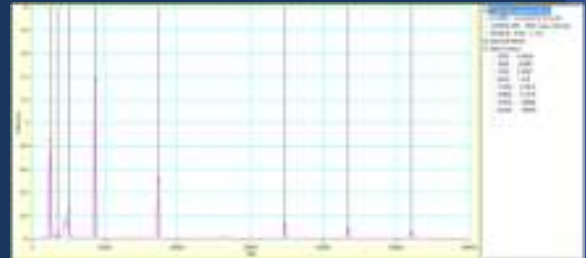
- Vibration spectra show high 1X and gear mesh vibration on the high speed gearbox

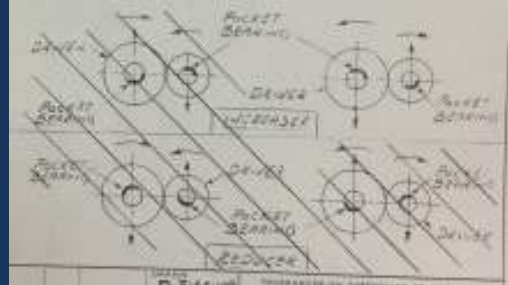
- Gearbox output shaft bearings were installed upside down

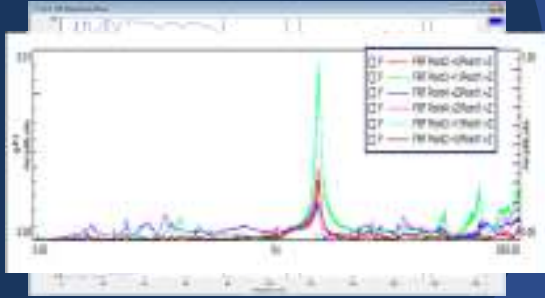
- So... how'd it go?

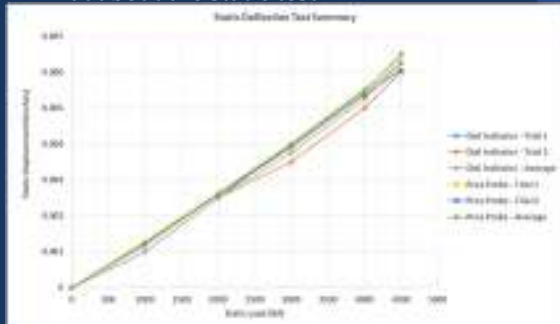
- What about the static test?

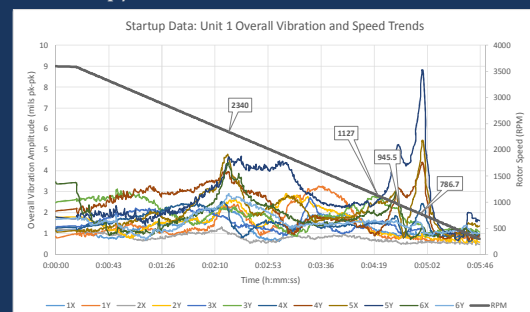
- Startup/Coast Down Vibration

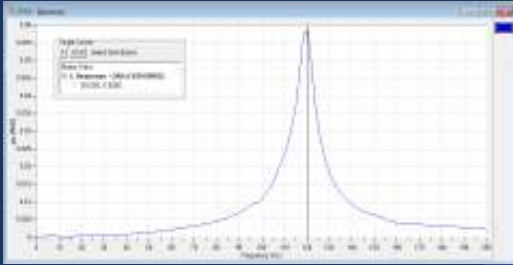
- Impact Data

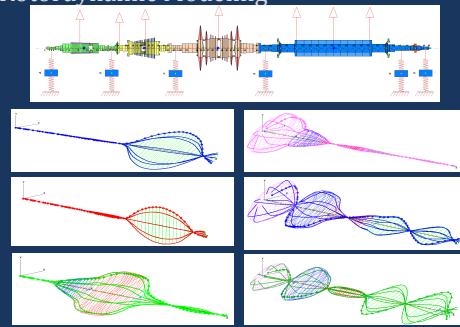
- Rotordynamic Modeling

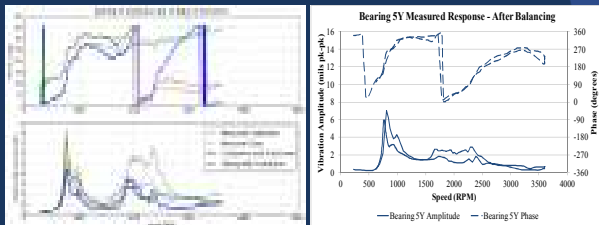
- Balancing Results

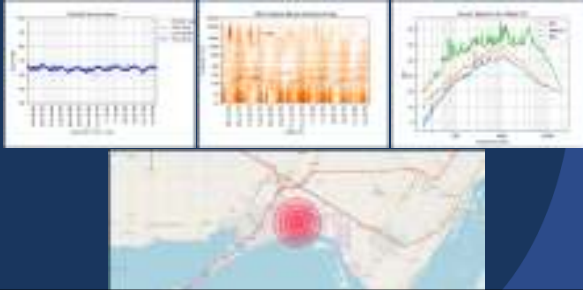
- Overall levels, Octave band filtering, attenuation from weather conditions

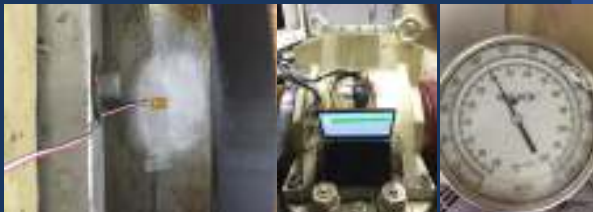
- Careful surface preparation and calibration procedure required for strain gage application

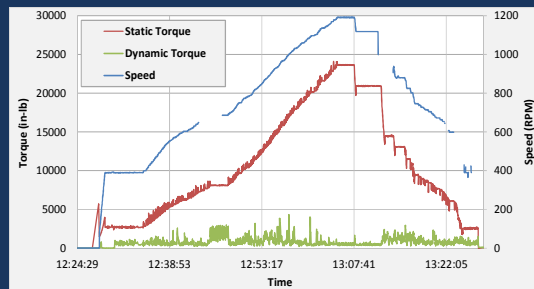
- Static/Dynamic Torque Data Looks Great!

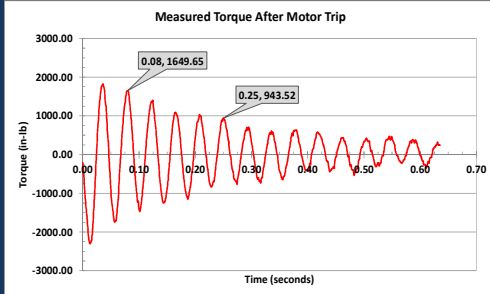
- TNF matches prediction very well!

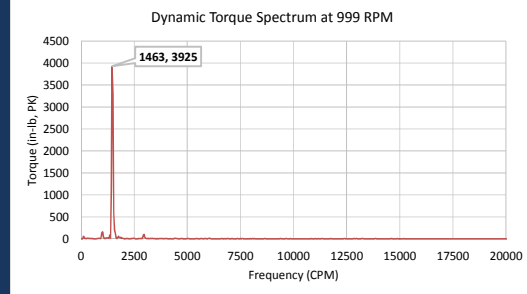
- Dynamic Torque below acceptable limit!

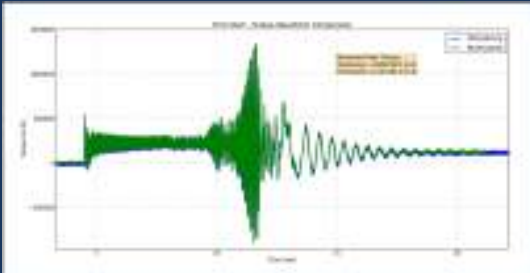
- How did the online system compare to known temporary instrumentation... GREAT!

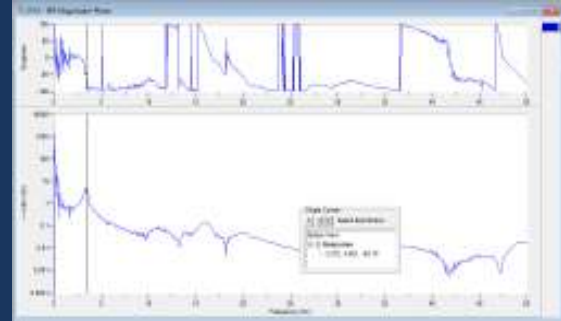
- Very low first natural frequency (<4 Hz)

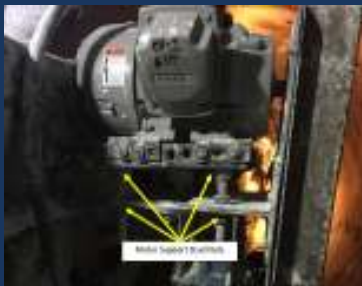
- Final Solution: Don't forget to tighten fasteners!

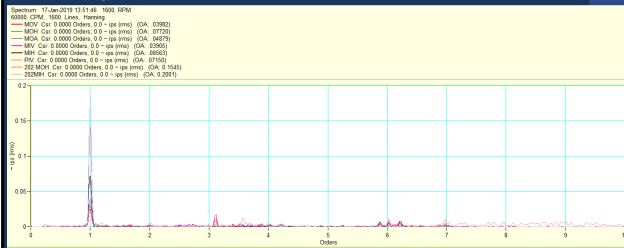
- Highest vibration at 1X running speed
- Indication of excessive imbalance
- Maybe resonance... Let's Check!

- Source of imbalance was the improperly sized keys on the coupling
- The keys were too short to fill the void in the keyway
- Balance correction weights were installed at the same angle as the key to correct

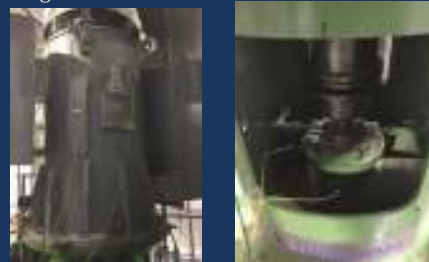
- Measurement Setup:
 - Accelerometers on motor bearings and pump upper bearing

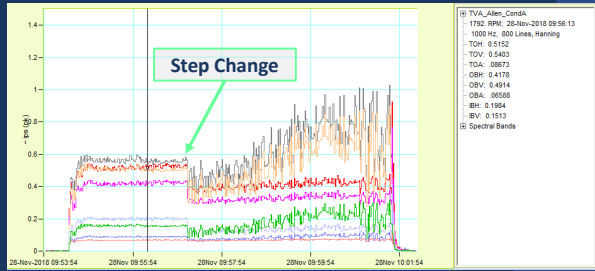
- Test Data – Overall Vibration Amplitude Trend

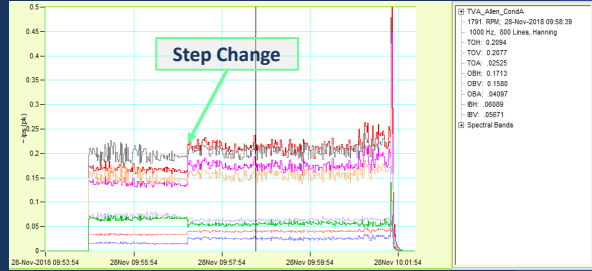
- Test Data – 1X Vibration Amplitude Trend

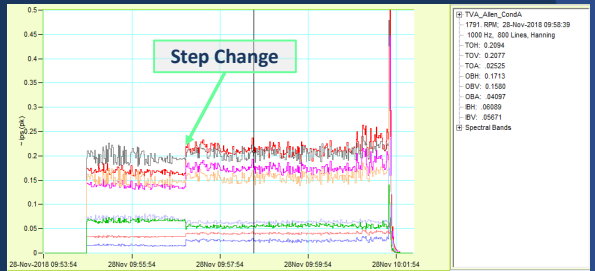
- Test Data – 1X Vibration Amplitude Trend

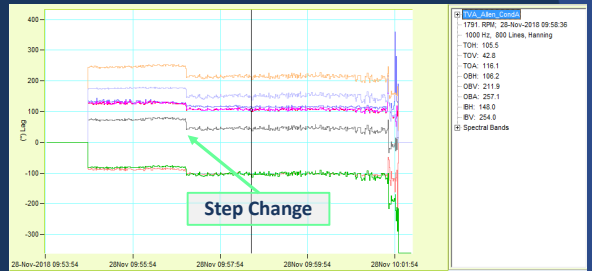
- Test Data – 1X Vibration Phase Trend

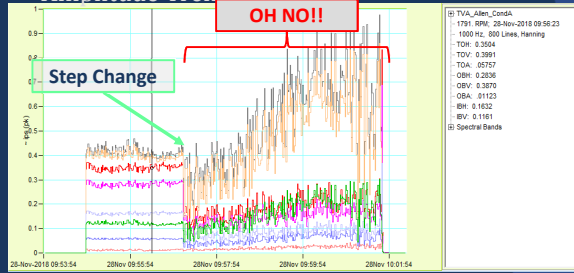
- Test Data – Subsynchronous Vibration Amplitude Trend

- So... What was wrong?
- Pump ingested foreign material
 - Caused pump impeller damage and excessive imbalance (High 1X) leading to excessive pump bearing clearance (High Subsynchronous)
 - Subsynchronous pump vibration excited structural natural frequencies
- What about the motor solo?
 - Motor was supplied with excessive imbalance

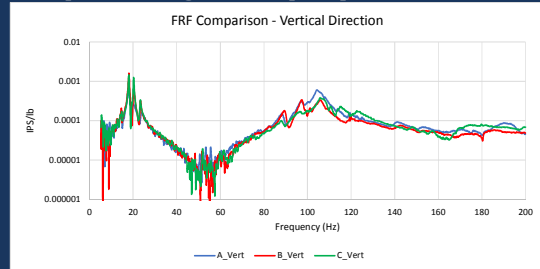
- Why is only A Pump bad? Structural?
- Impact testing on all 3 pumps...
