45<sup>TH</sup> **TURBOMACHINERY** & 32<sup>ND</sup> **PUMP SYMPOSIA**  
HOUSTON, TEXAS | SEPTEMBER 12 – 15, 2016  
GEORGE R. BROWN CONVENTION CENTER

# Vibration Analysis for Turbomachinery

Ed Wilcox

Chevron Energy Technology Company  
Houston, TX

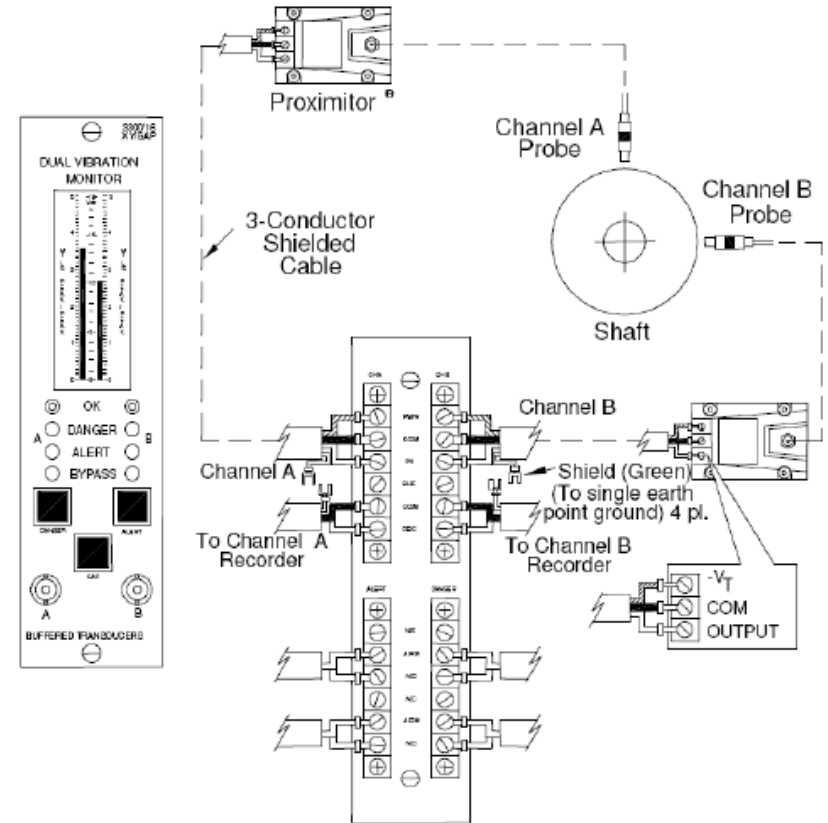
- Measures actual shaft displacement
- Includes probe, extension cable, and proximator which are a matched set
- Limited to  $< 1000-1200$  hz

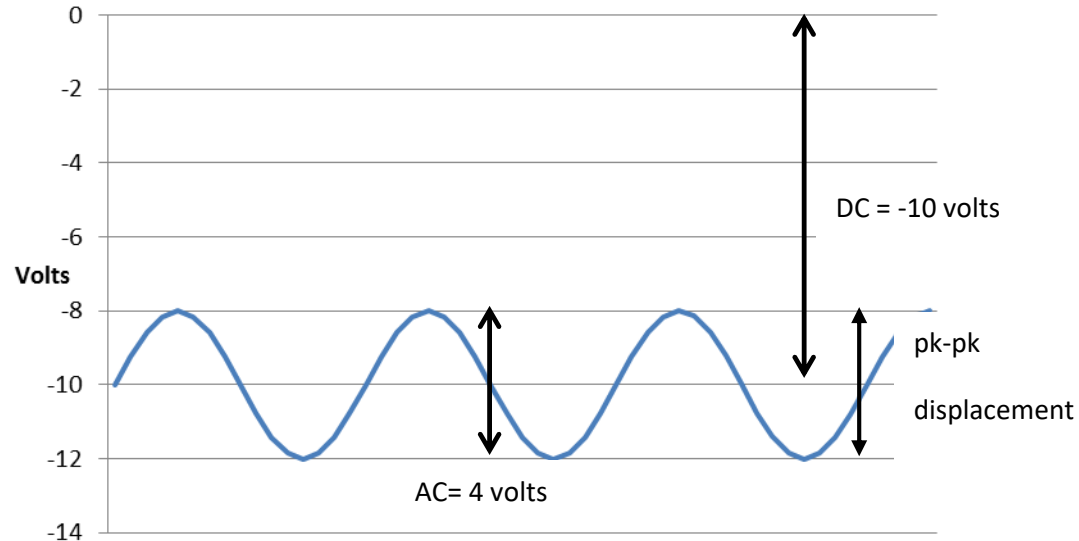
- DC component represents shaft position
- AC component represents shaft vibration

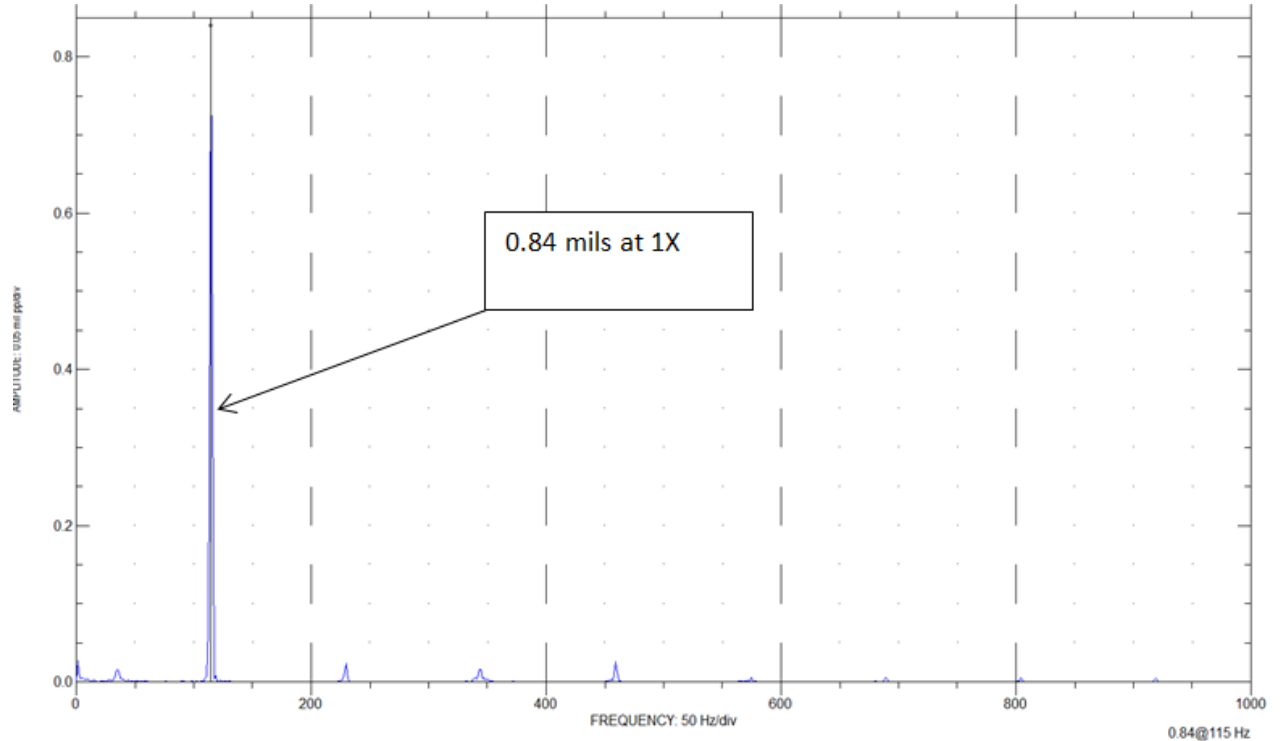
- Same rotor kit, probe, proximator, added 4 m extension cable

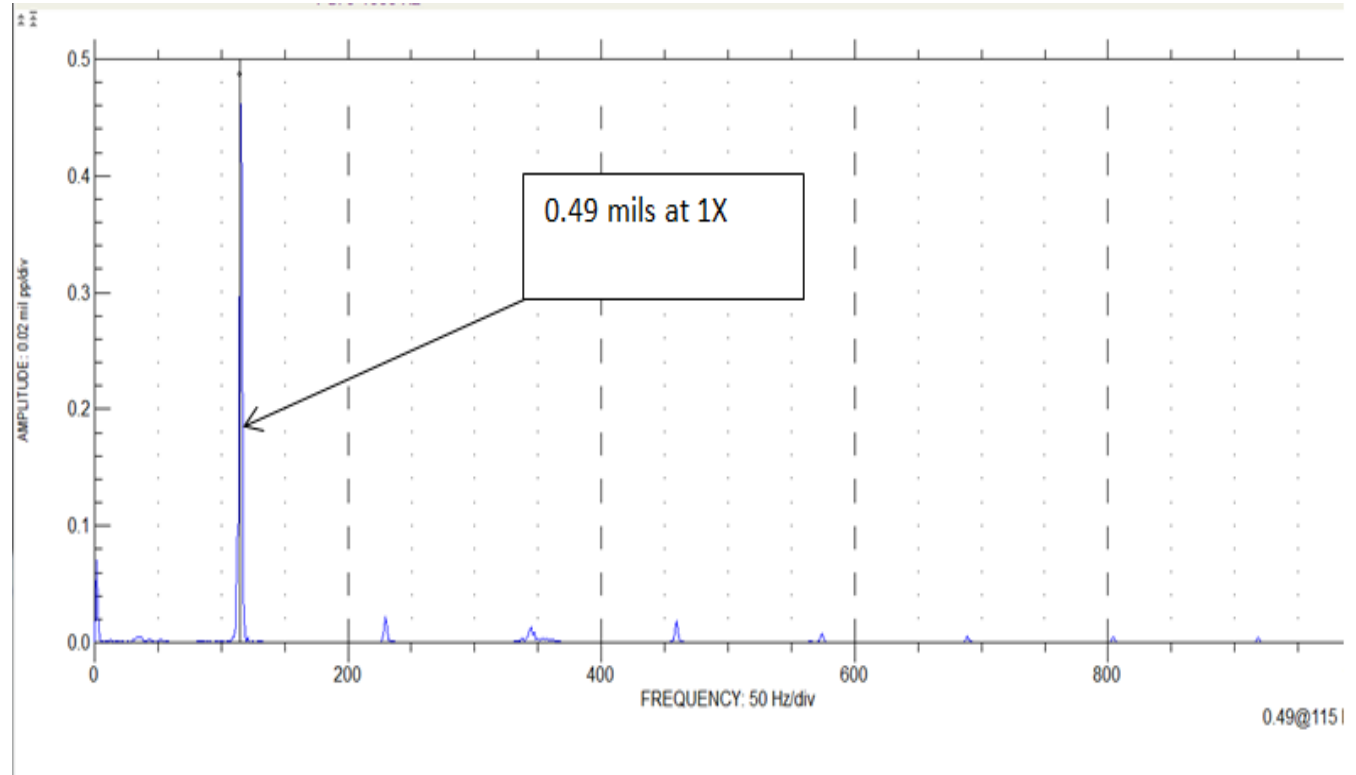
- Same rotor kit, probe, proximator, added 8 m extension cable

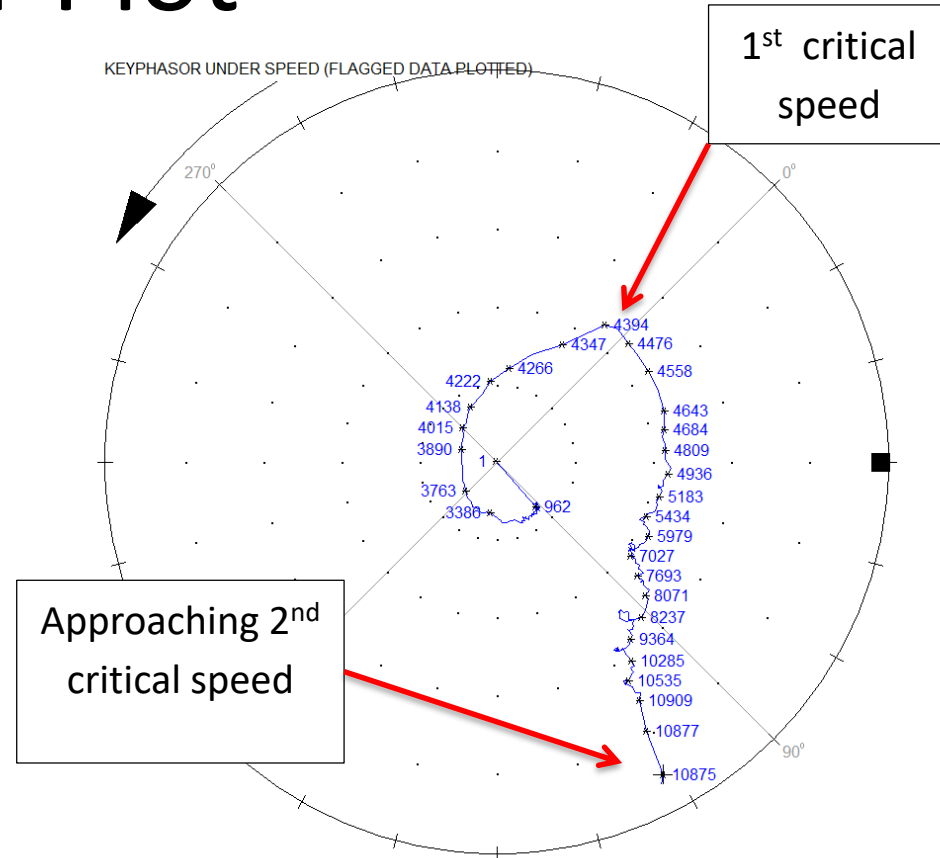
- Polar Plot – same data as Bode Plot, just different format
- Critical speed defined by maximum peak and approximately  $180^\circ$  phase change

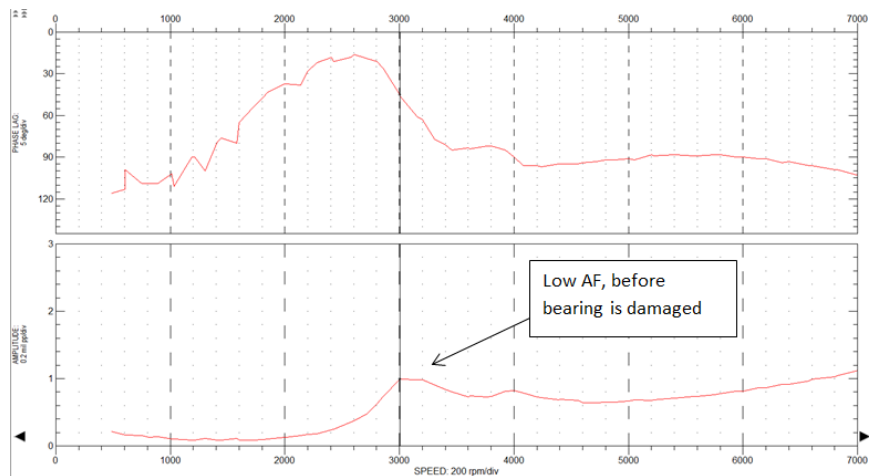
### Before Trip

## Detecting Bearing Damage in Centrifugal Compressor

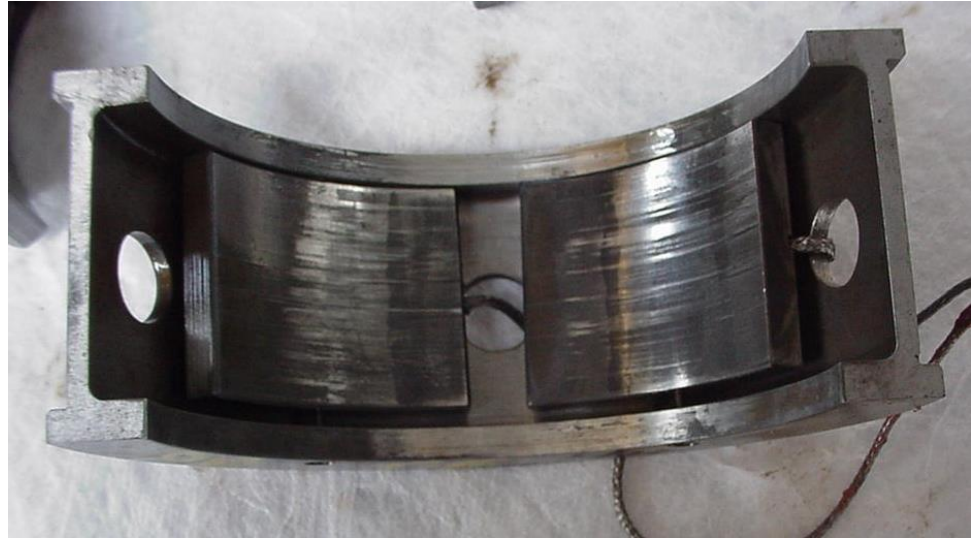
- Bearing showed evidence of loss of lube
- Clearance was 30 % above maximum
- Increase in clearance reduces damping and increases AF

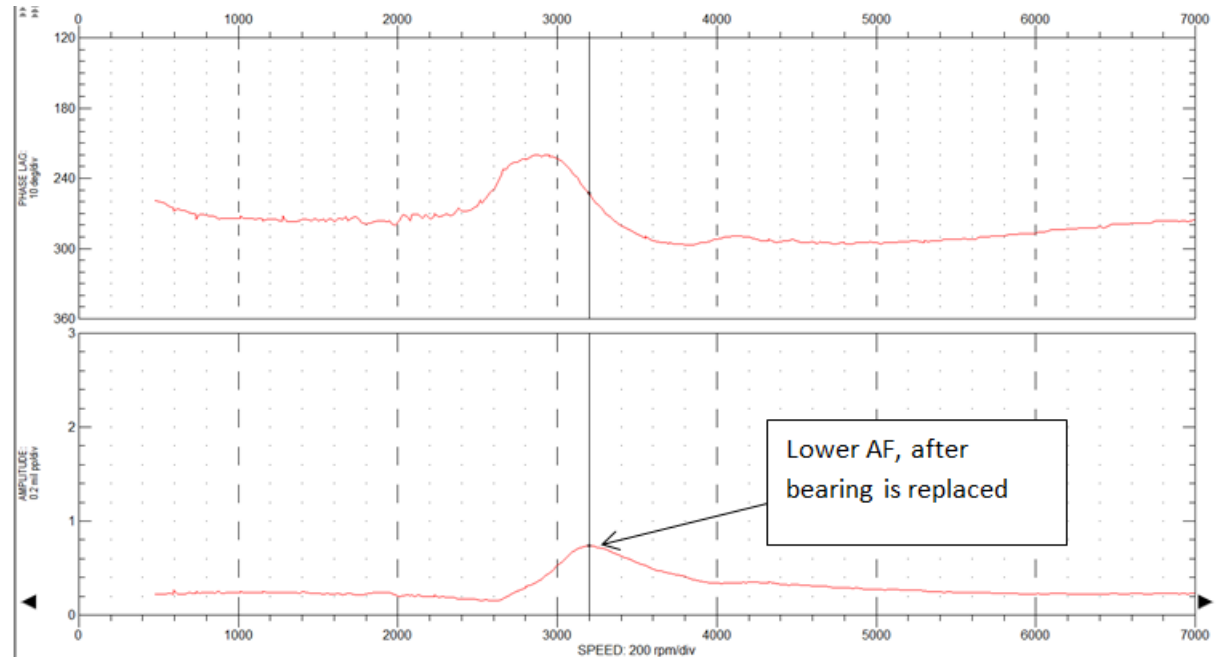
- Both radial bearings replaced
- AF returns to normal level

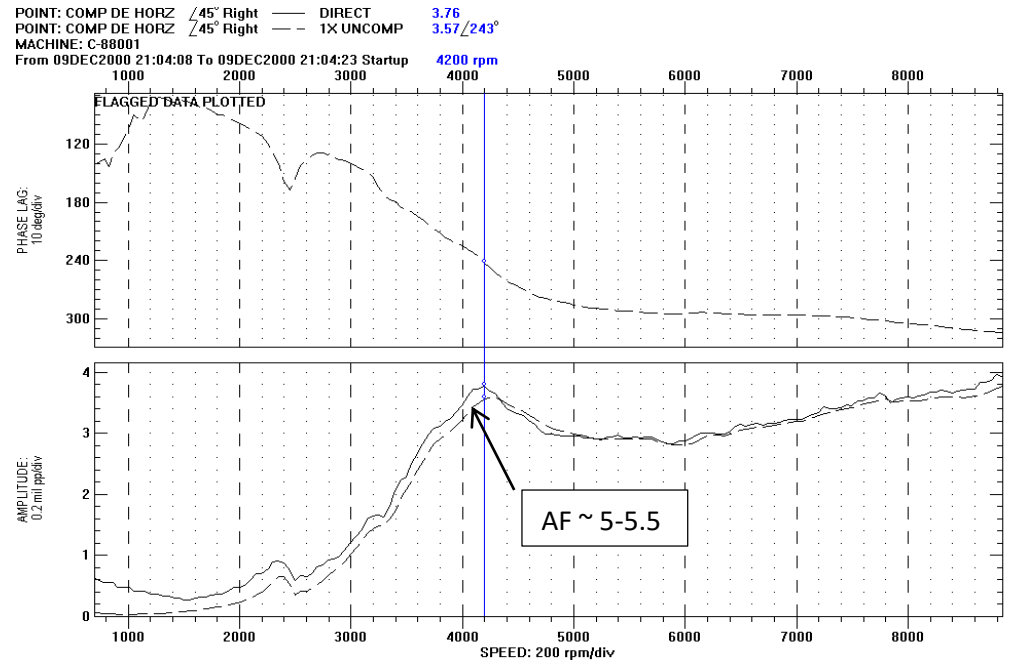
- After extended plant outage, compressor restarts with high radial vibration
- Rotor inspection shows large amount of fouling, cleaned returned to service

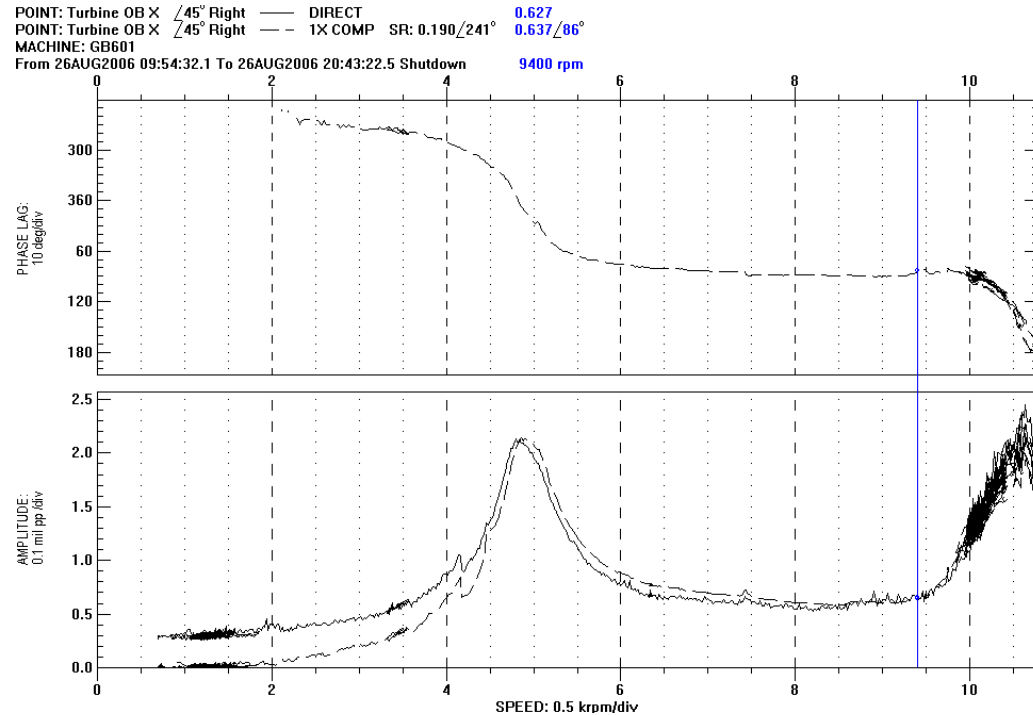
- High radial vibration on steam turbine outboard end during overspeed trip testing, 10,700 rpm
- Turbine normally operated below 10,000 rpm with vibration < 1 mil

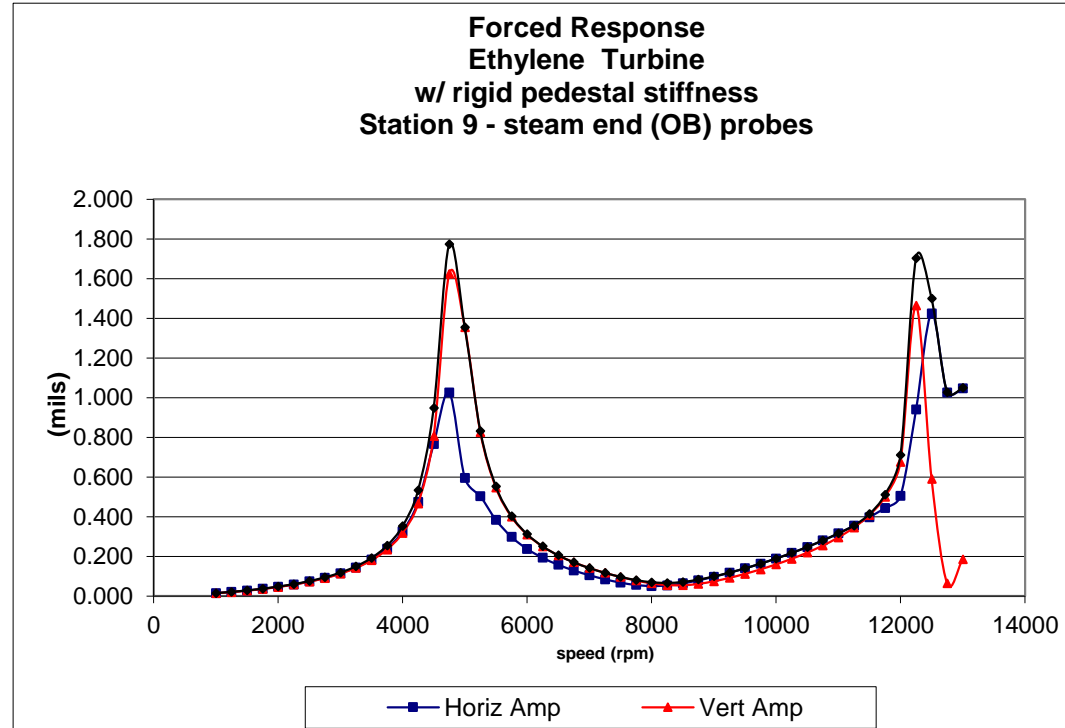
- Rotor model built to evaluate cause of vibration
- Model predicts 2<sup>nd</sup> critical much higher than vibration in field.
- Rotor model assumes rigid supports

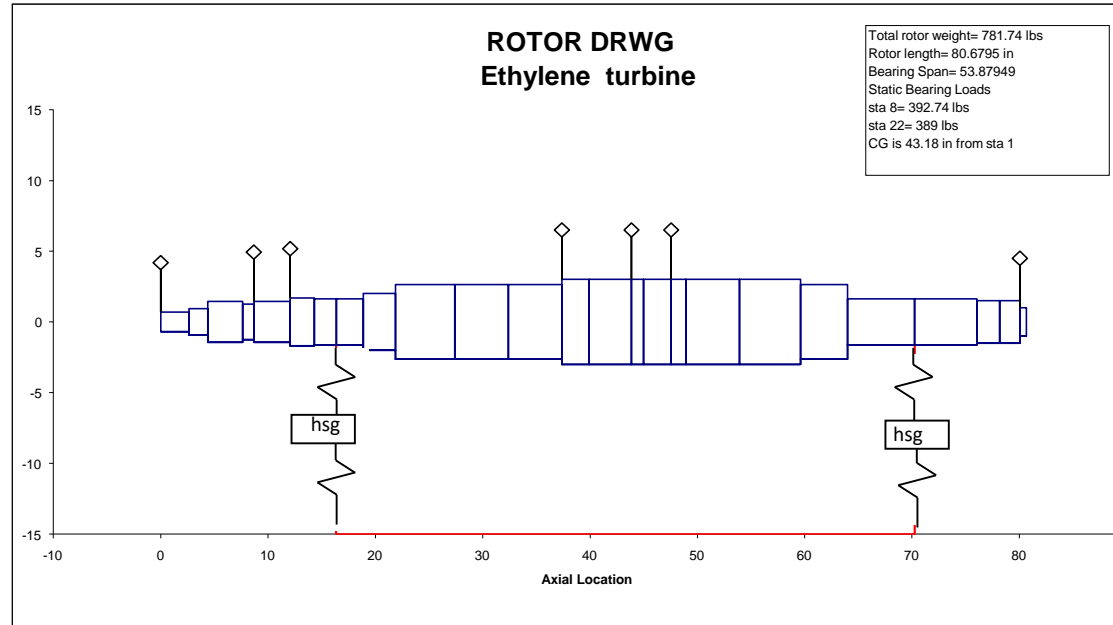
- Turbine outboard bearing has a “wobble foot” design to allow for thermal expansion
- Bearing housing support stiffness added to rotor model

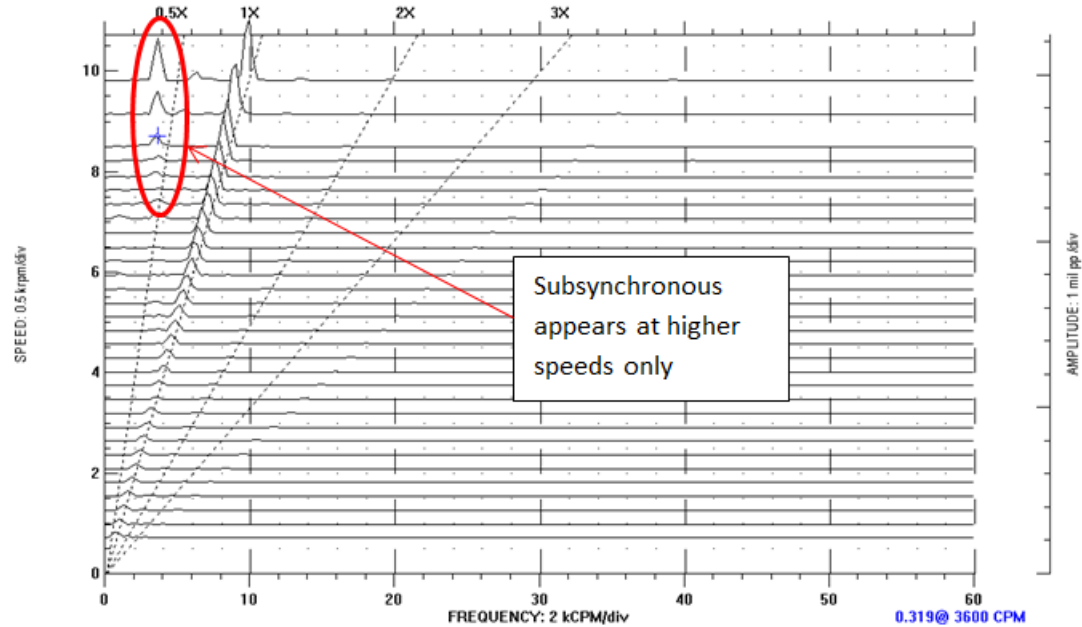
- Cascade plot shows subsynchronous peak appears only at higher speed
- Indicates that sub-synchronous could be exciting 1<sup>st</sup> critical

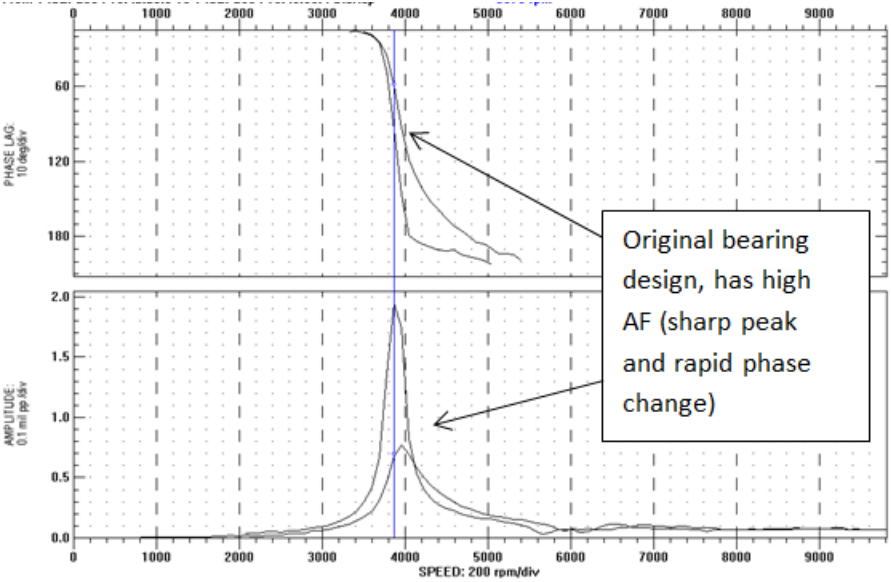
### Original LBP bearing

Original bearing design, has high AF (sharp peak and rapid phase change)

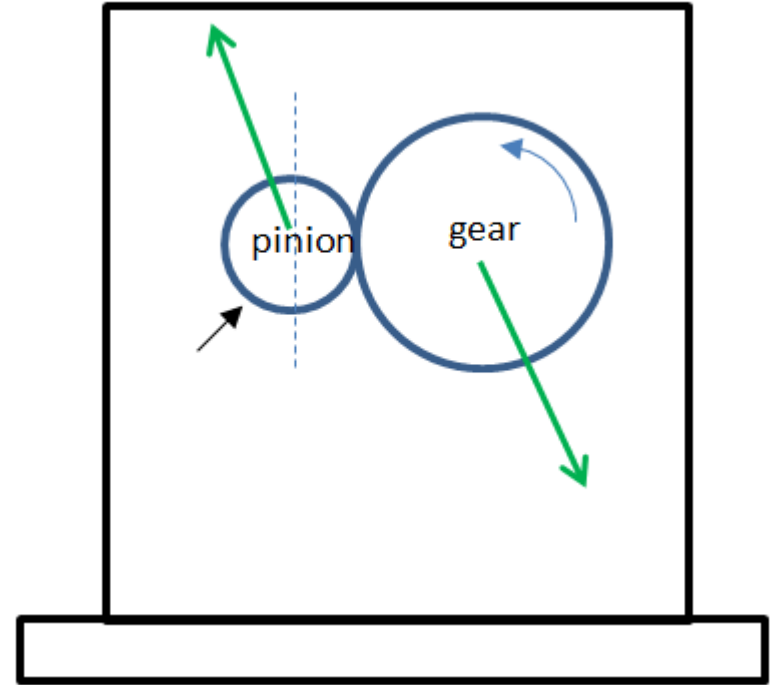
- Gear radial load pushes down on bull-gear and up on pinion
- Gear load more than enough to lift weight of pinion and keep it stable (no whirl)
- Pressure dam bearing in lower half of pinion used to load pinion up at low power conditions

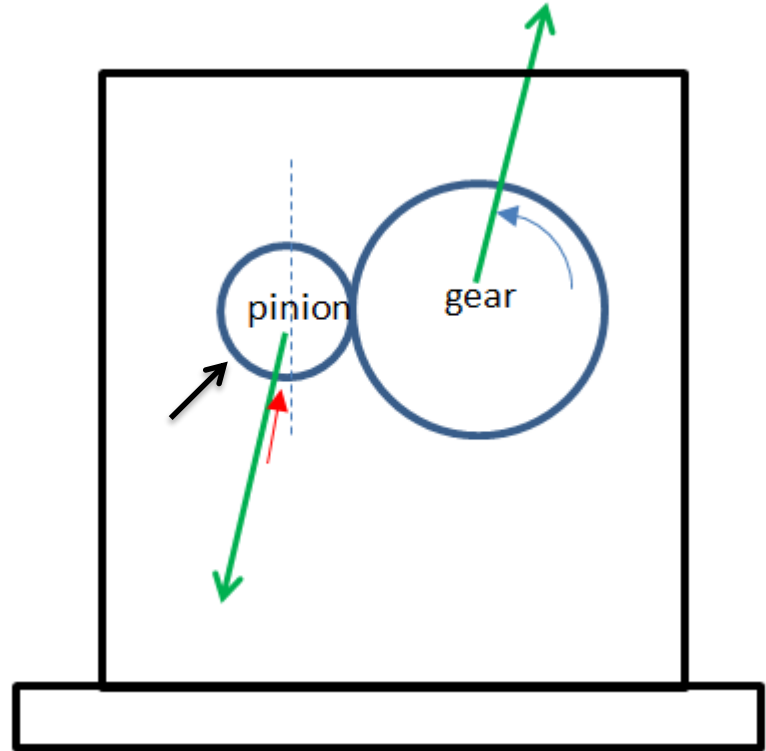
- Open breaker reverses gear load and pushes down on pinion
- Pressure dam in lower half of pinion bearing rotated to  $20^\circ$  so that it is opposite gear load during reversal

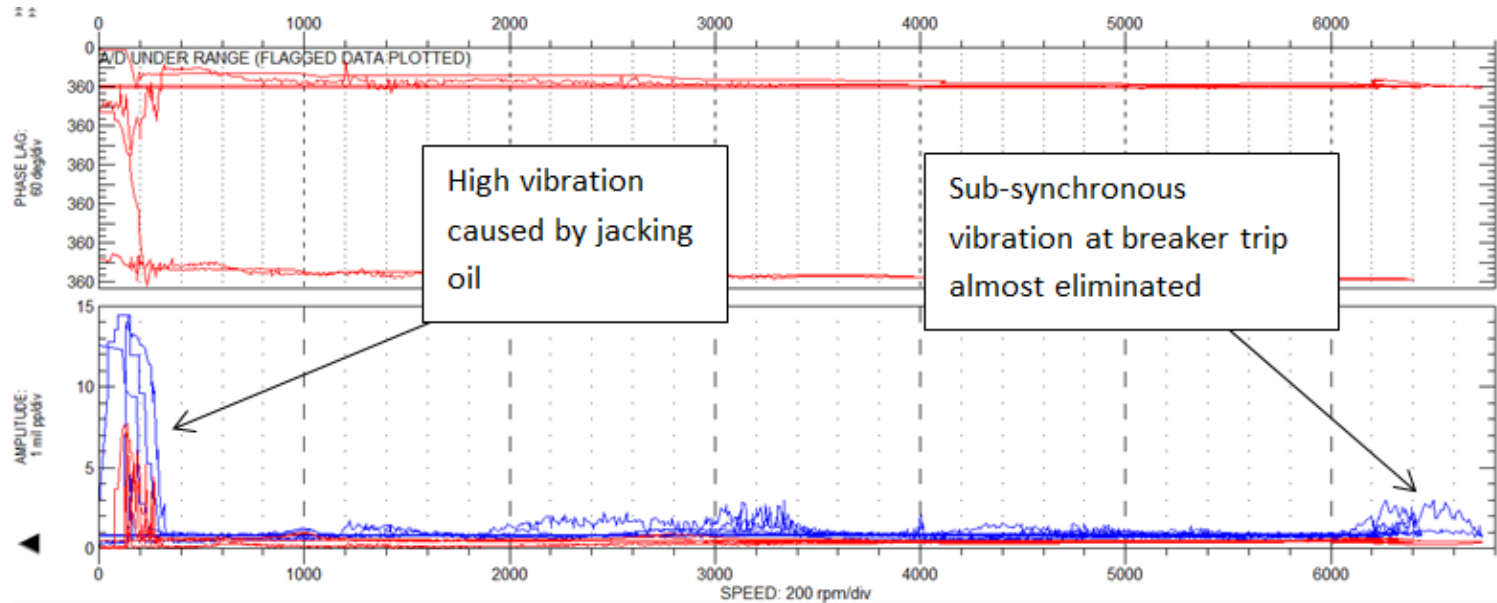
- Bearing modifications minimize sub-synchronous during open breaker test
