Texas A&M University
Graduate Engineering Class Presentation

AXIAL VIBRATION FOR A SYNCHRONOUS MOTOR, GEARBOX, COMPRESSOR TRAIN

TWO POLE MOTOR VIBRATION DIAGNOSTICS, ANALYSIS AND SOLUTION

Vertical Turbine Pump Reliability Improvement

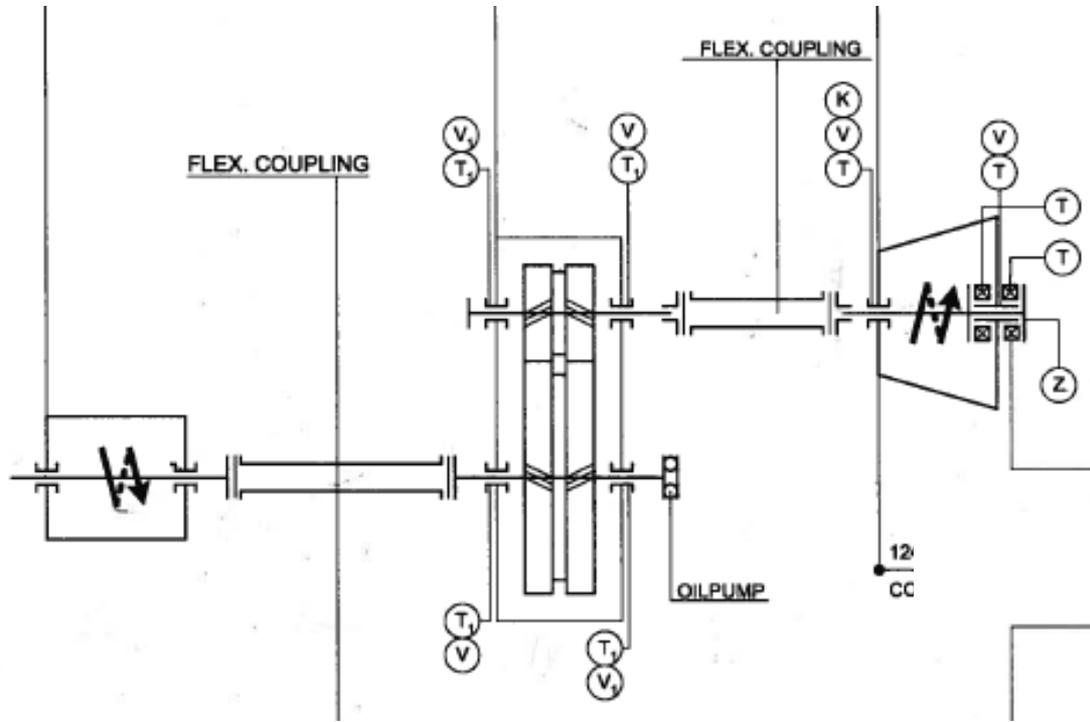
Mathematical Model

- The train experienced axial vibration at 2X of the train 1st axial natural frequency. Bull gear and pinion relative displacement was observed and calculated.
- Excitation force came from misalignment and motor magnetic centering force.
- The motor is not designed to run off magnetic center. The motor centering force is believed to be around 100-200 lbf/1000 HP.
- The motor centering force is believed to be non-linear to the axial displacement.
- The motor centering force coupled with misalignment was sufficient to trigger the observed axial oscillation.
- High axial vibration was resolved by better alignment.
- The study concluded axial vibration thresholds exist. They depend on axial excitation forces and axial mass-elastic property.
- More research in this directions is necessary to improve coupling design requirements and alignment criteria.

- Compressor trains with very low axial stiffness coupling tend to have low frequency axial oscillations.
- High alignment targets can reduce the excitation force. The process can be time consuming and misalignment change with ambient condition.
- Damping effect is low in the discussed motor compressor train which makes this simplified simulation valid and relates well with what was observed.
- Running at 2X axial natural frequency can cause axial vibration and LCF at coupling and gearbox. This can be a significant reliability issue.
- Precaution shall be given to coupling design to increase the lowest axial critical speed frequency.

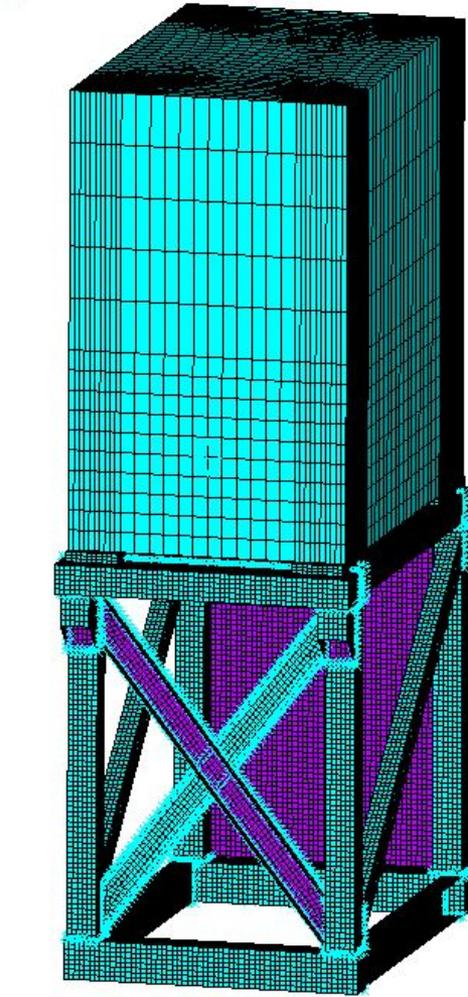
Finite Element Model

As-Design Condition

- The support has a natural frequency at 57.9 Hz, which is very close to the motor's running speed of 60 Hz
 - This resonance was likely the original cause of the foundation crack
 - Simply fixing the loose foot due to the damaged foundation did not and will not solve the resonance problem
 - This mode must be pushed away from the motor's synchronous excitation

- As designed, the support has a natural frequency at the motor's running speed, causing resonance
- This resonance is likely the cause of the original foundation crack
- To increase the resonance frequency of the support outside the motor operating speed range, stiffening device should be added to areas with the most amount twist, instead of areas with the most displacement
- Based on the FE results, it is recommended that plates of $\frac{3}{4}$ " to be welded to the East and West side of the support structure
- Turnaround team found out soft foot again that was fixed a year ago. Further prove the validity of the analysis and the softfoot was a result but not a solution to the structural resonance issue.

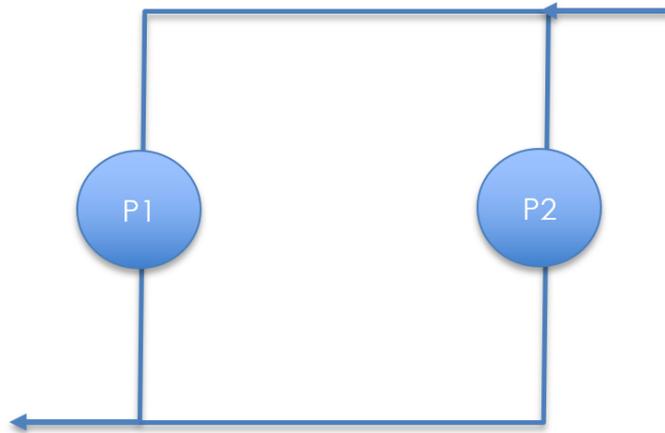
Pump System Configuration

Two (10 stage) pumps for on-stream backup.

Back pressure control valve.

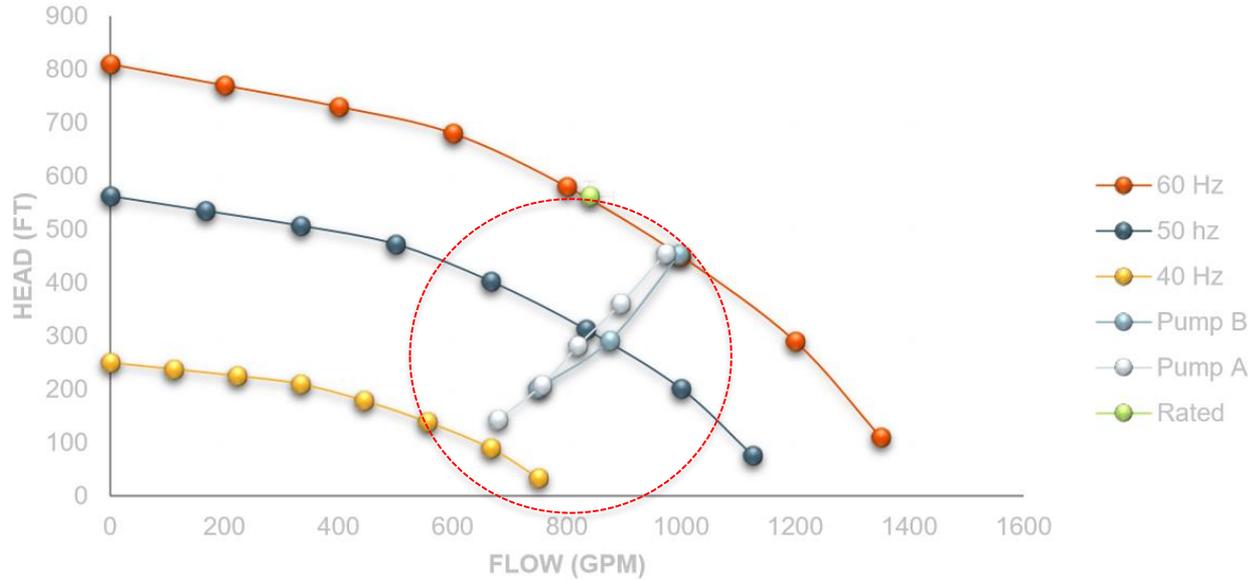
Pump Curve and Operating Points

Due to the deviation between the pump design condition and its actual operating condition, flow turbulence and recirculation in the pump impellers produced enough vibration excitation forces that caused the mechanical seals to fail prematurely and to leak.

- Reviewed pump curve and compared with other transport pumps for similar service. The review indicated pump re-staging would bring pump to operate closer to its rated condition and enable an extended operating range. This recommendation was not implemented.
- Vibration signatures at various speed and back pressure taken to generate Performance & Reliability Map (PRM) to set a “**safe to operate range**”.
- Transitional seal flushing orifice installed to reduce a turbulence flow effect on the rotor but results were marginal.
- In addition, a review of thrust loading showed absence of balance orifices in the impellers for VFD drive pump. Motor bearing selection needs to be reviewed to consider thrust load to prevent frequent bearing failure.

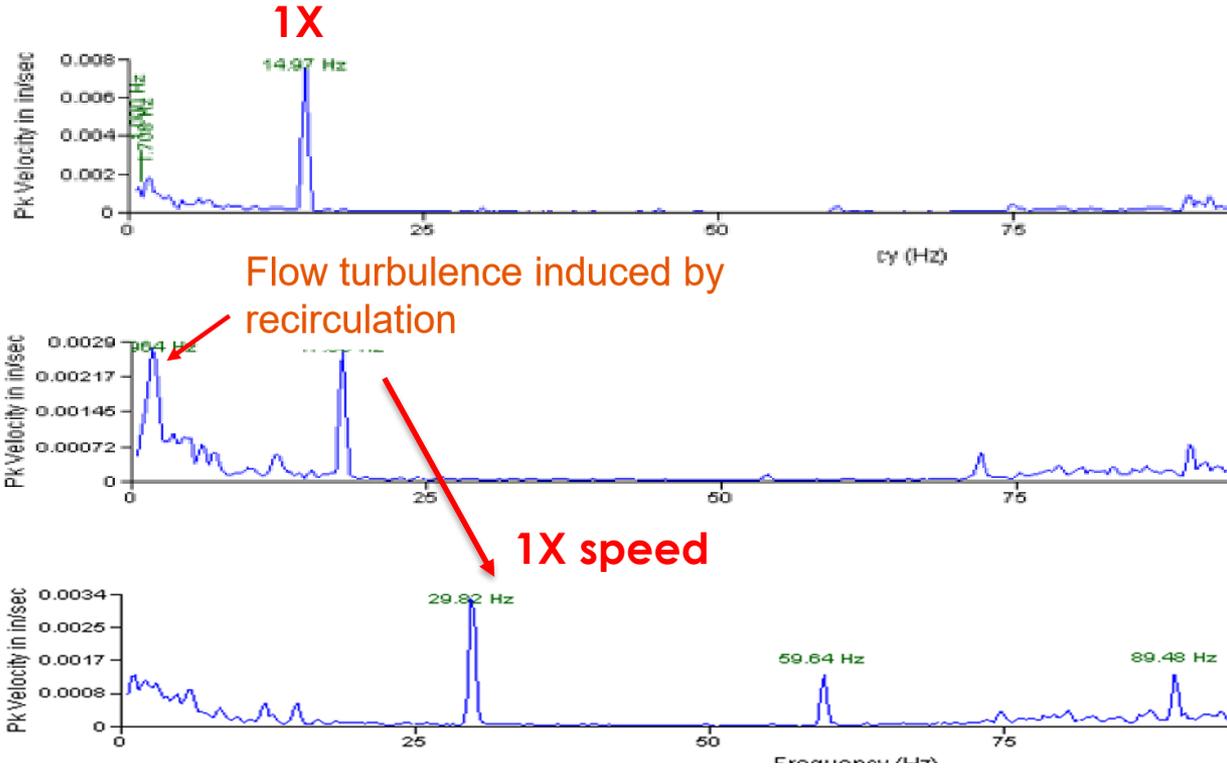
Vibration Spectra At Various Speeds

- Vertical Turbine/Pump used for pipeline transport service experienced high level of vibration that caused premature seal failures and condensate leakage.
- Radial Vibration produced severe damage of top two bushings (last two stages). 1st stage bushing showed edge loading wear pattern.
- Rotor dynamics report indicated rotor resonance at lower end of the operating speed range.
- During pump repair, tighter clearance bearing bushings were installed (3rd party repair shop). Rebuilt pump ran with loud metal scratching noise and leaking condensate from the mechanical seal over most of its operating speed range.
