Bently Nevada Rub, Morton Effect, Parametric Excitation, and Shaft Crack in Rotating Machinery - Real Cases

John J. Yu, PhD **Senior Technical Manager** Machinery Diagnostic Services

April 2, 2019

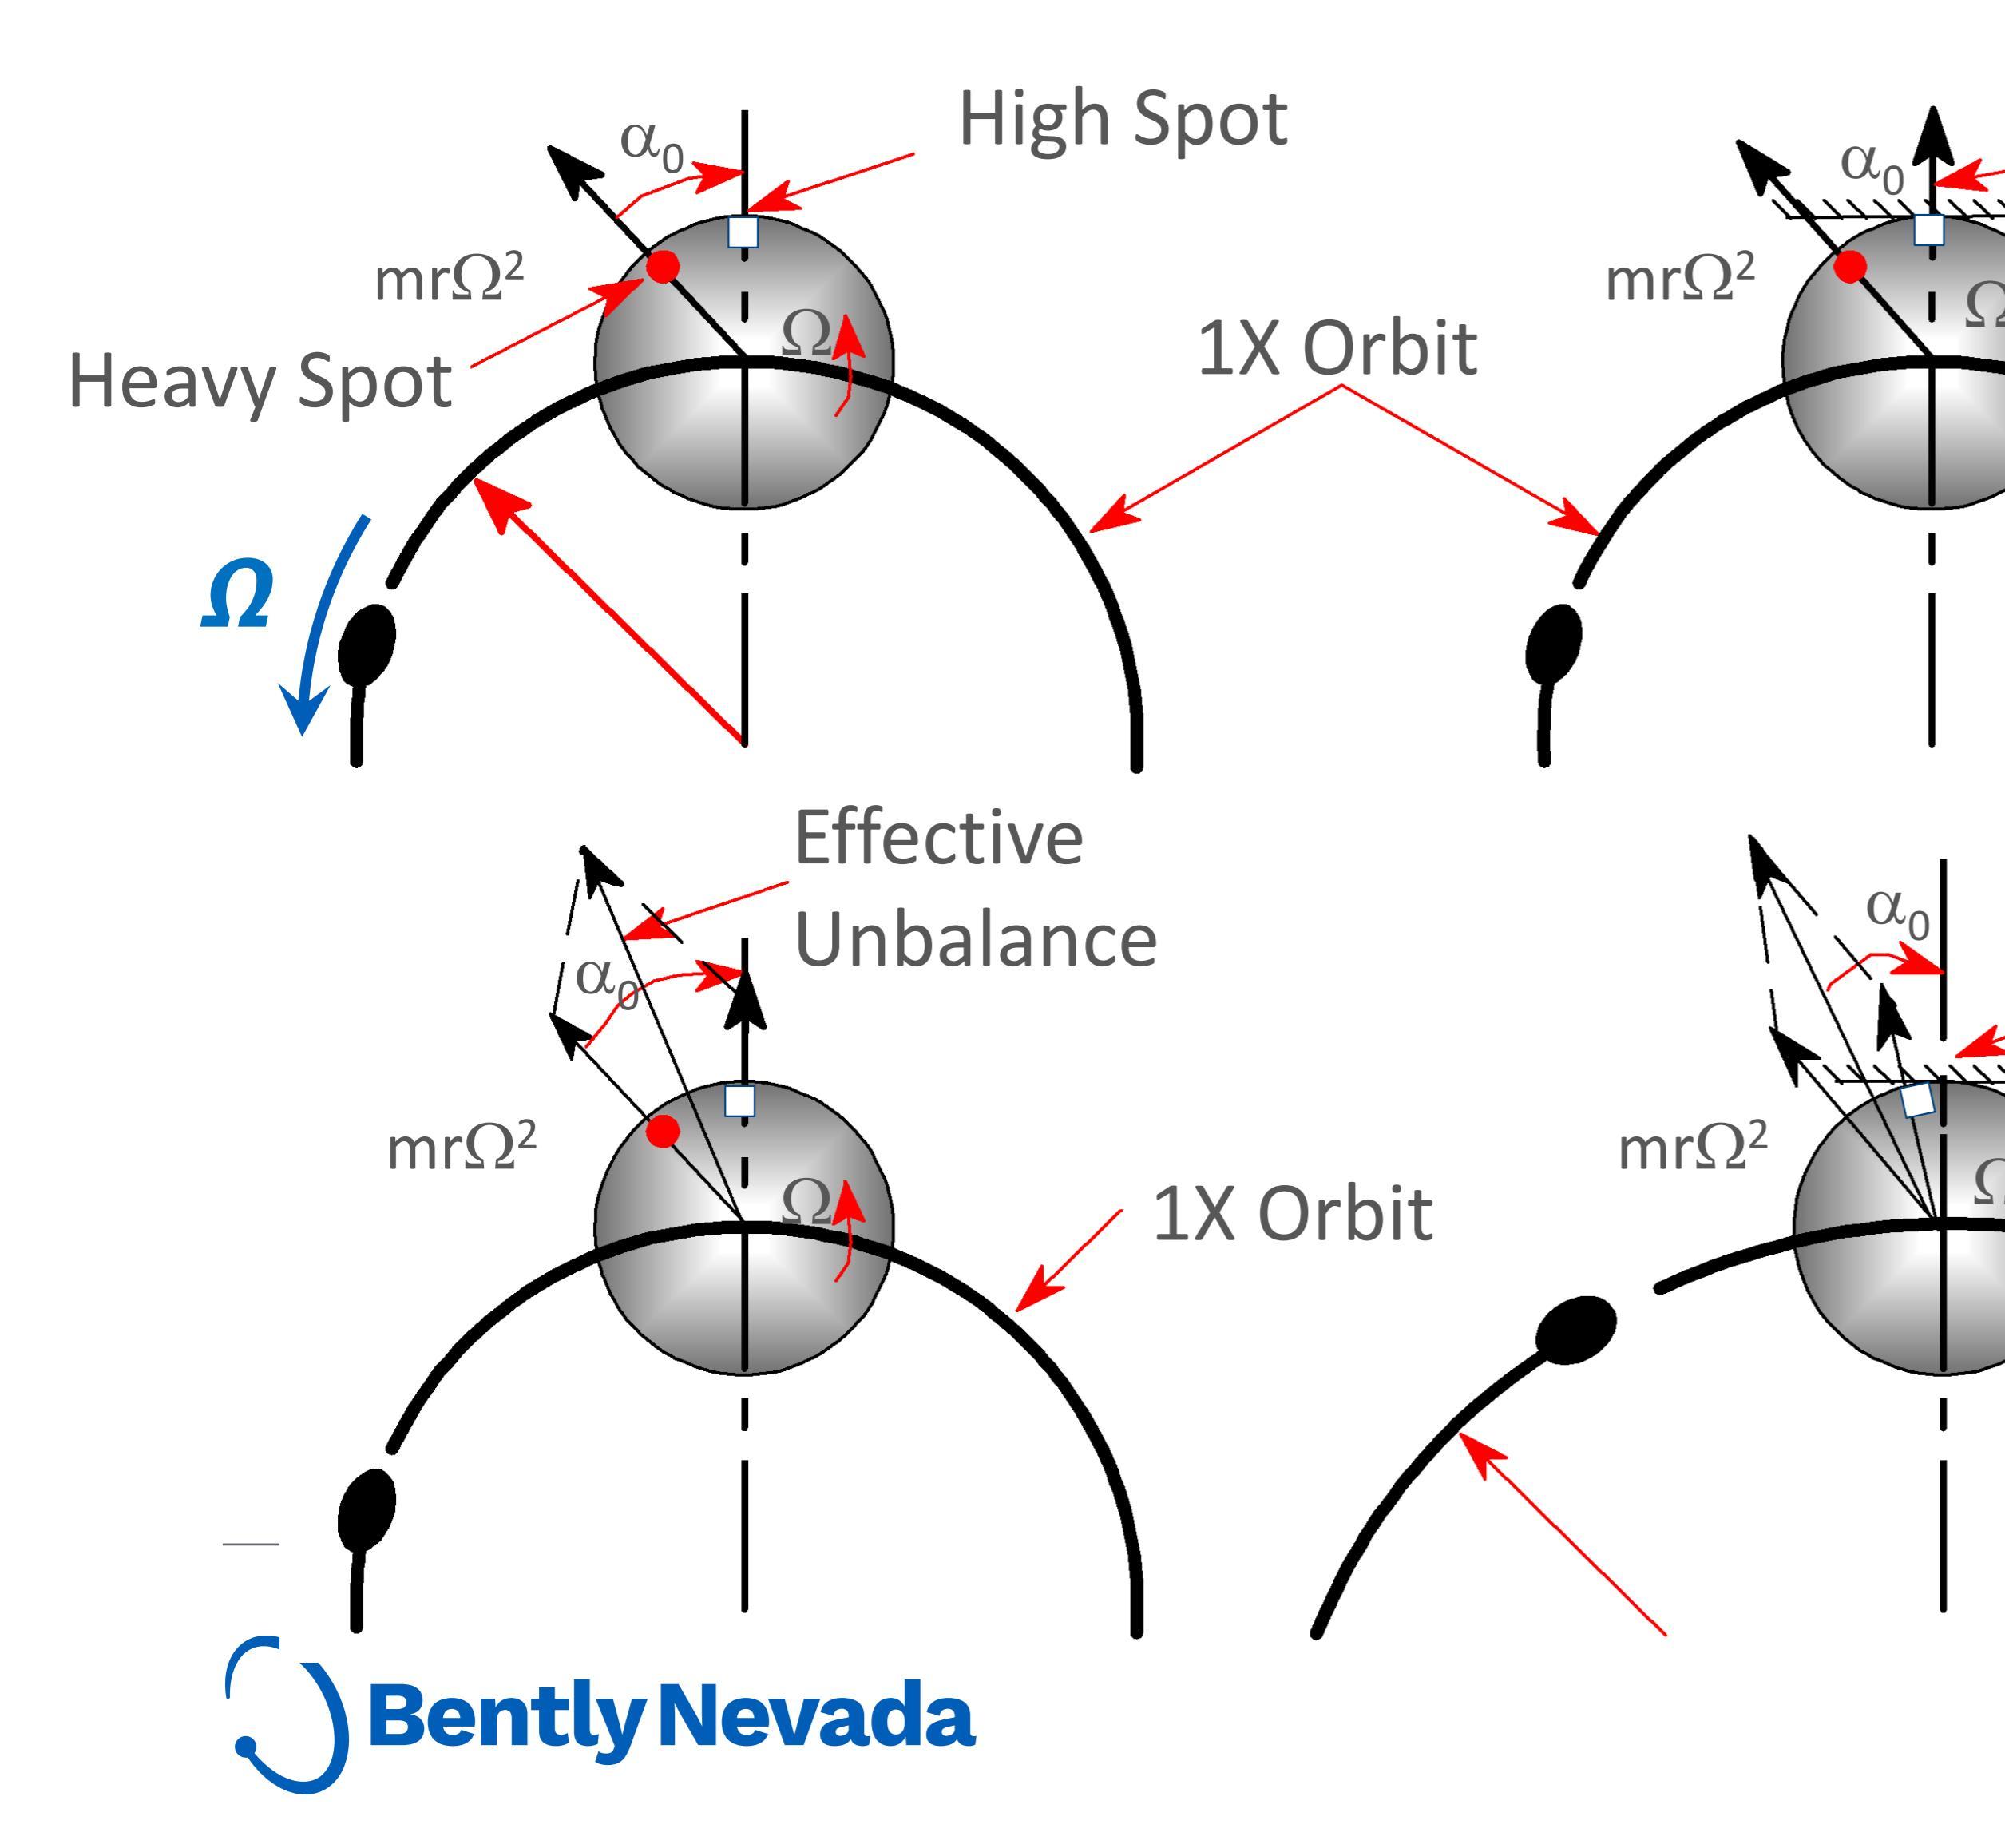
Thermal Bow Effect of Rub – causing 1X amplitude & phase to change

Rubbing Spot

Seal

A New High Spot and Rubbing Location

Increased 1X Orbit

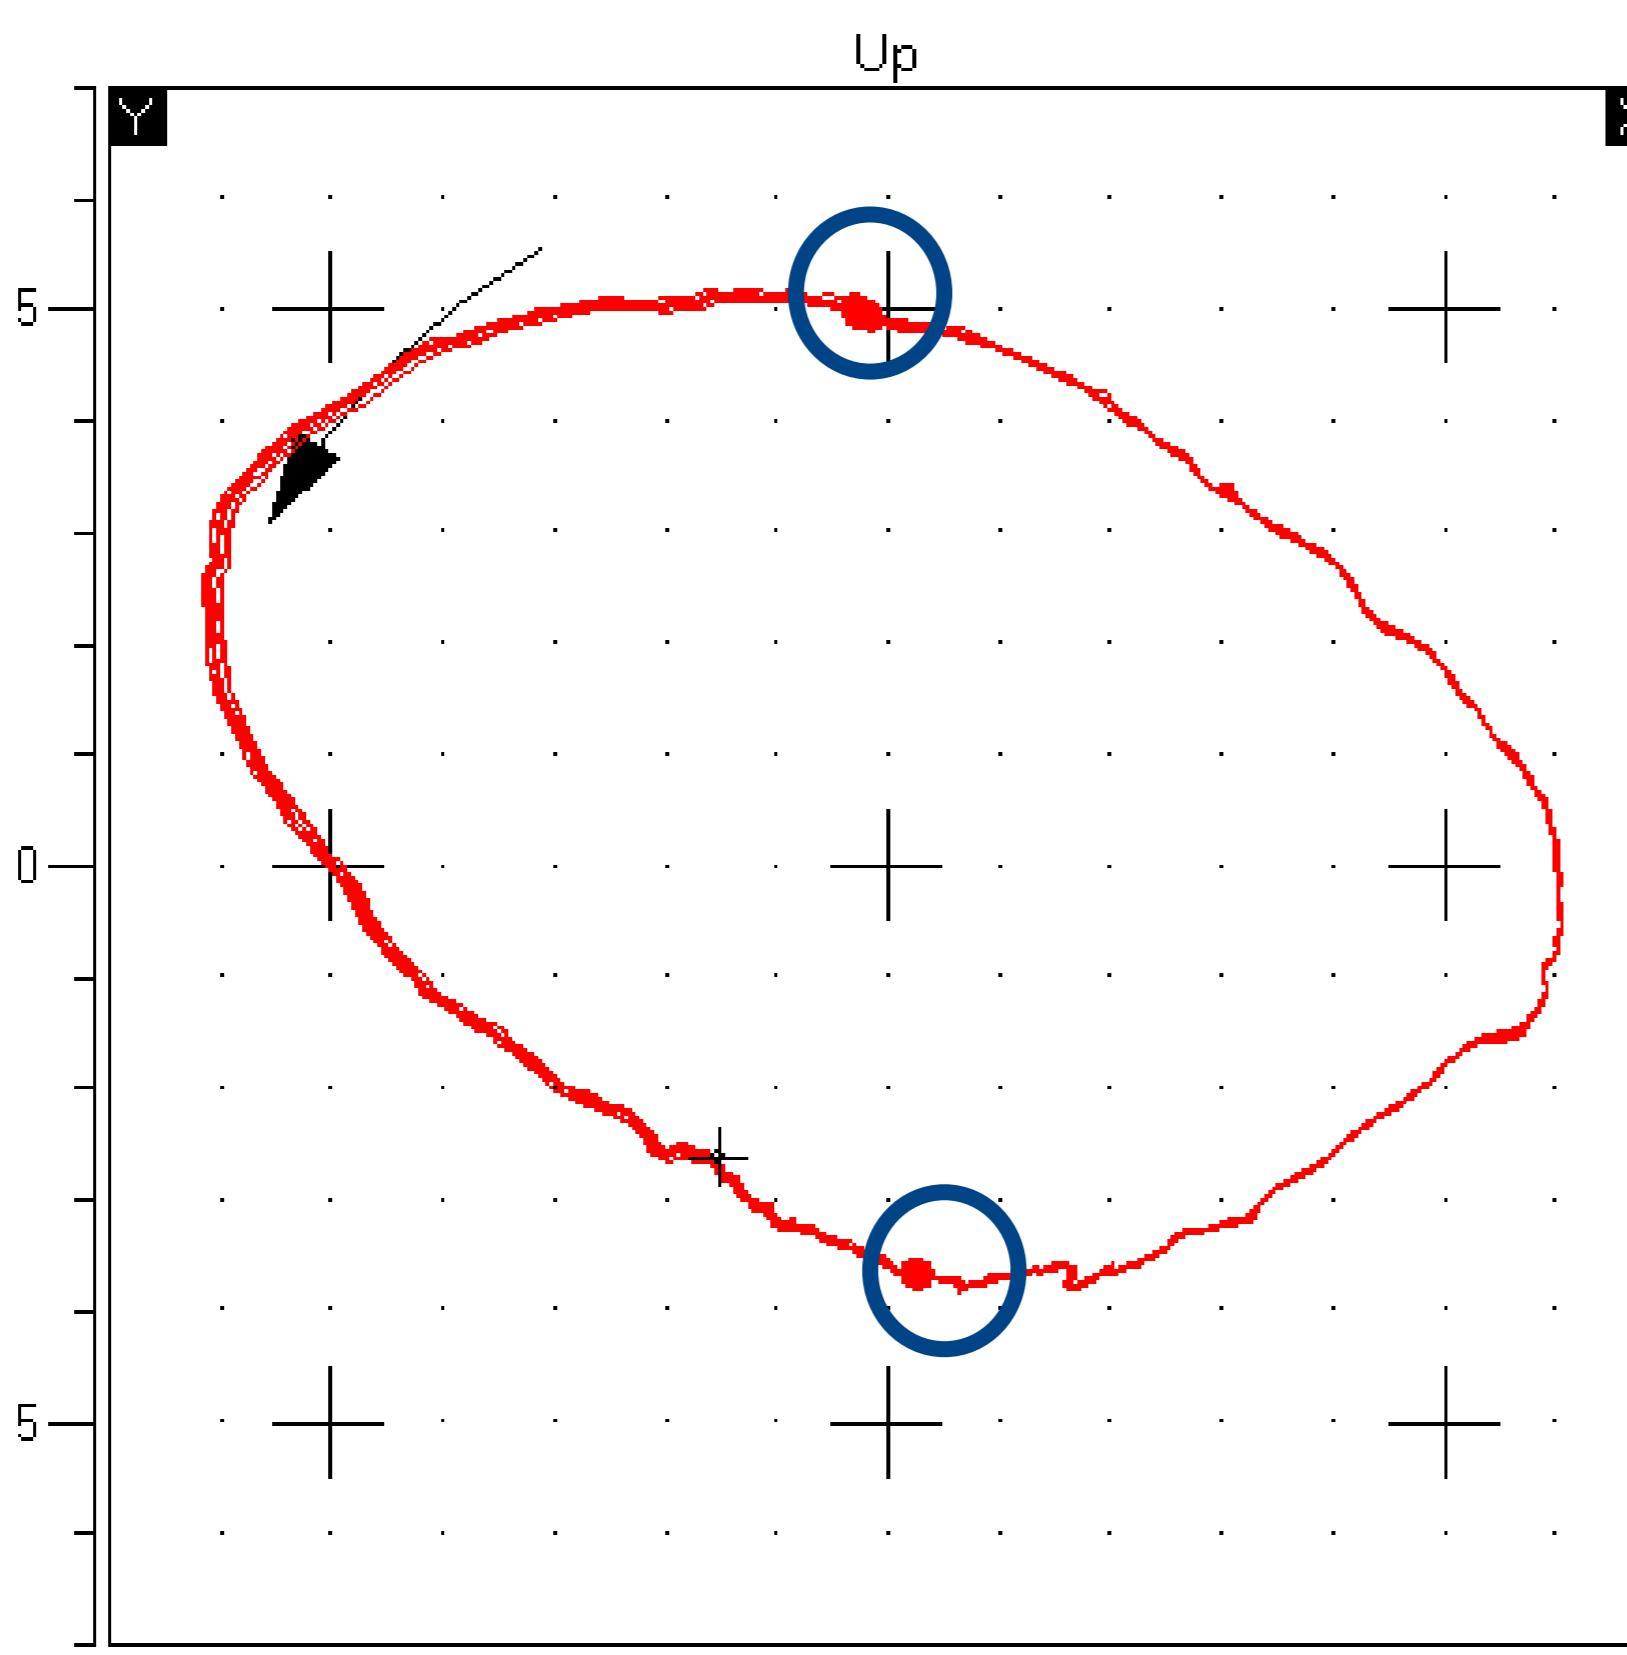
¹/₂X Vibration

Keyphasor dots are locked on the orbits

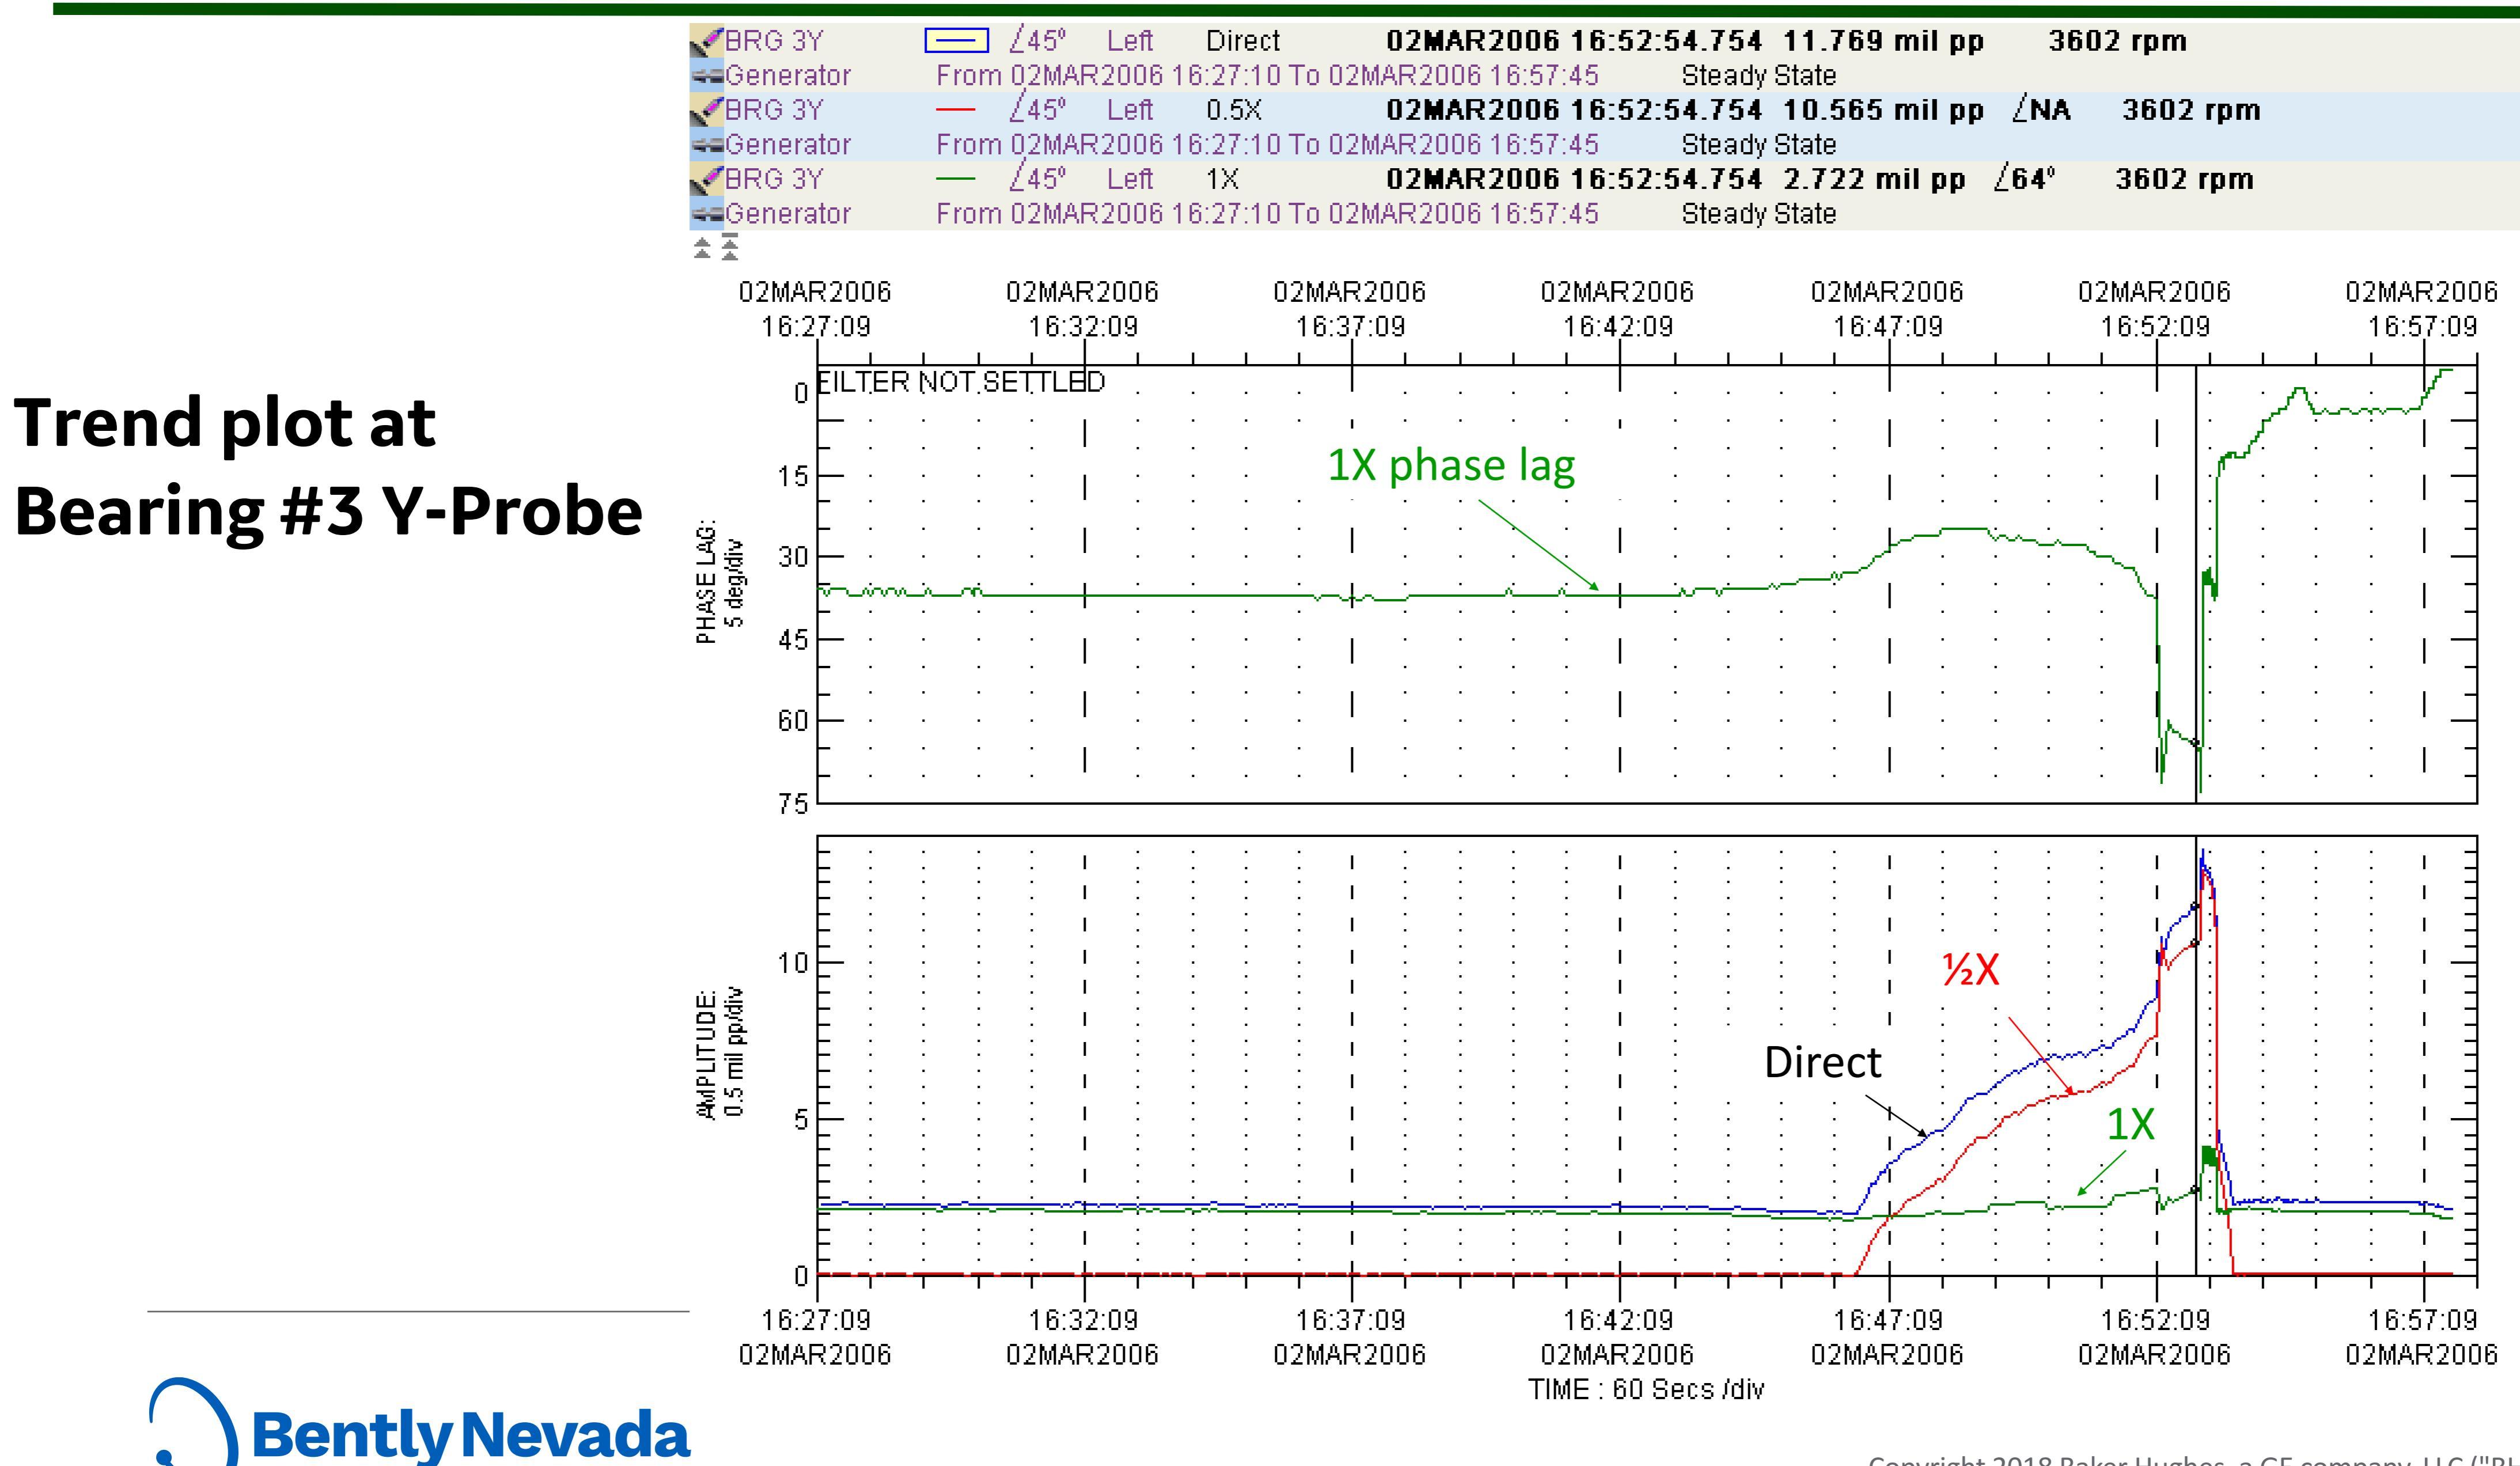
Vibration excursion from approx. 2 mil pp (~50 µm pp) to 12 mil pp (~300 µm pp) at Bearing #3 at 2 MW, due to

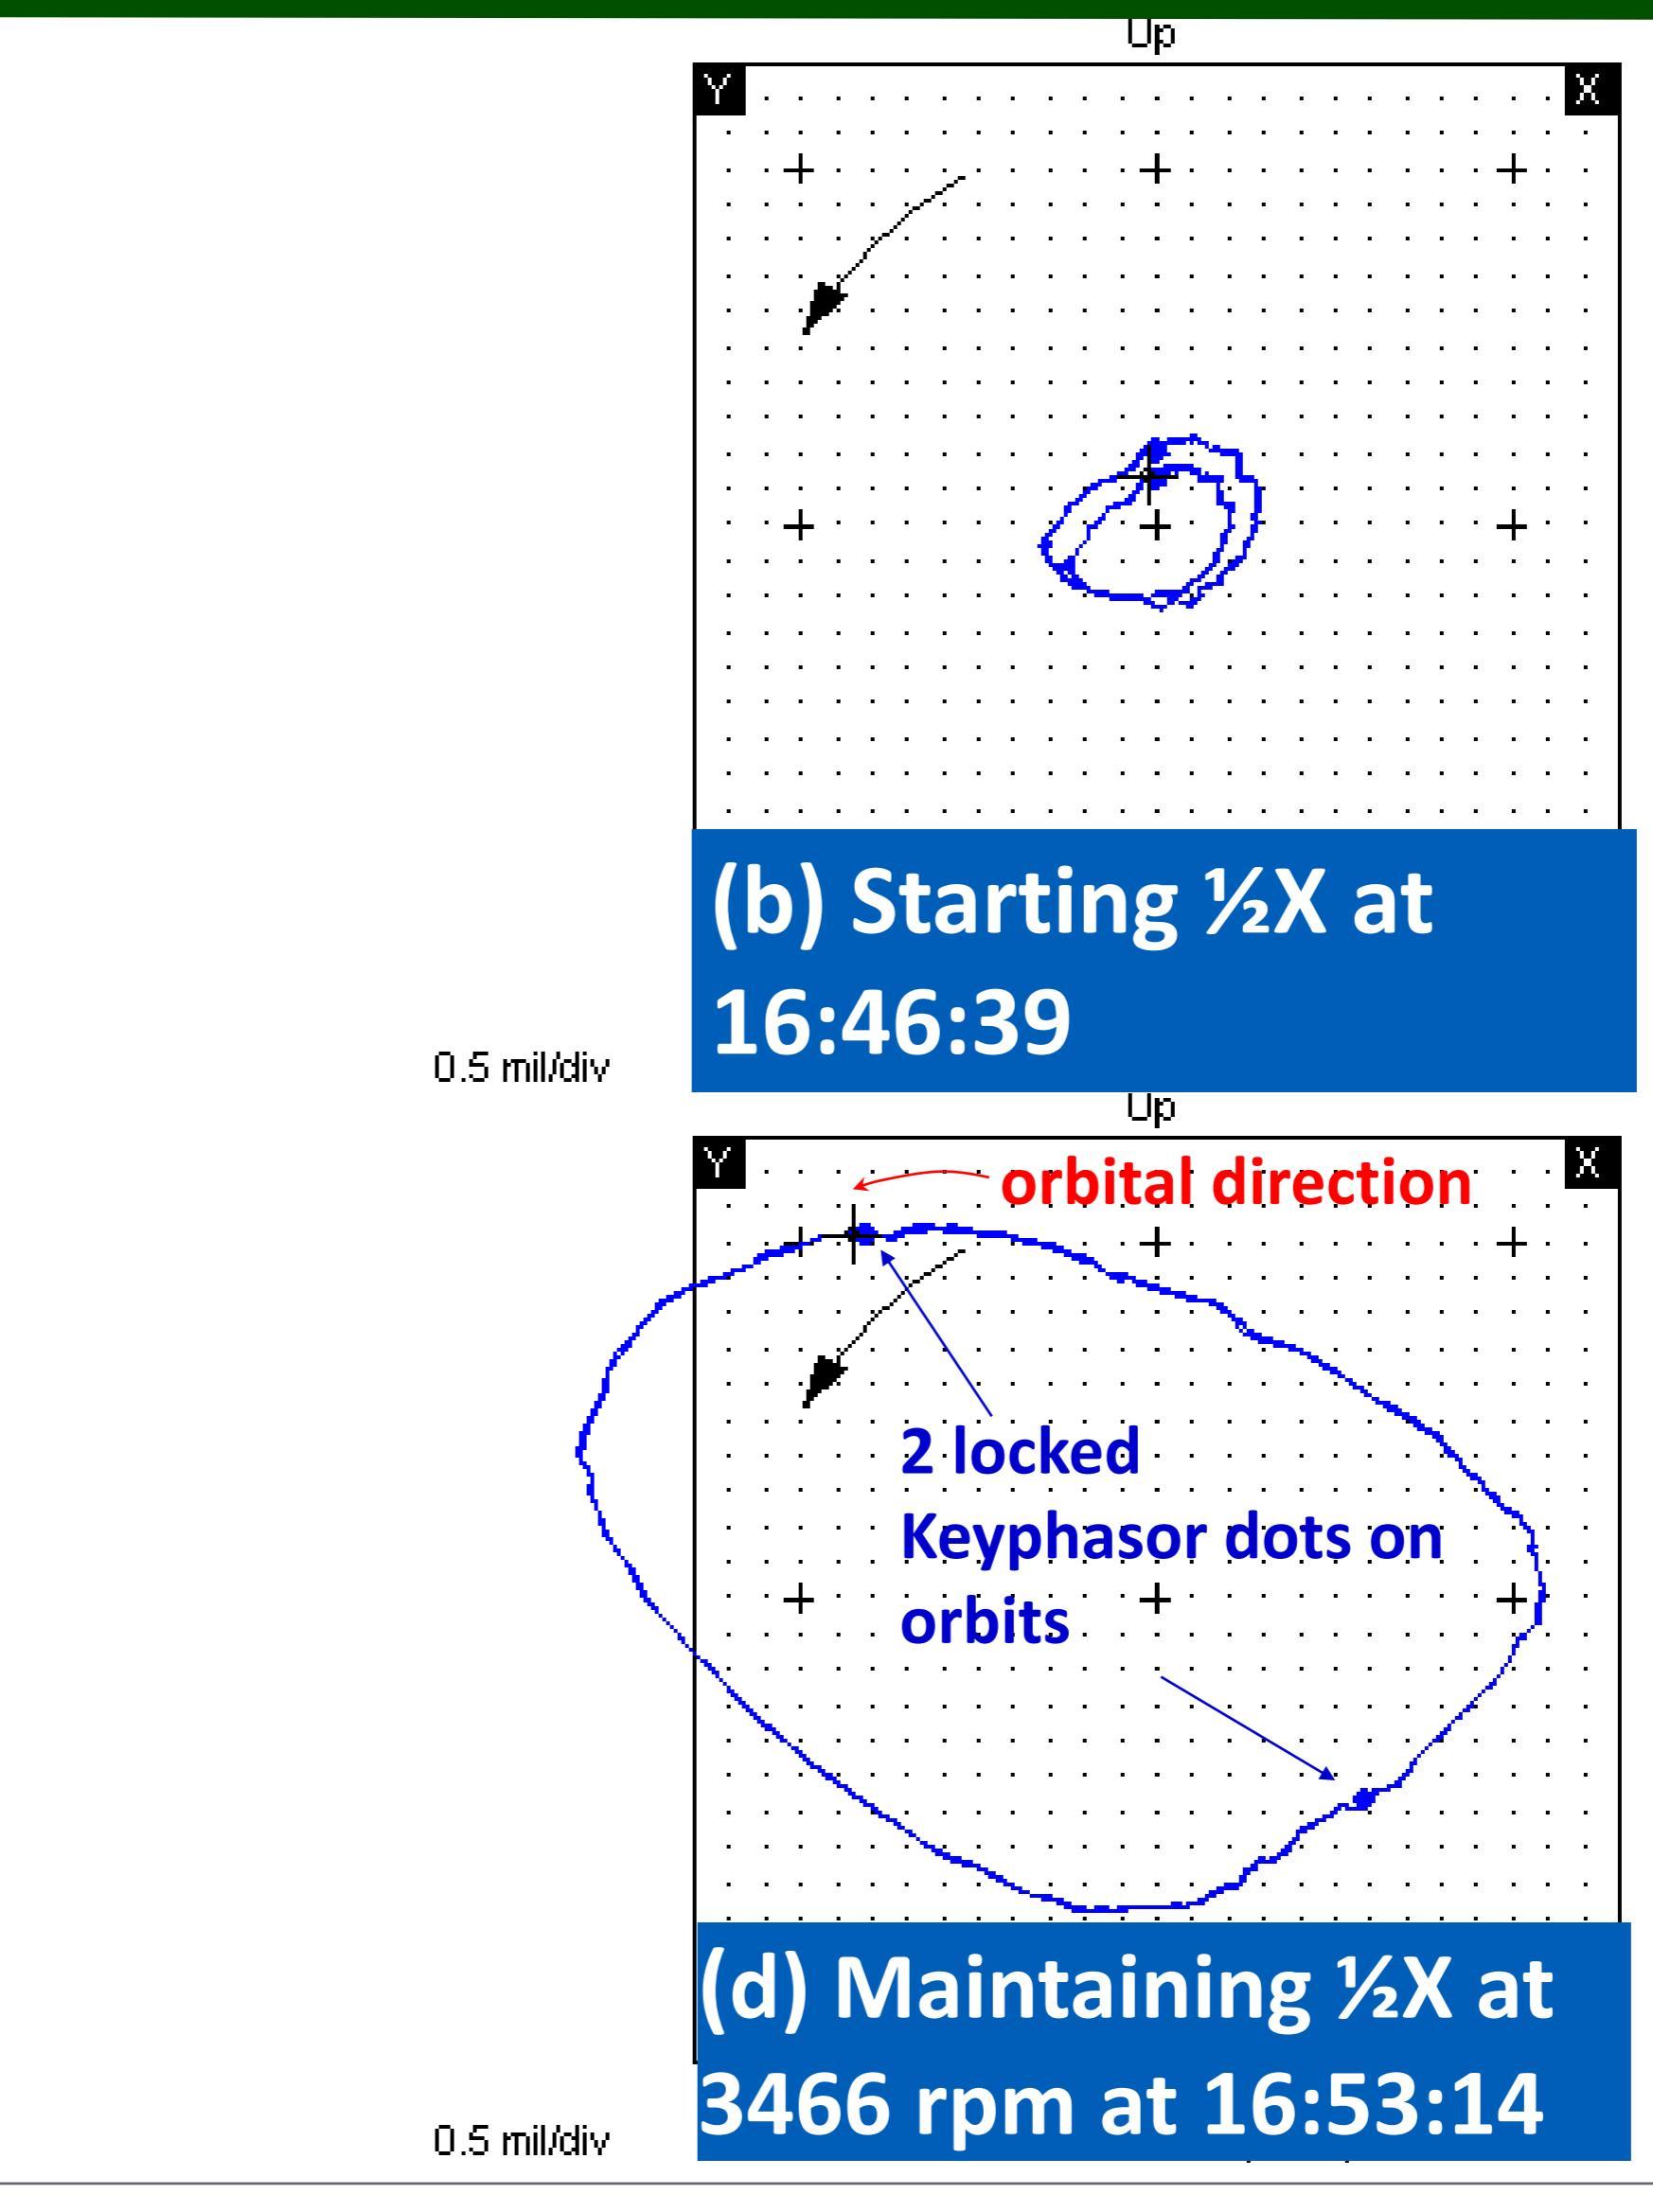
Waterfall plot from Bearing #3 Y-Probe

Indicative of natural frequency at near 1800 cpm or half of the running speed (most likely due to suppressed oil whip), prior to onset of $\frac{1}{2}X$.

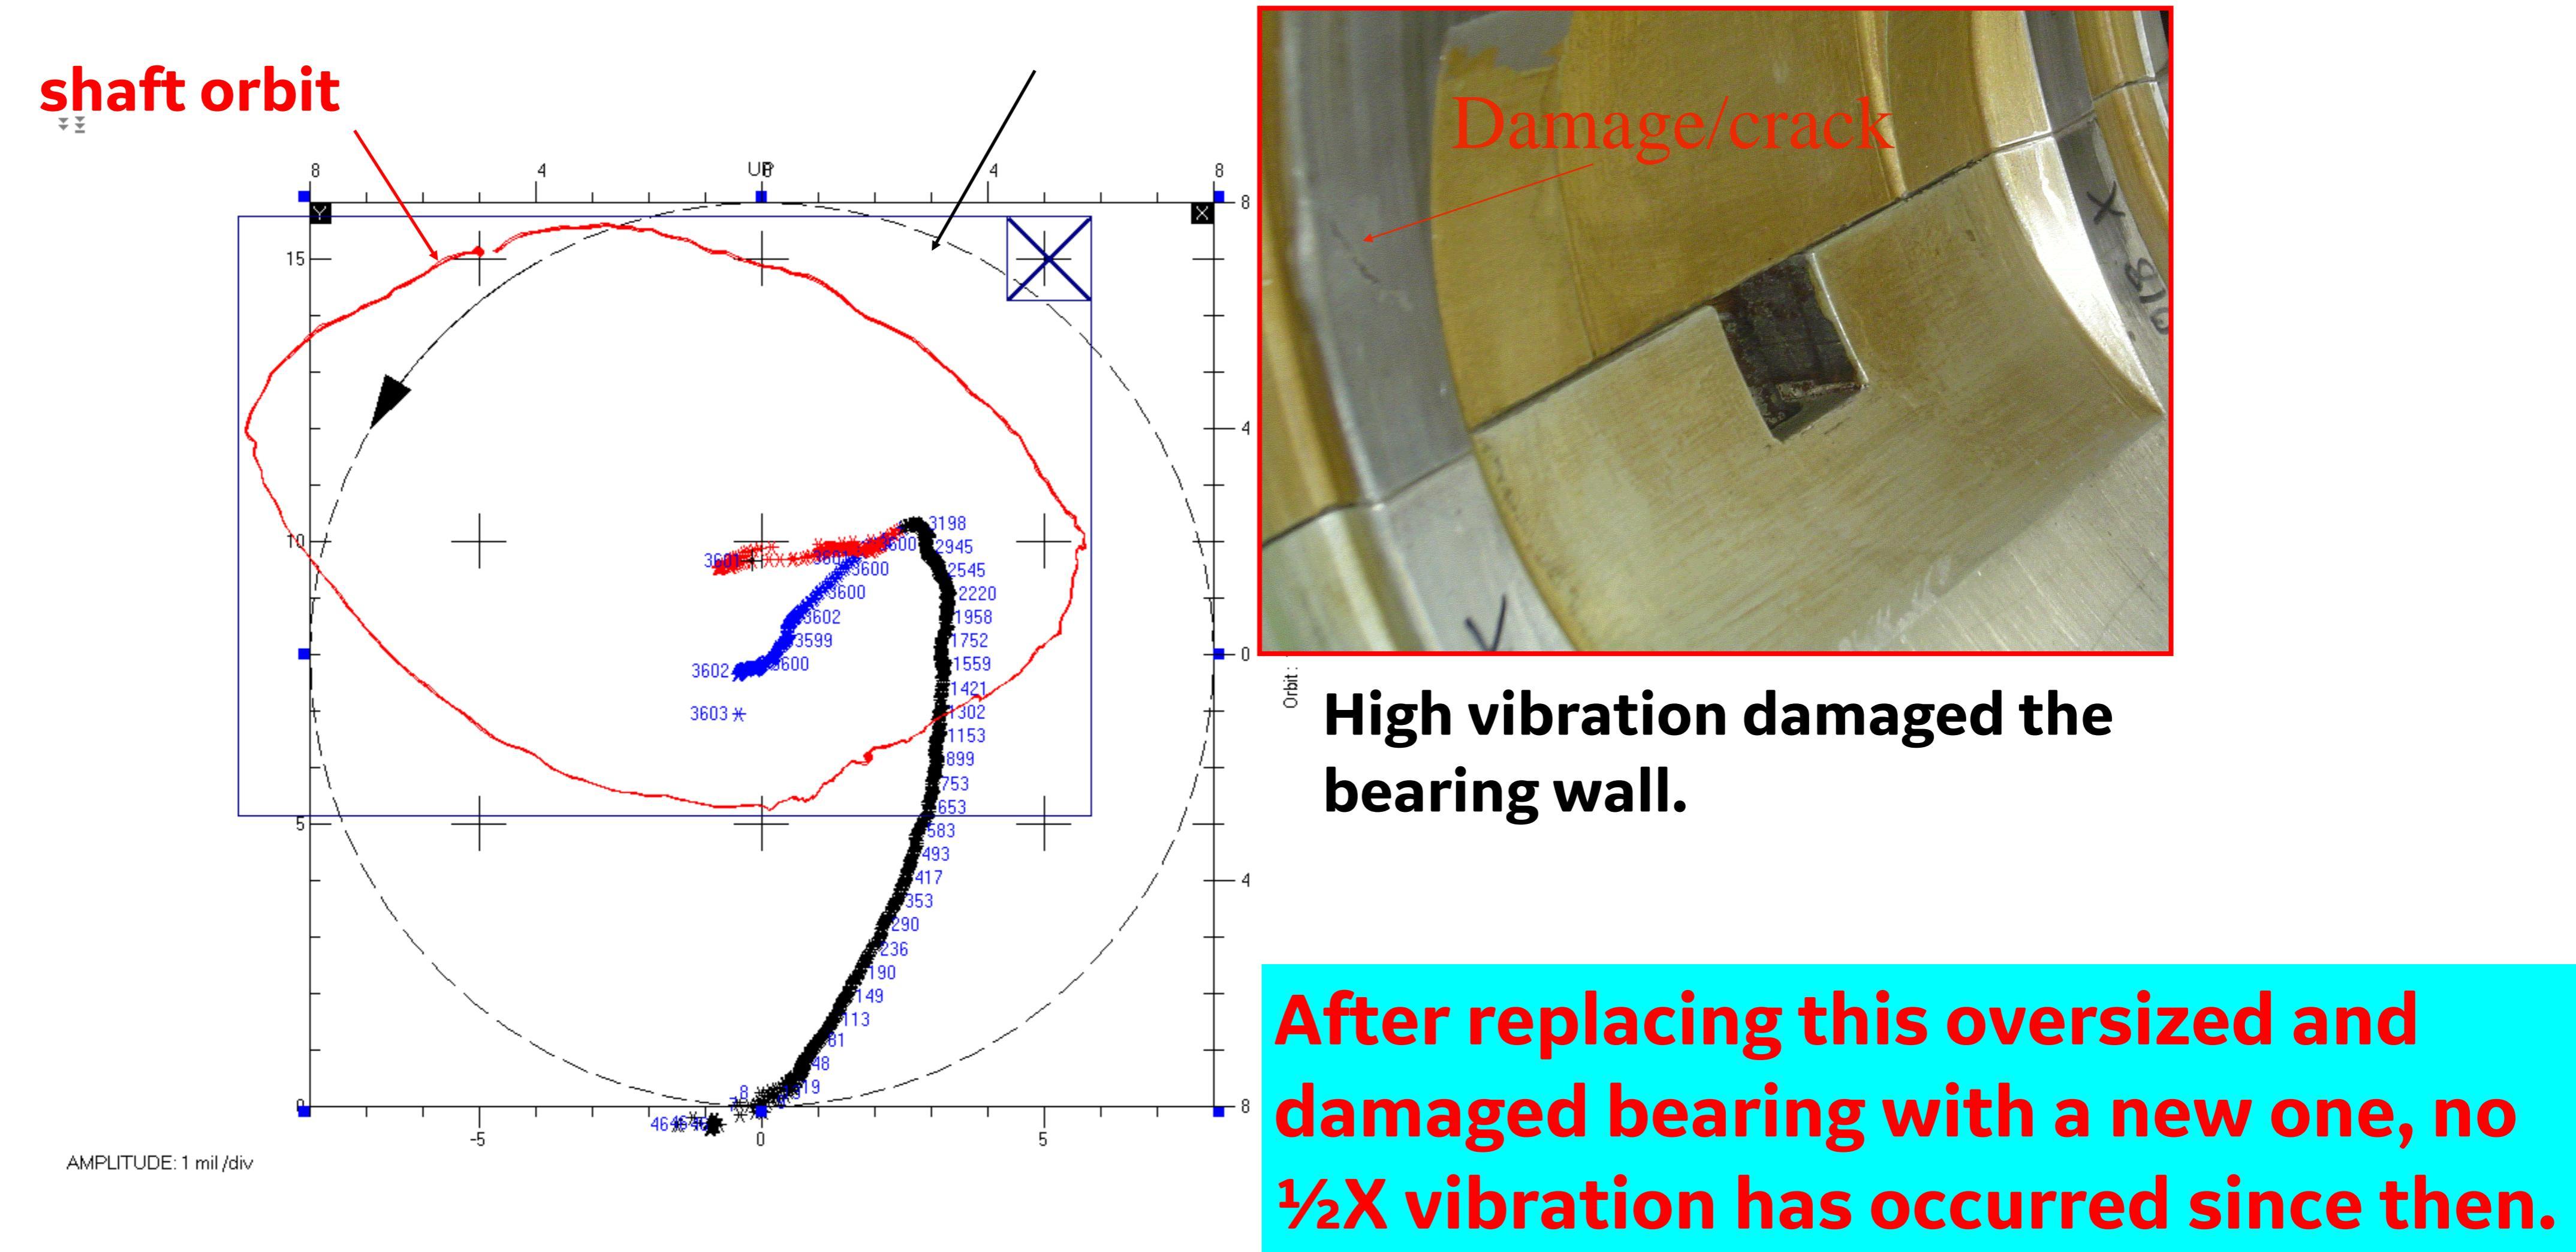
- **Oversized bearing. Diametral clearance** 0.005 inch (127 µm) higher than its spec
- Damage on the bearing surface.

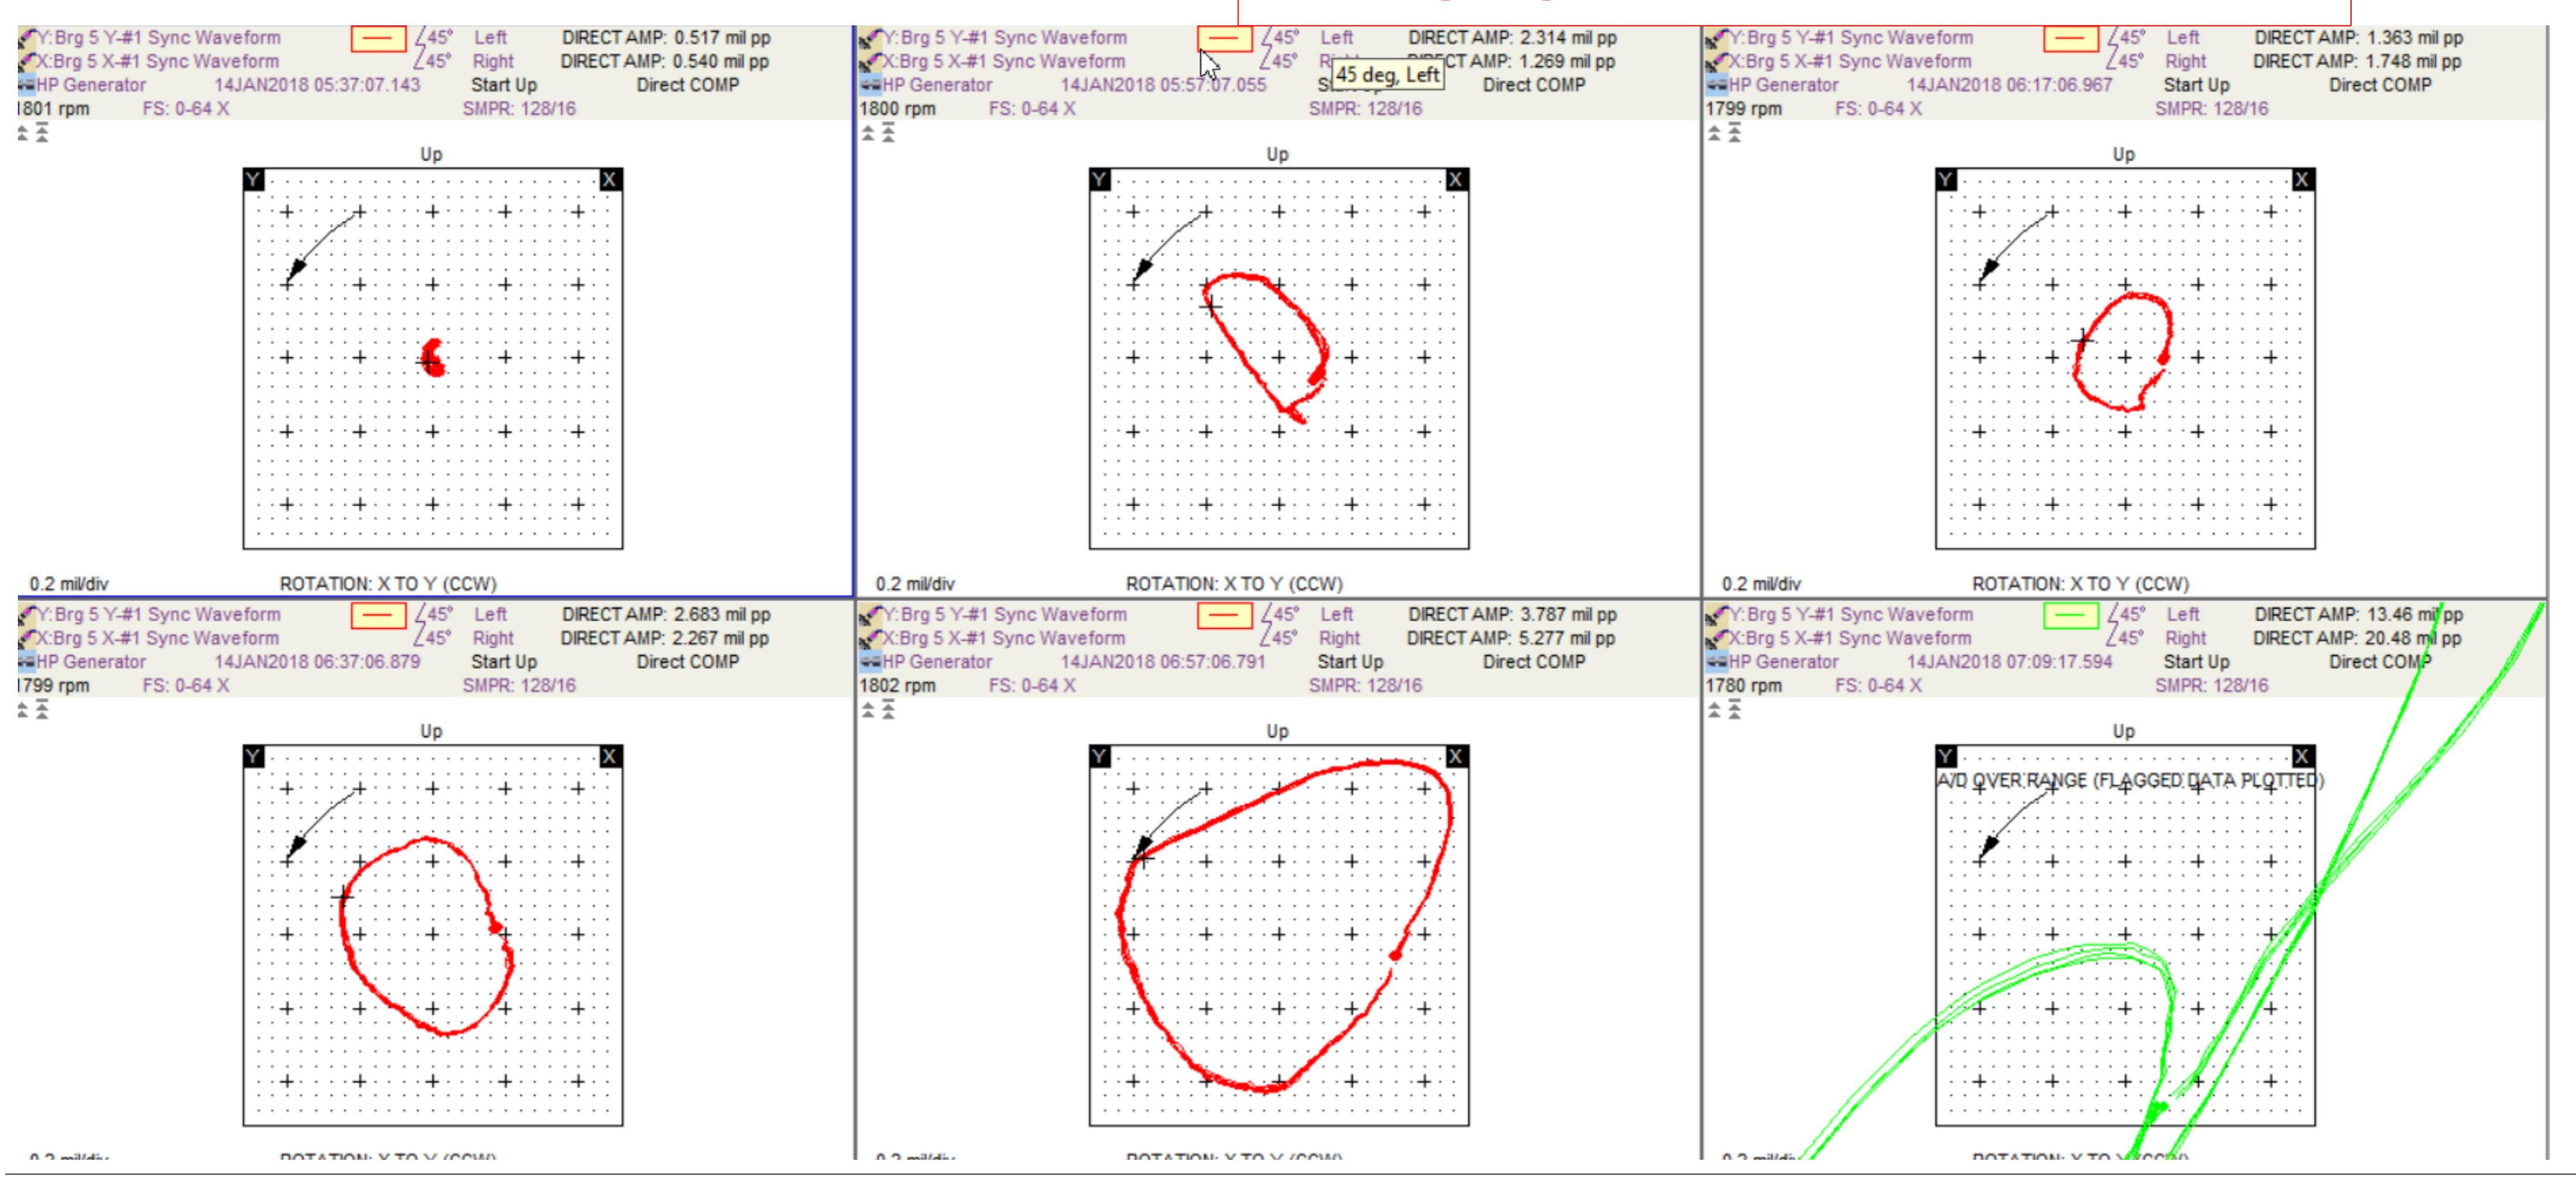
Waveform-compensated orbits:

>1X vectors changed at constant speed Distorted orbits at Brg#5 Likely due to changes in shaft centerline position What caused ¹/₂X vibration ? – oversized bearing
