Bently Nevada Rub, Morton Effect, Parametric Excitation, and Shaft Crack in Rotating Machinery - Real Cases

John J. Yu, PhD **Senior Technical Manager** Machinery Diagnostic Services

April 2, 2019

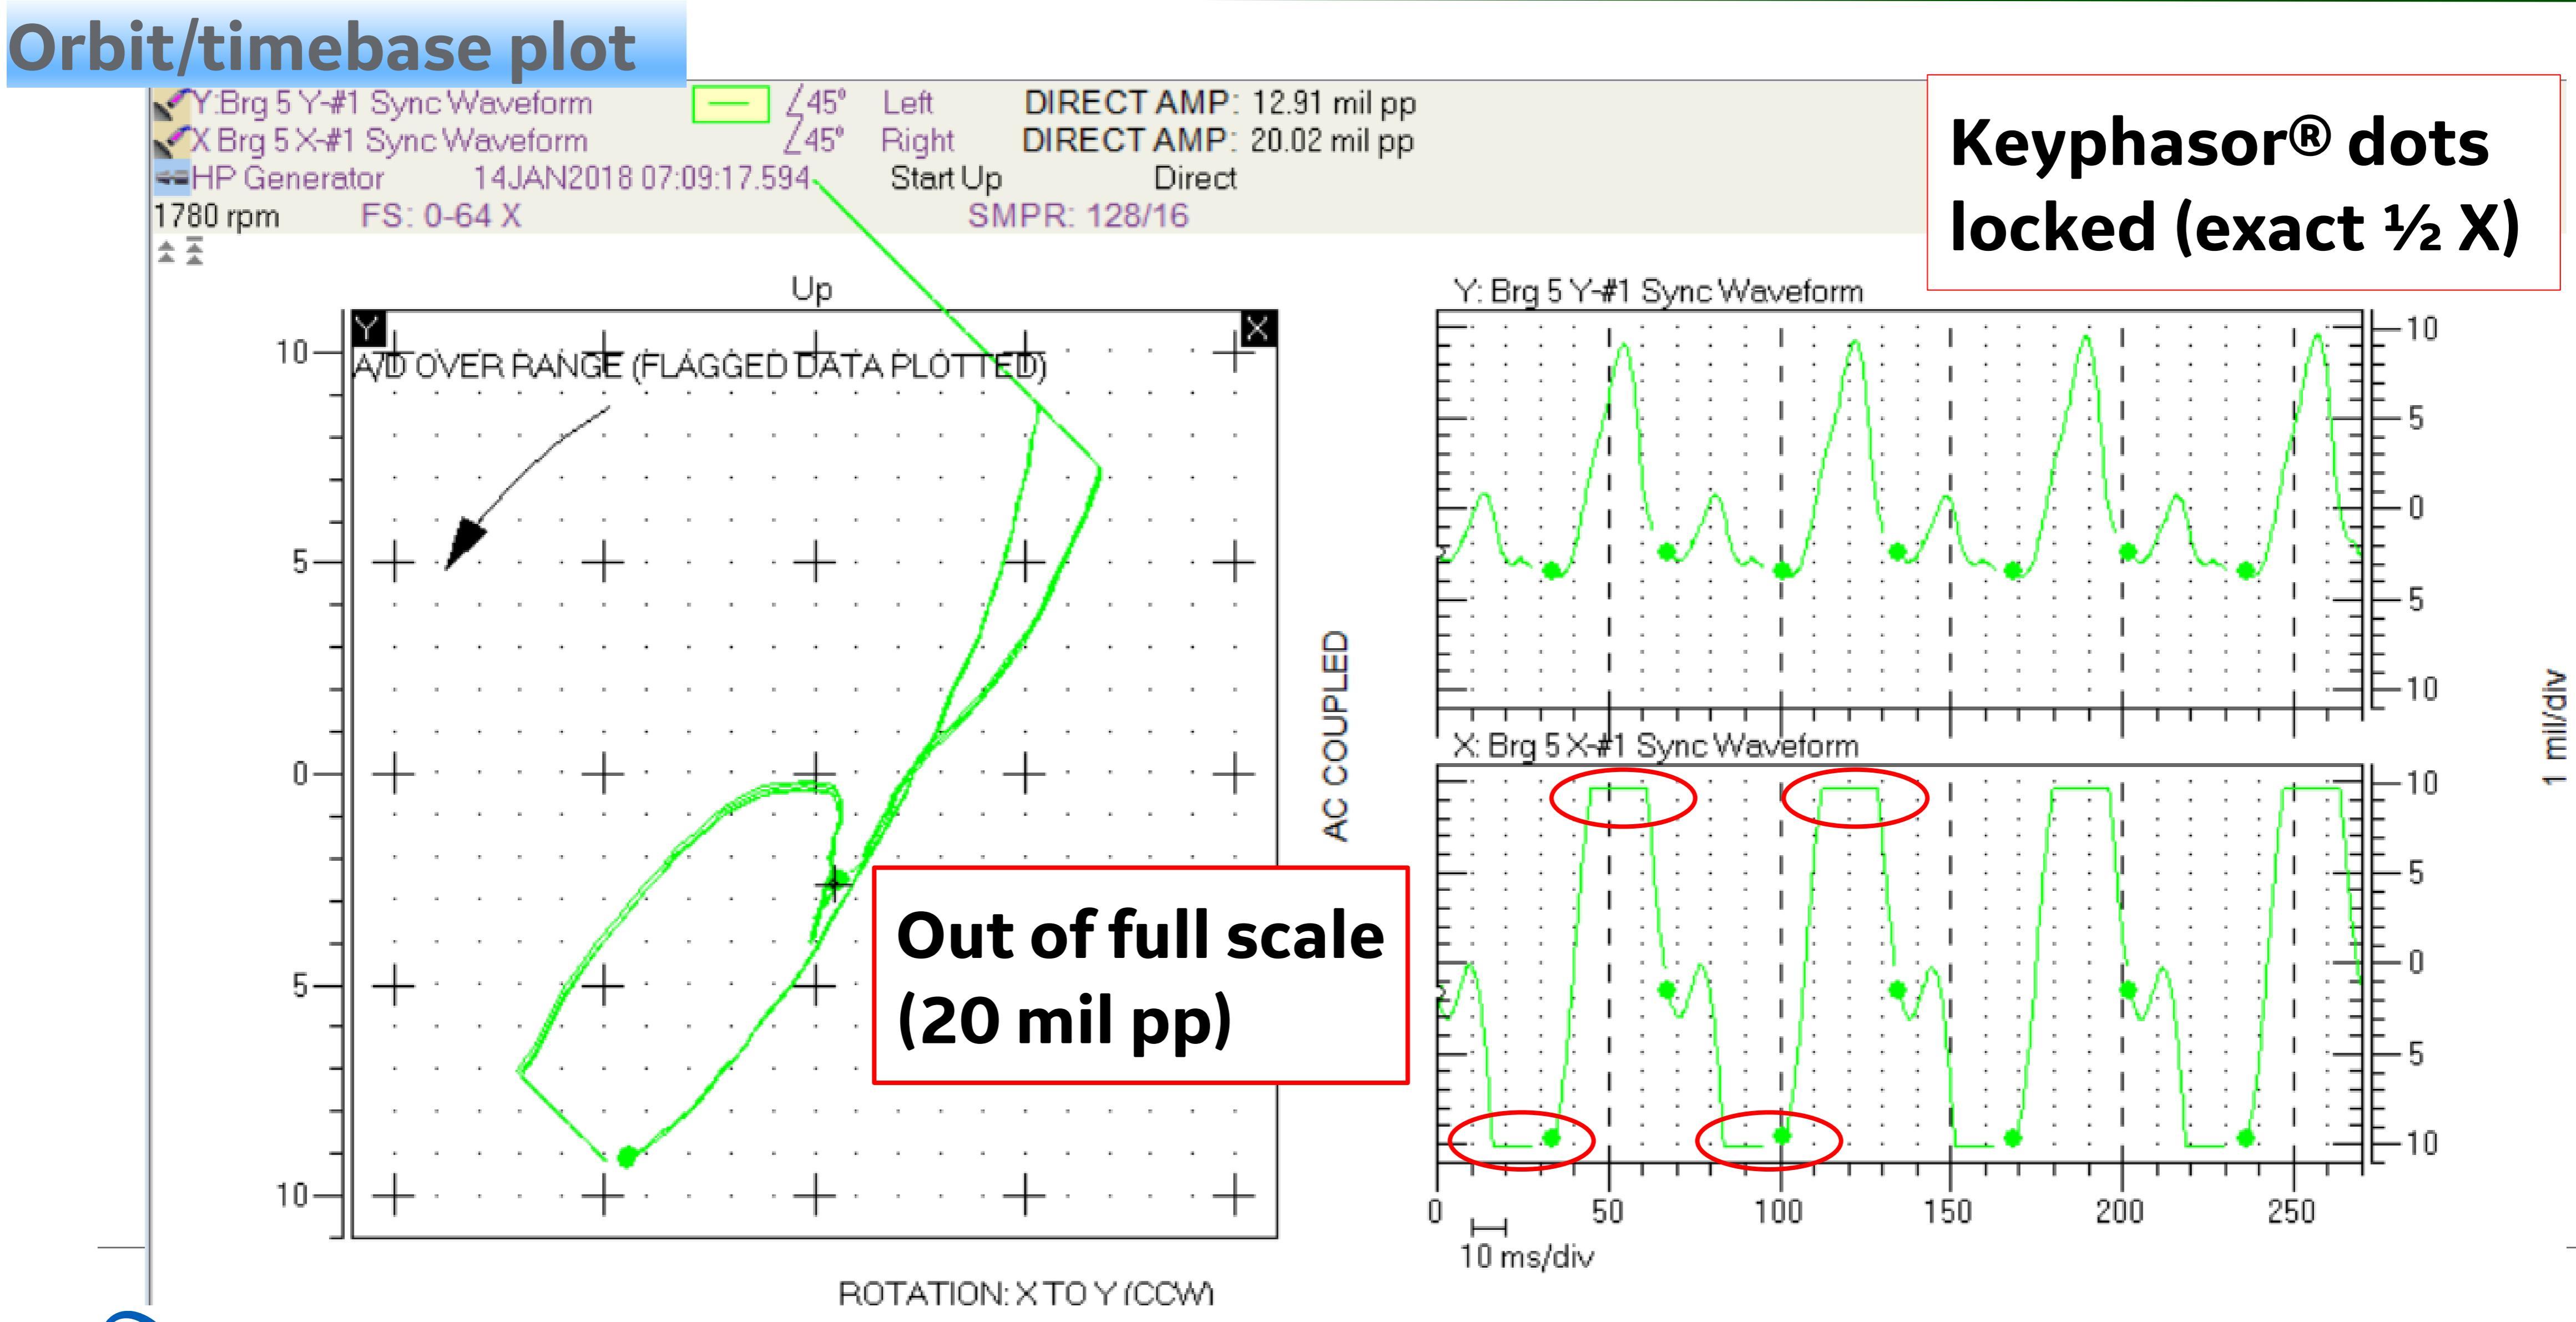
Changing with time at 1800 rpm

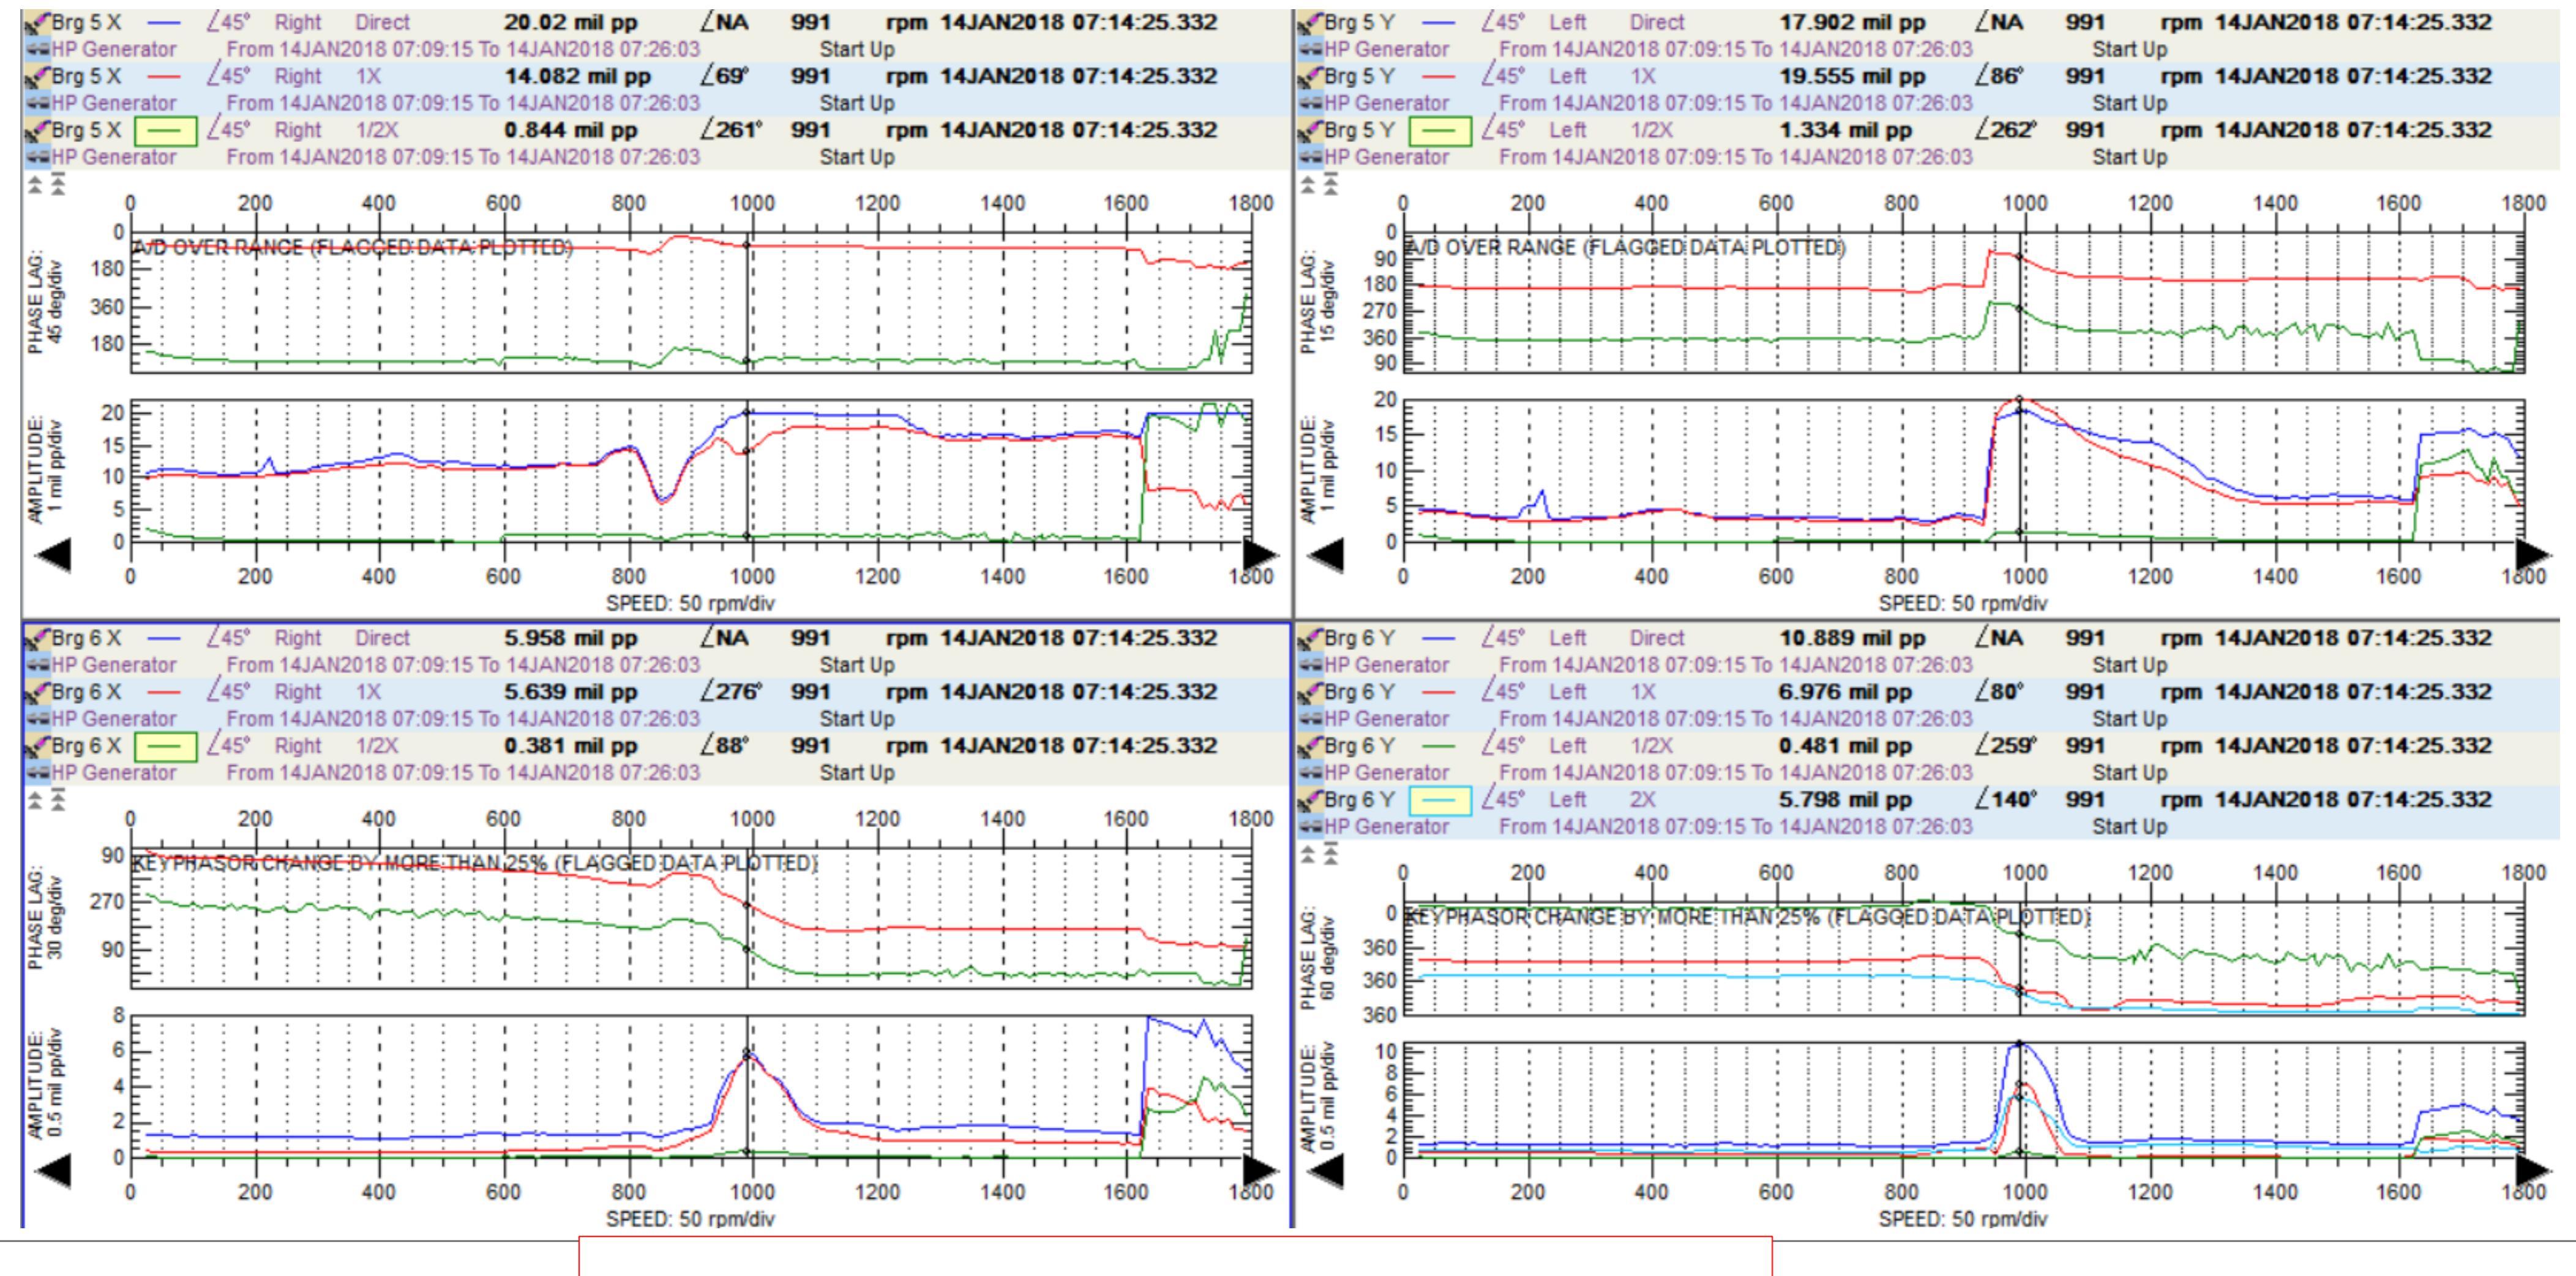
991 rpm as resonance or critical speed during coast-down

Direct, 1X, and ½X bode plots plots 1/2X maintained until 1631 rpm during coast-down

> 1X, followed by dominant $\frac{1}{2}X$ (20 mil pp), thus tripping the unit. ¹/₂X maintained above 1631 rpm during shutdown

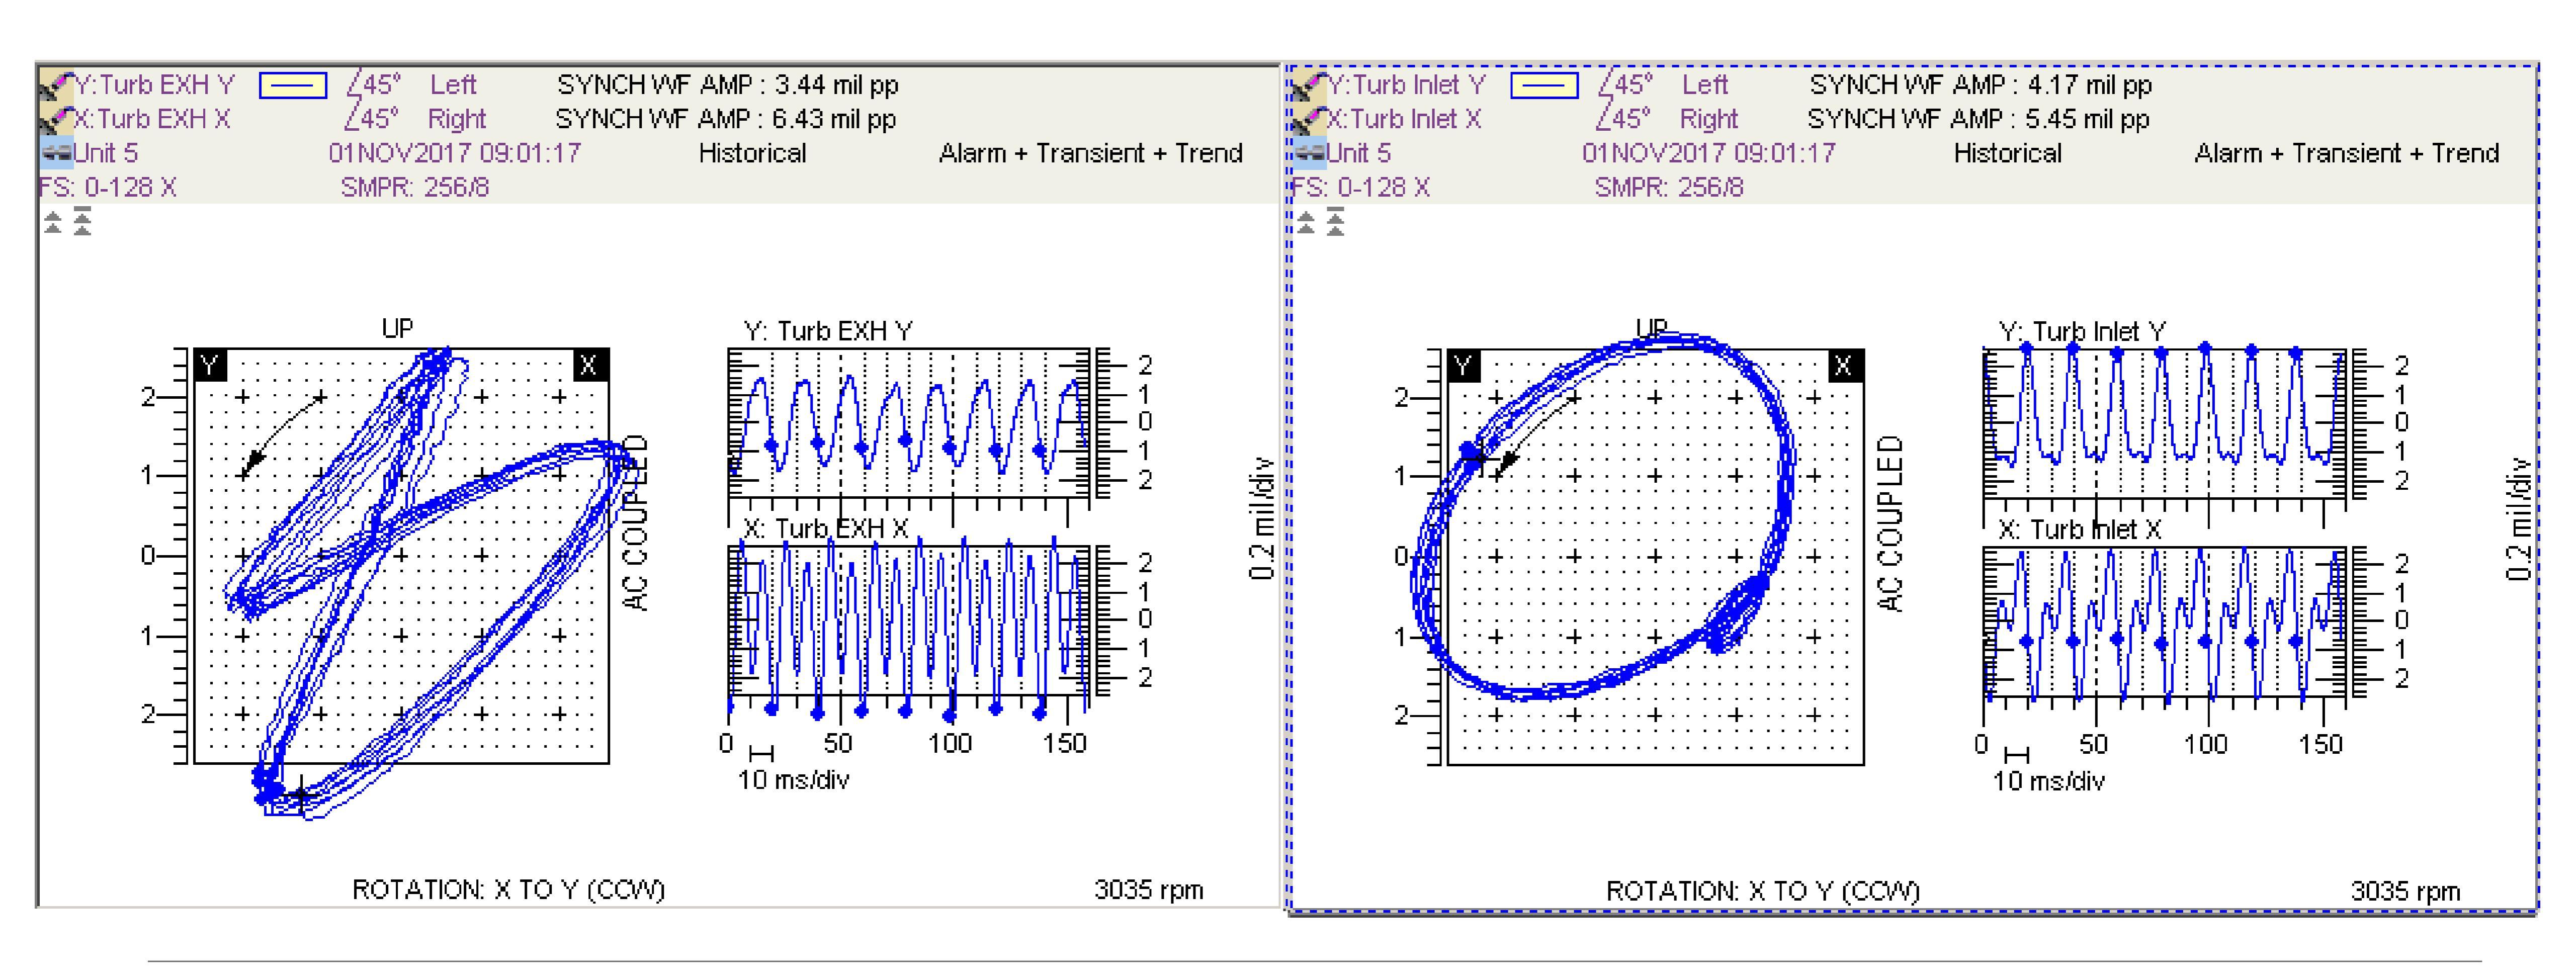
Direct compensated orbit of the TURB EXH bearing at 3035 RPM during shutdown

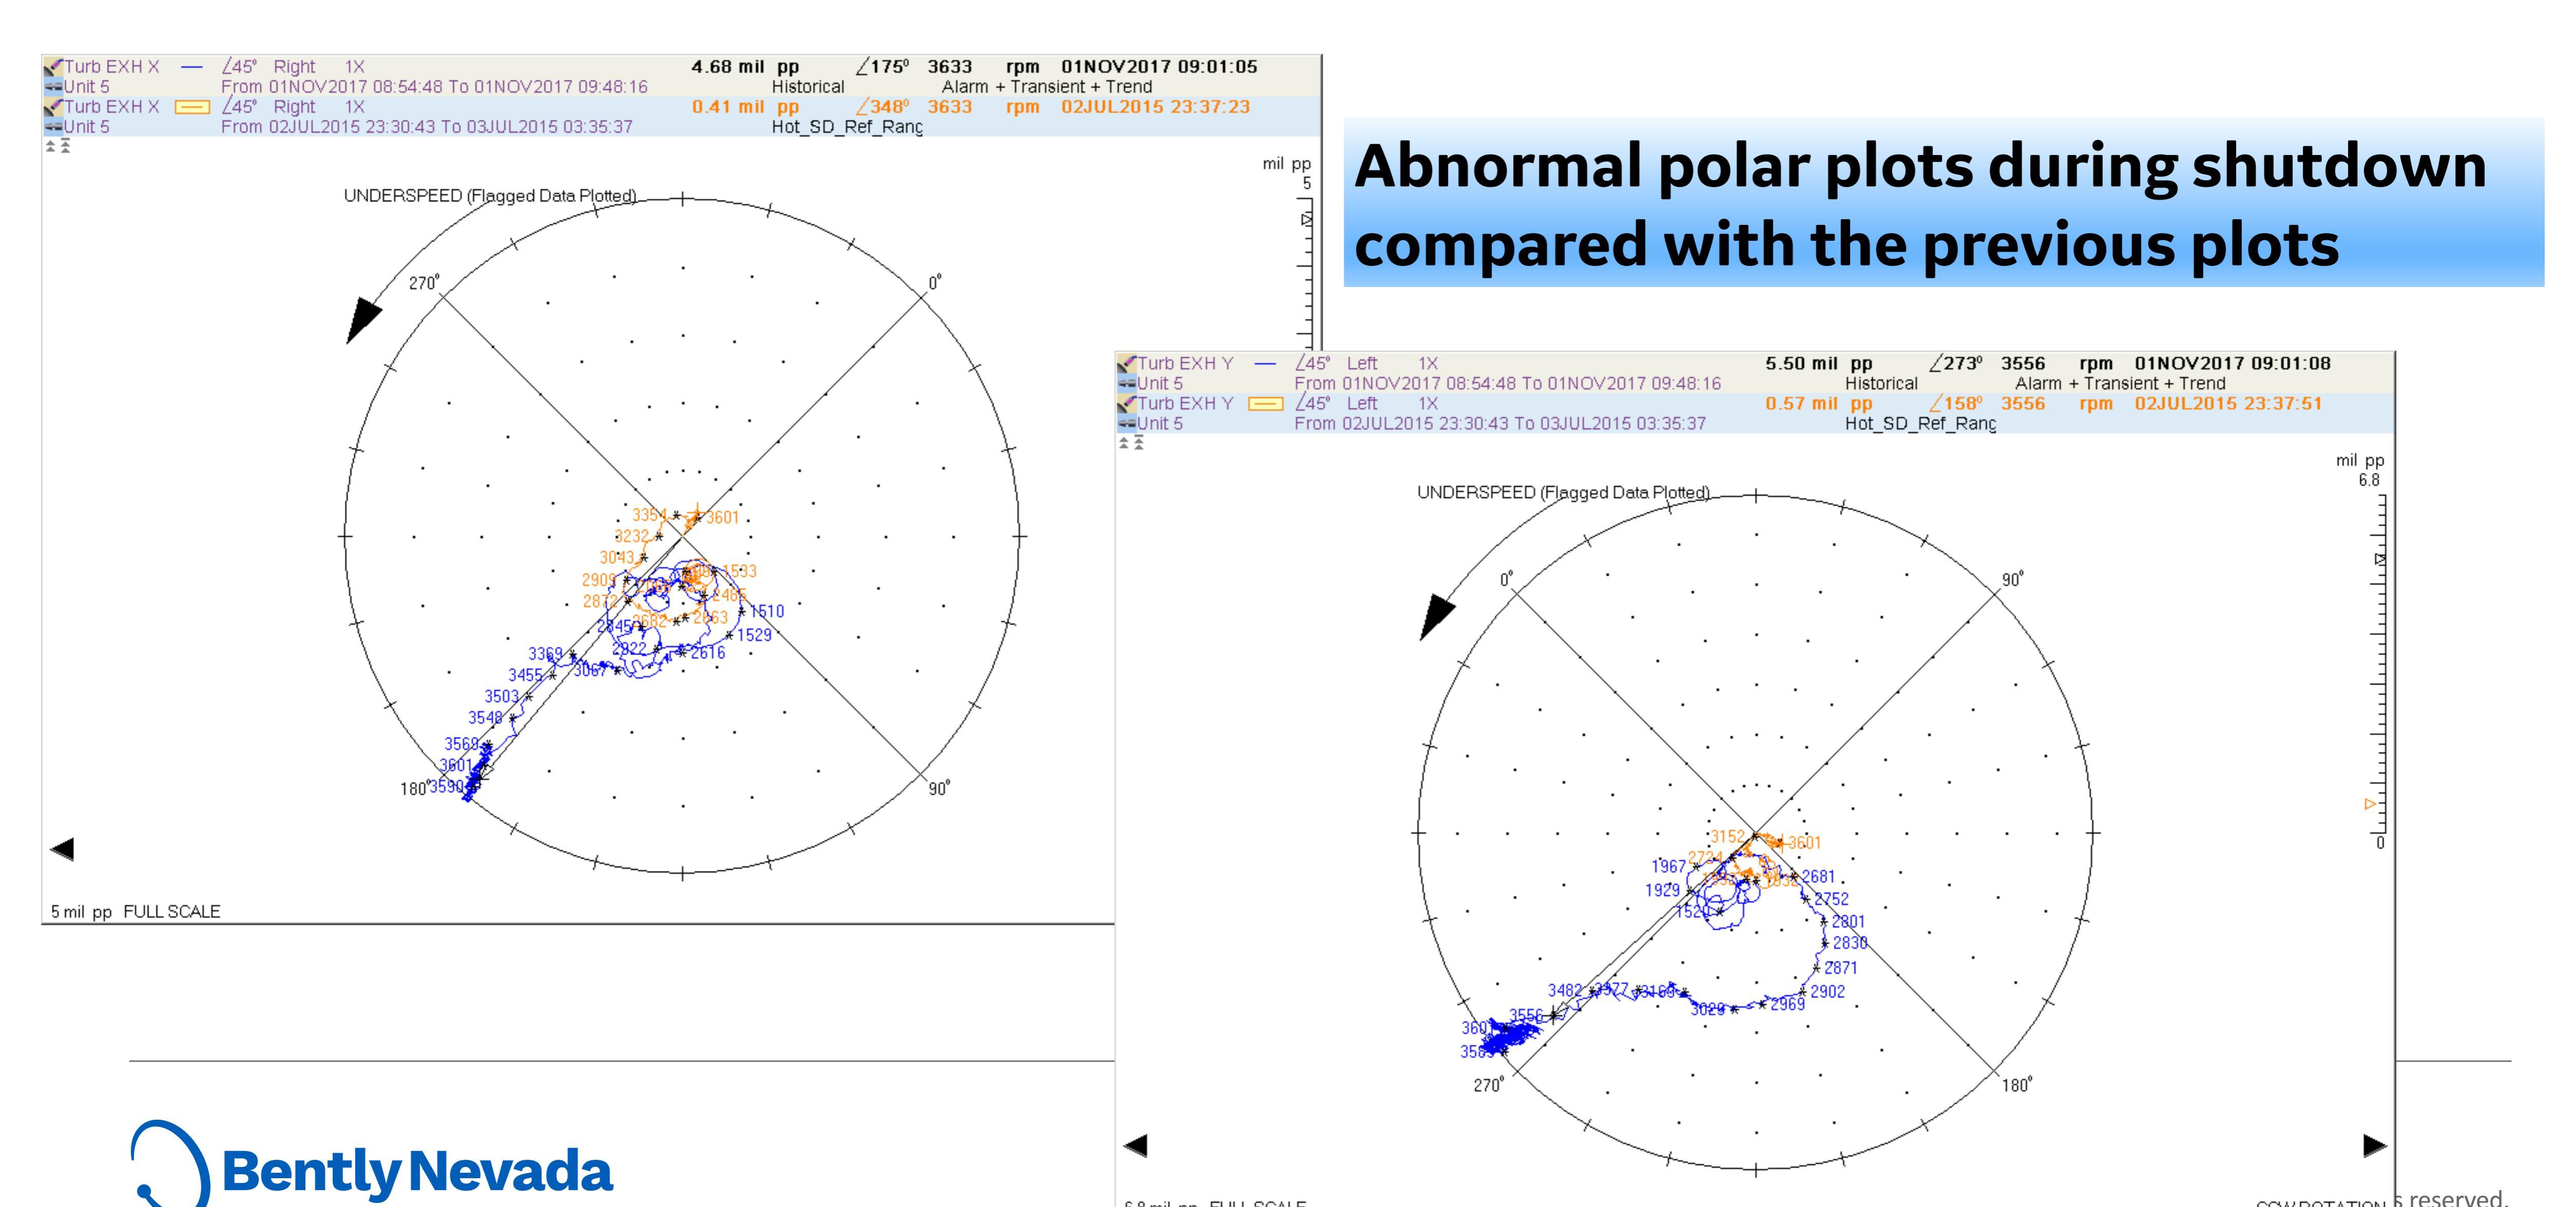
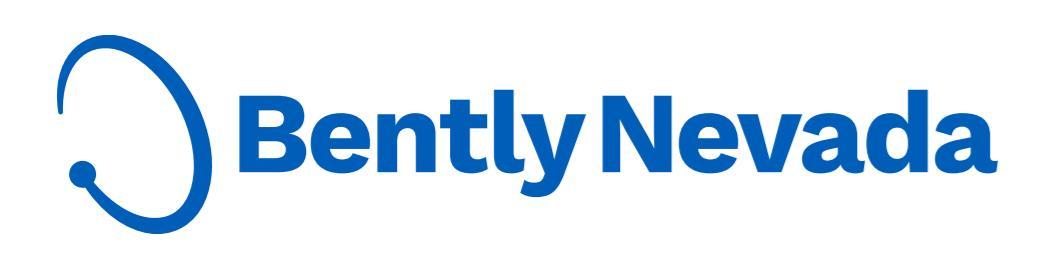
Cracks on torque tube that joins the compressor and turbine sections of the rotor
